# TRIGA FUEL EXAMINATION USING A GE EVEREST XLG3 VIDEOPROBE - WHAT IT MEANS FOR THE FUTURE OF FUEL INTEGRITY DETERMINATION (& OTHER POSSIBLE USES)

TRTR 2016 – Albuquerque, NM  
Dale Luke & Alan Robb  
August 22, 2016

# SNF Examinations

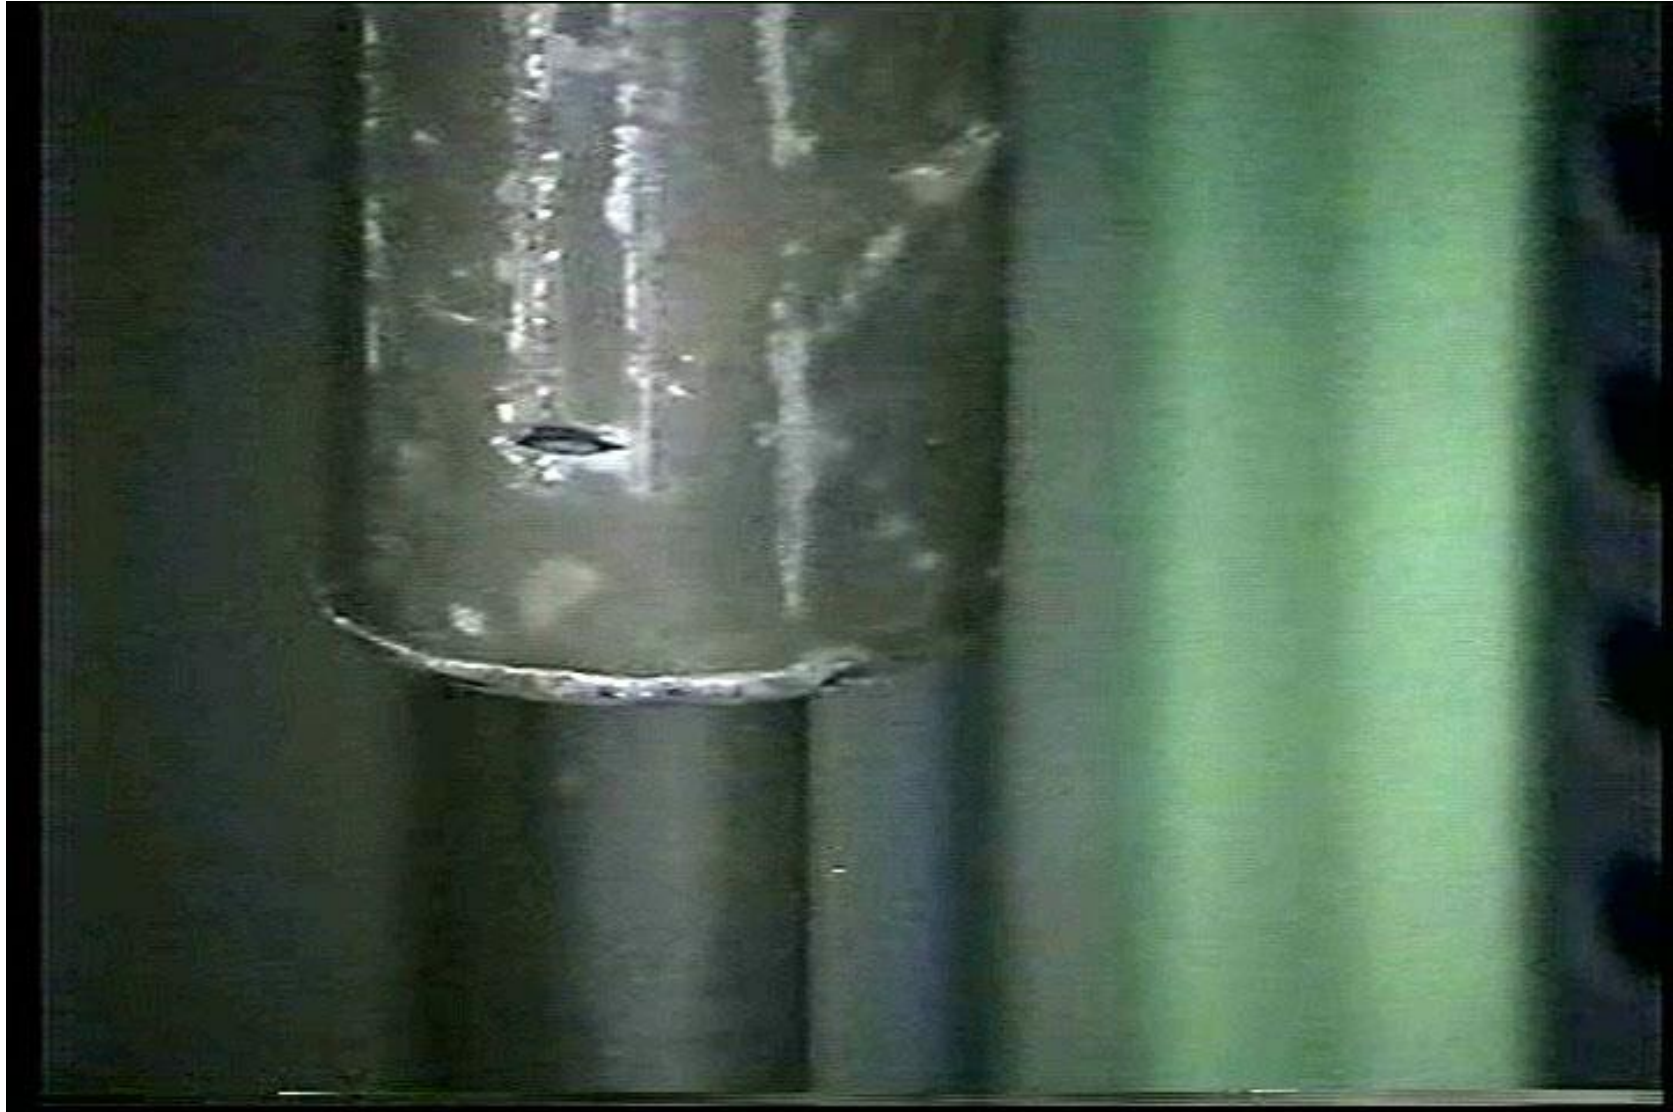
# Al-clad Element with Obvious Damaged Cladding

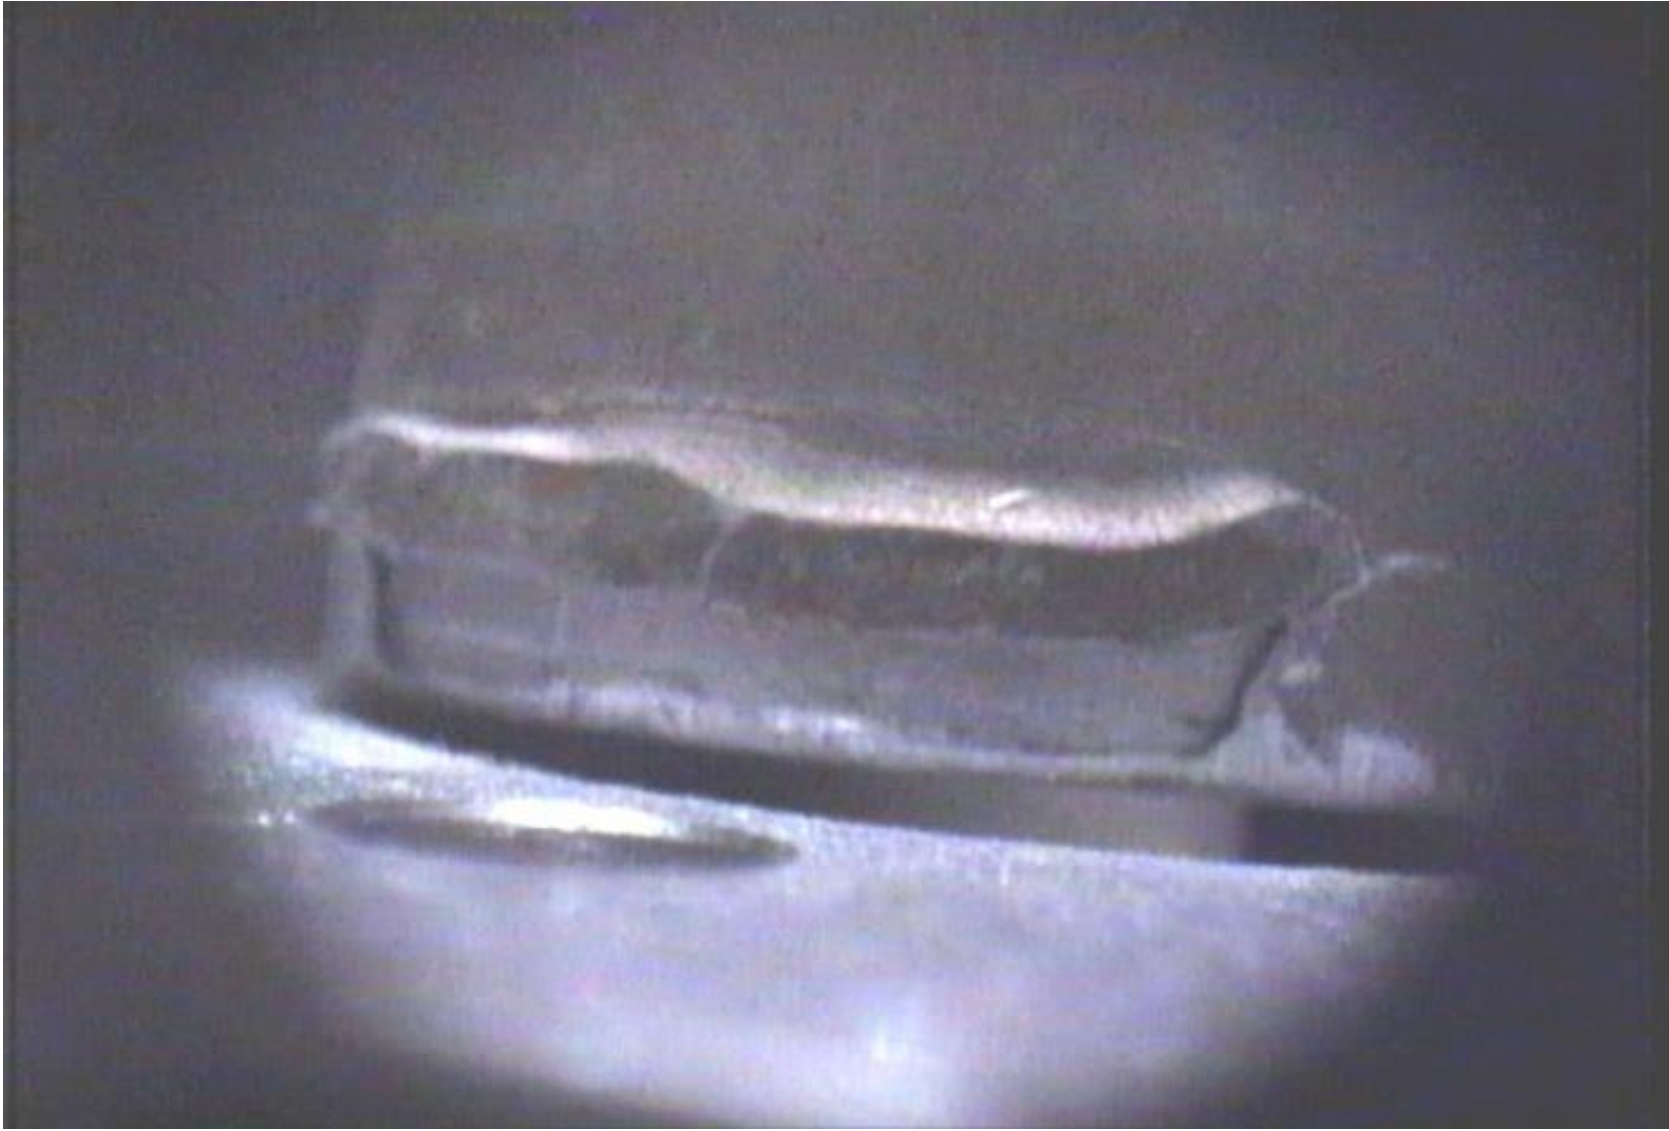
# Al-clad Element with Peeled Cladding & Crack

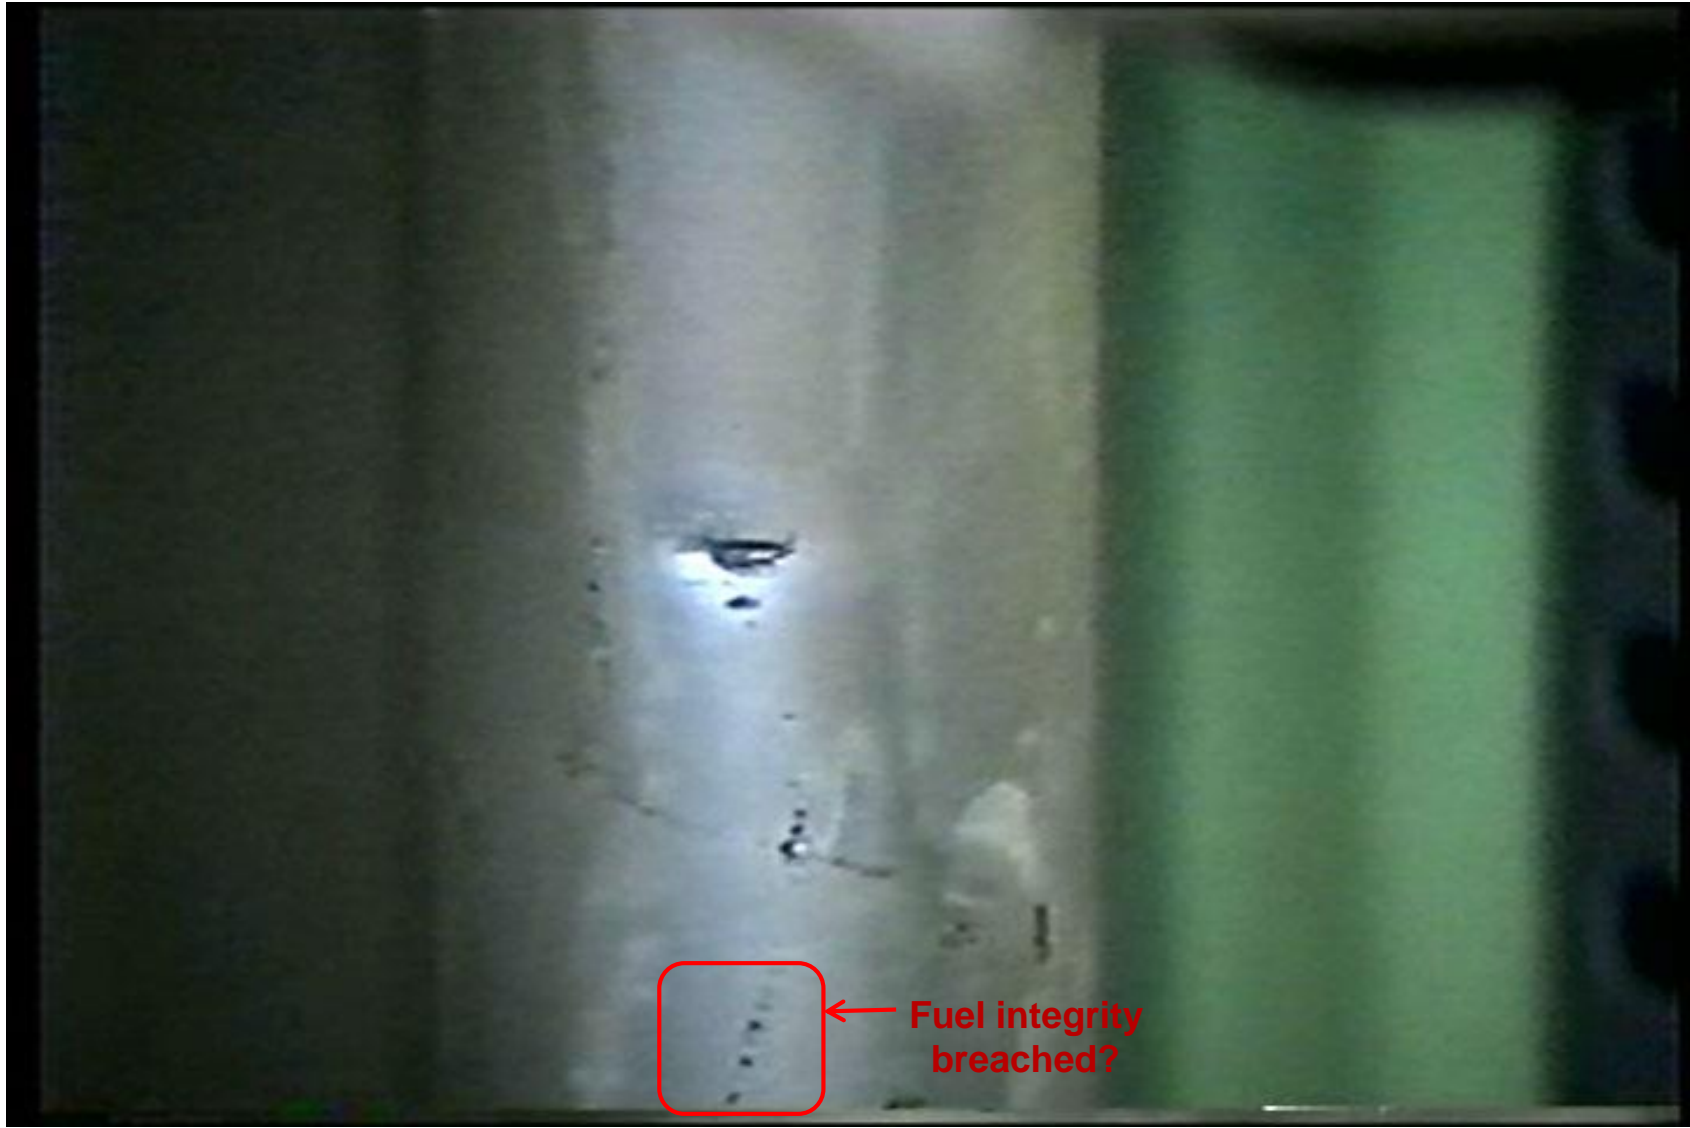
# Al-clad Element w/ Breached Cladding & Pinholes

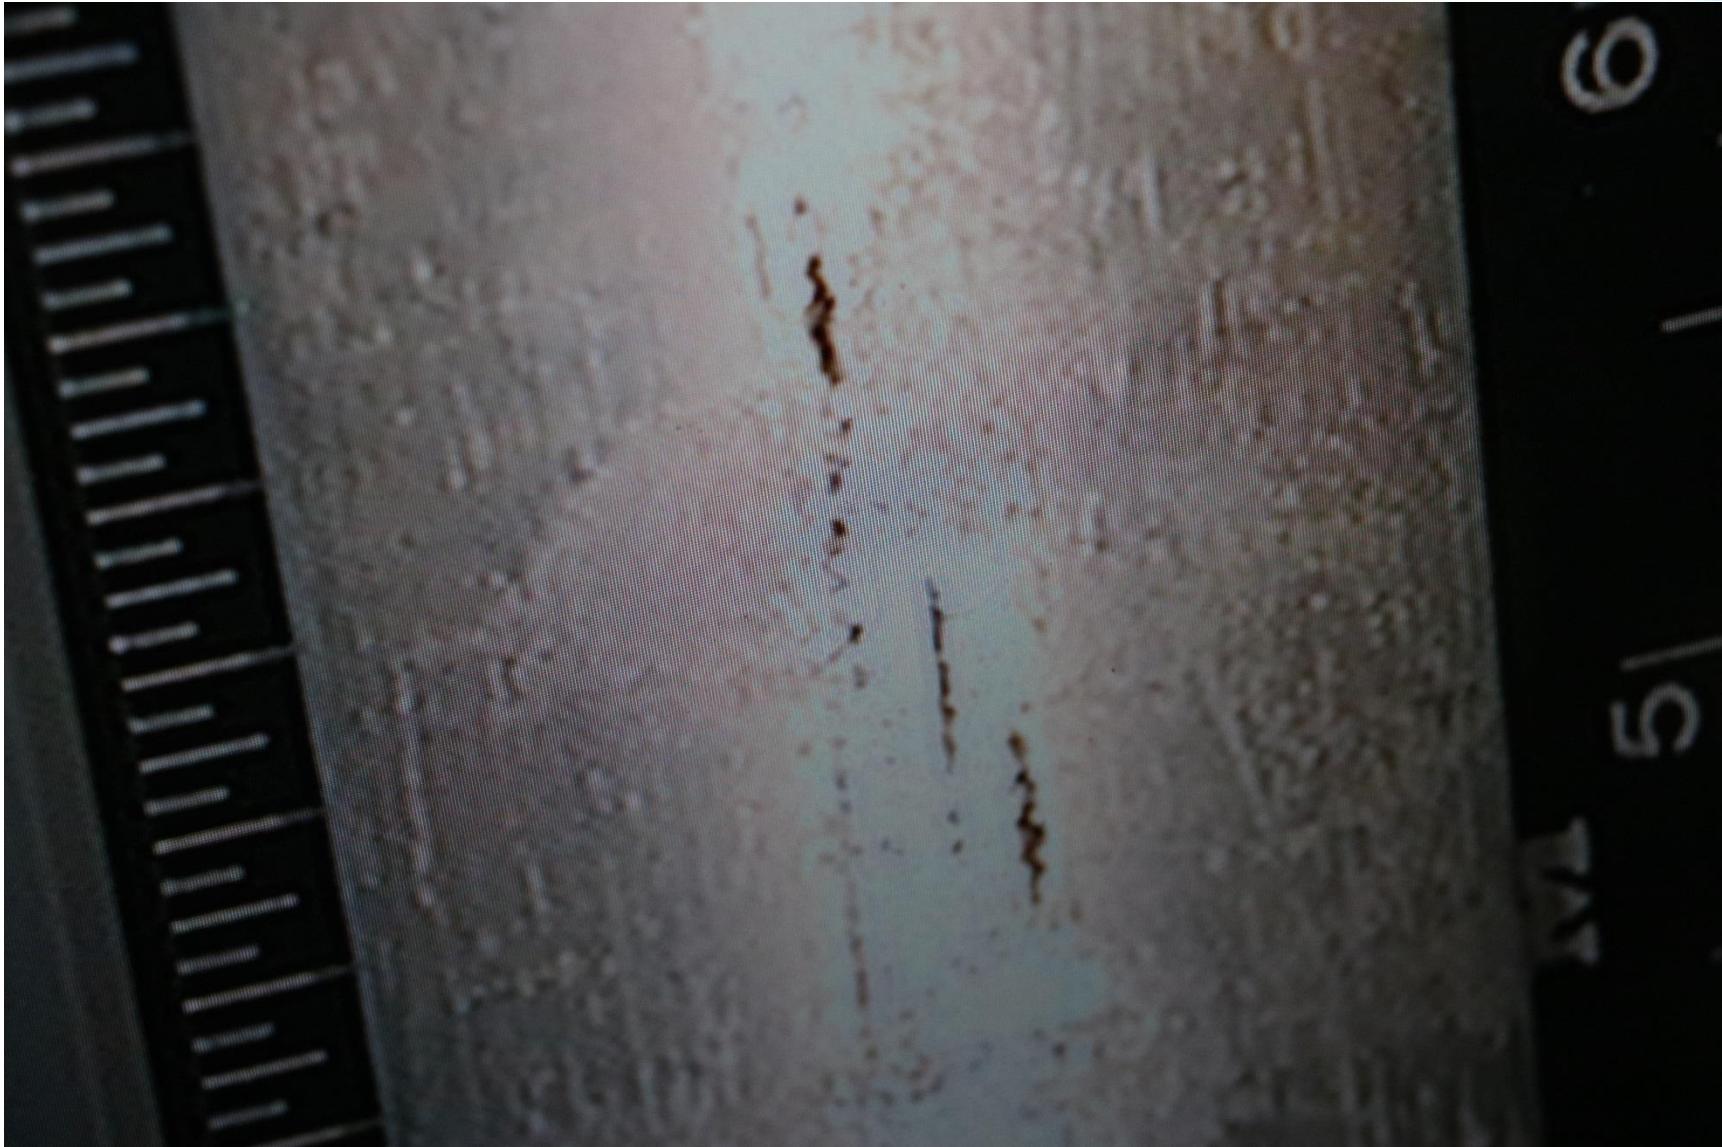
# Anomaly on TRIGA Element – Underwater Camera

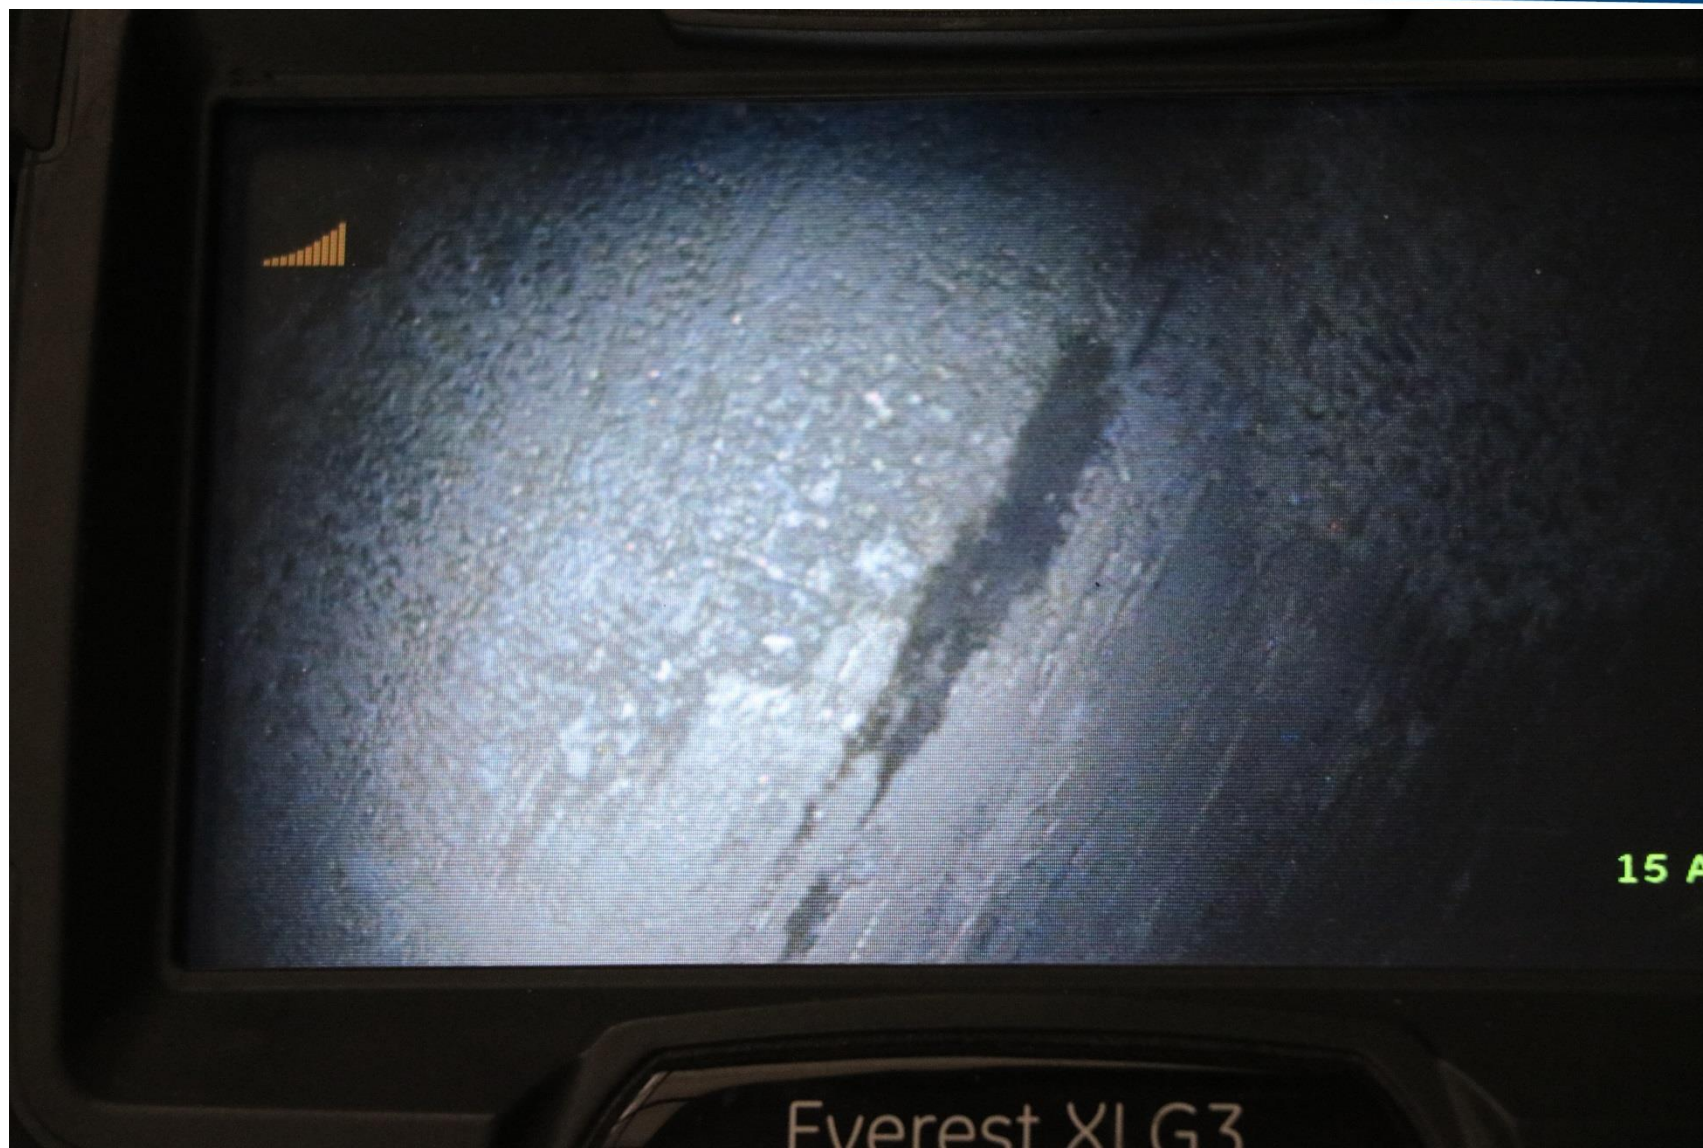
# Same Anomaly on Element – Seen w/ Video-Probe

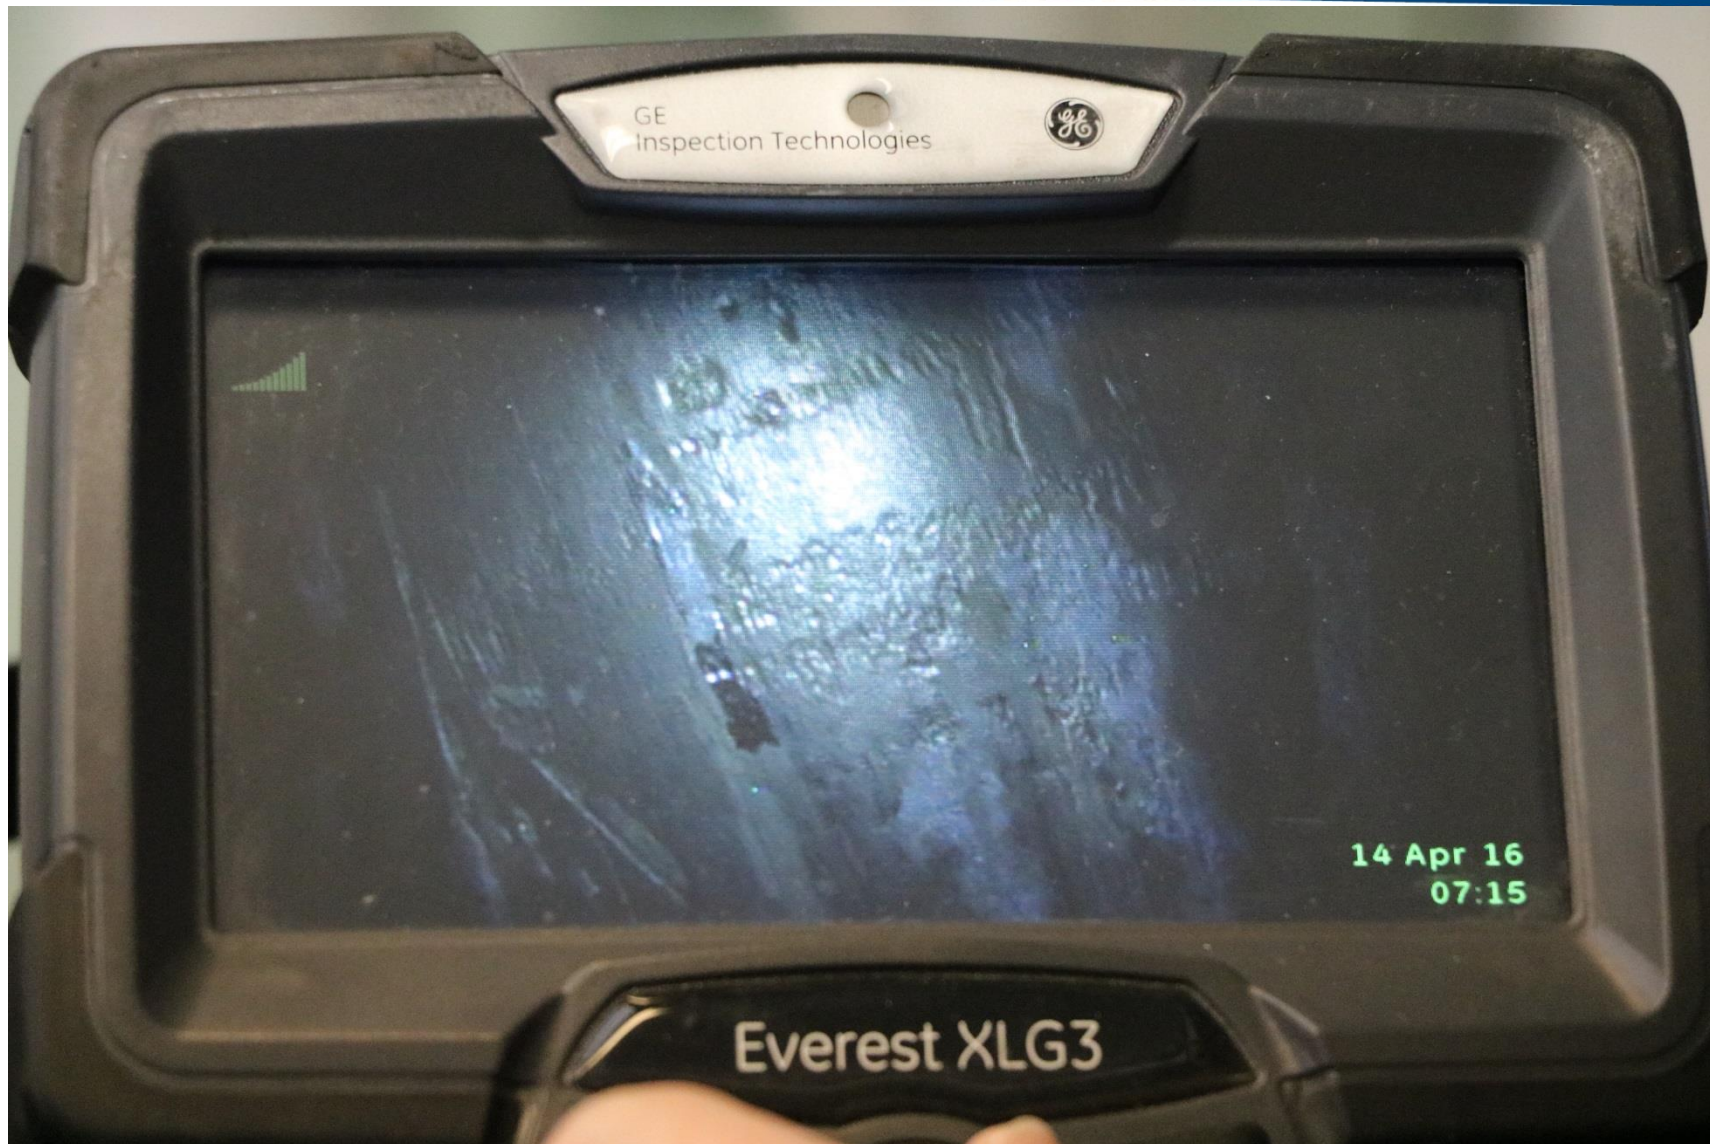
# Details of Anomalies – Seen w/ Video-Probe

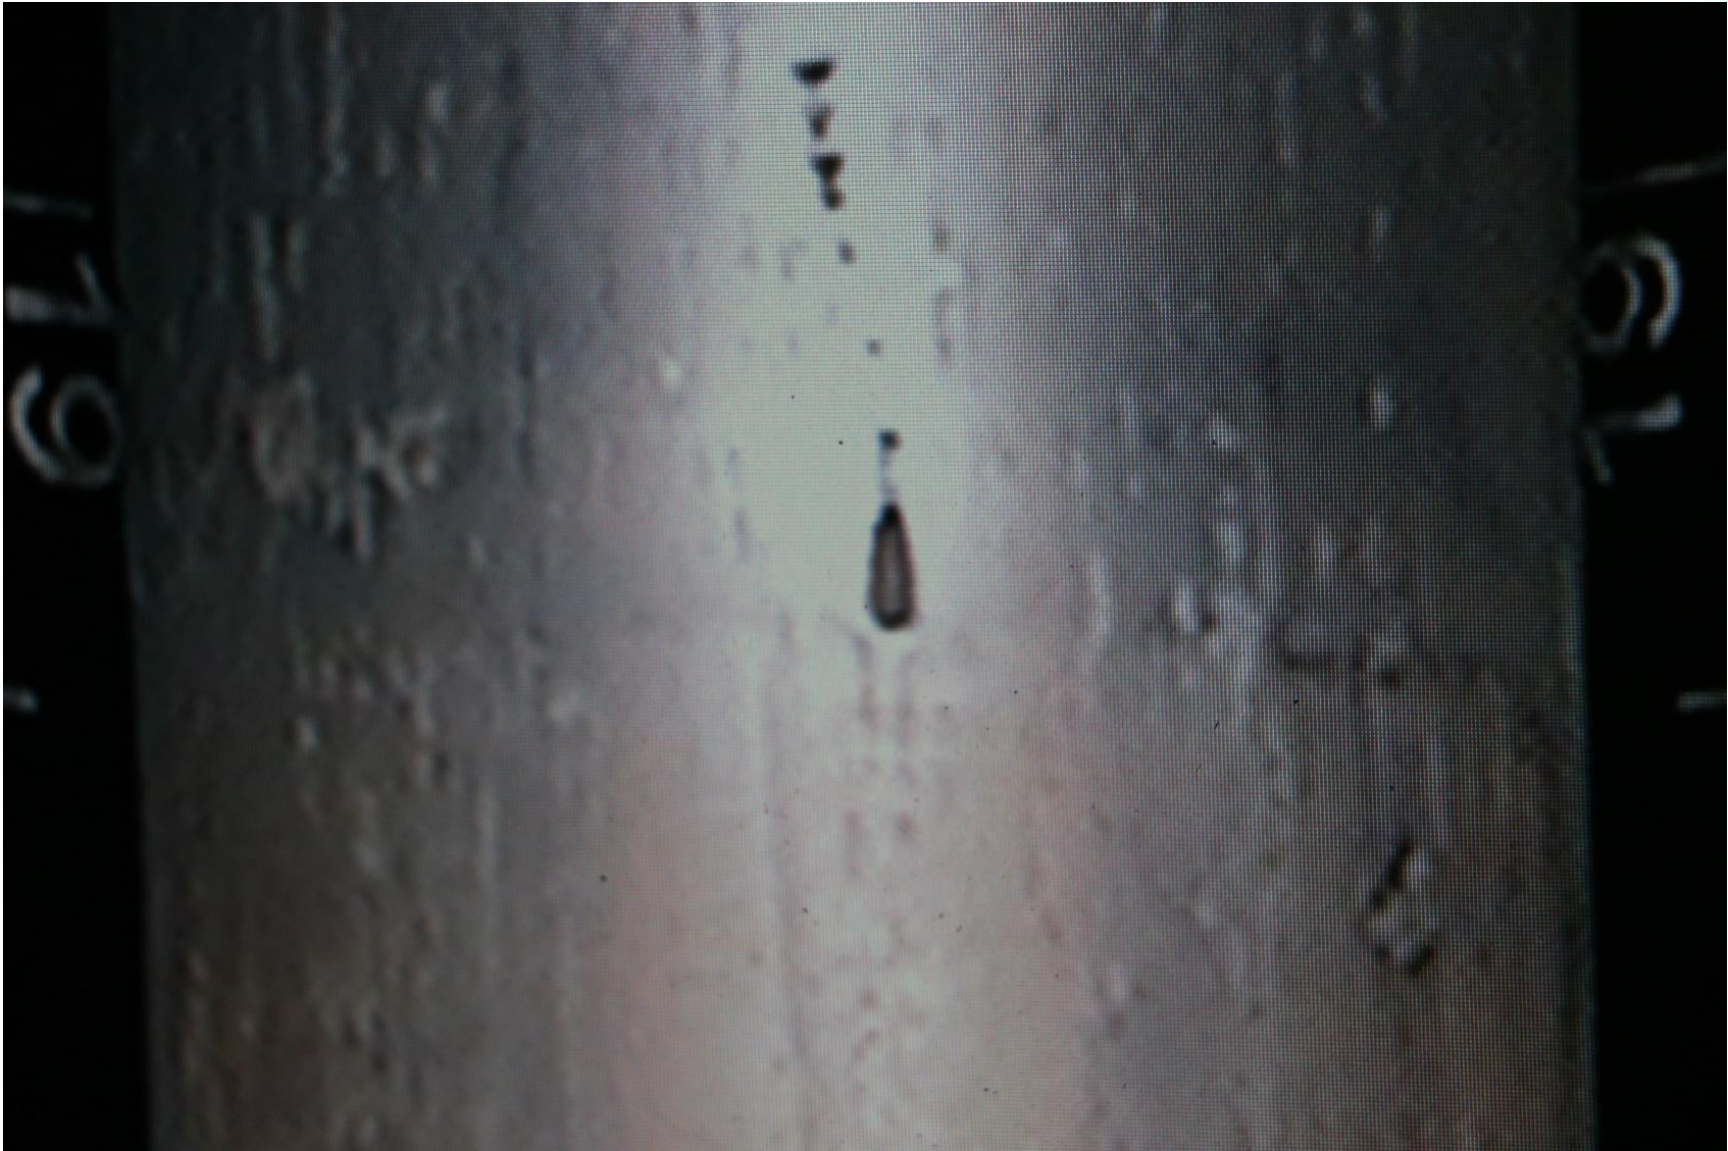
# Anomaly on TRIGA Element – Underwater Camera

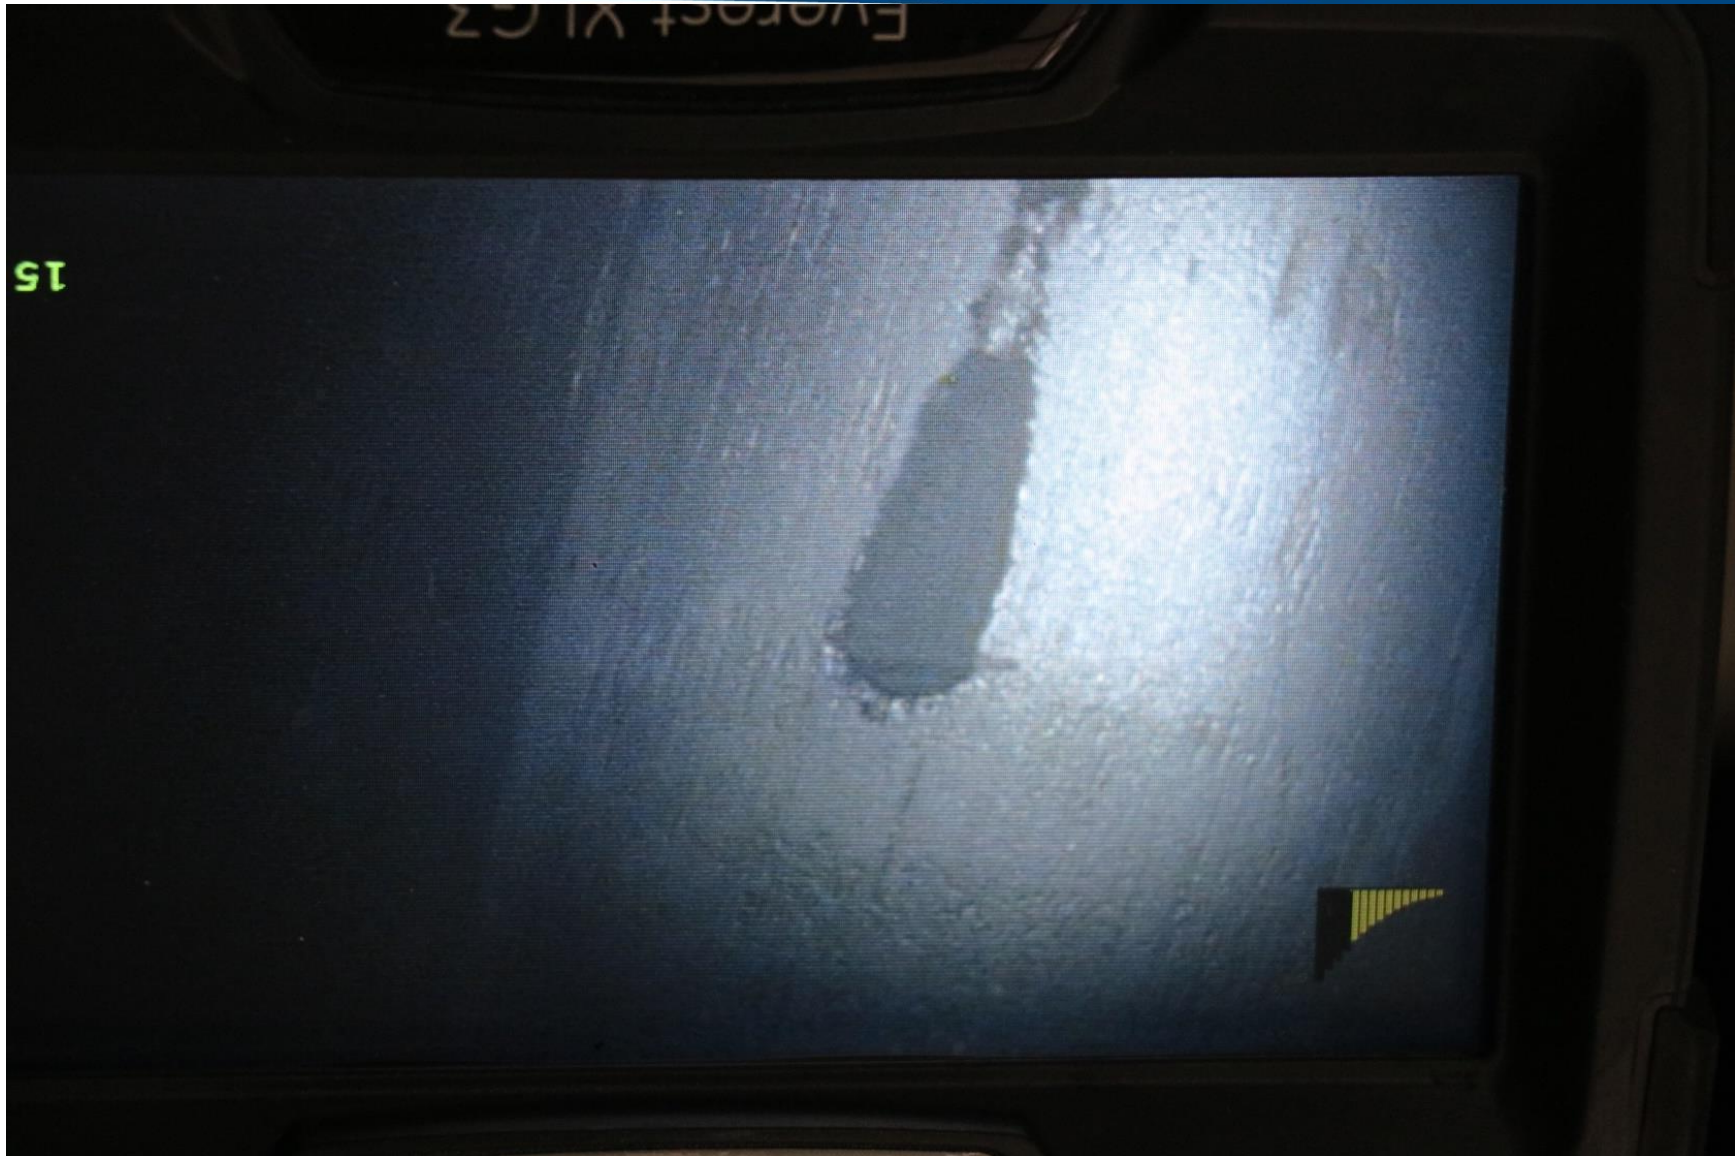
# Same Anomaly on Element – Seen w/ Video-Probe

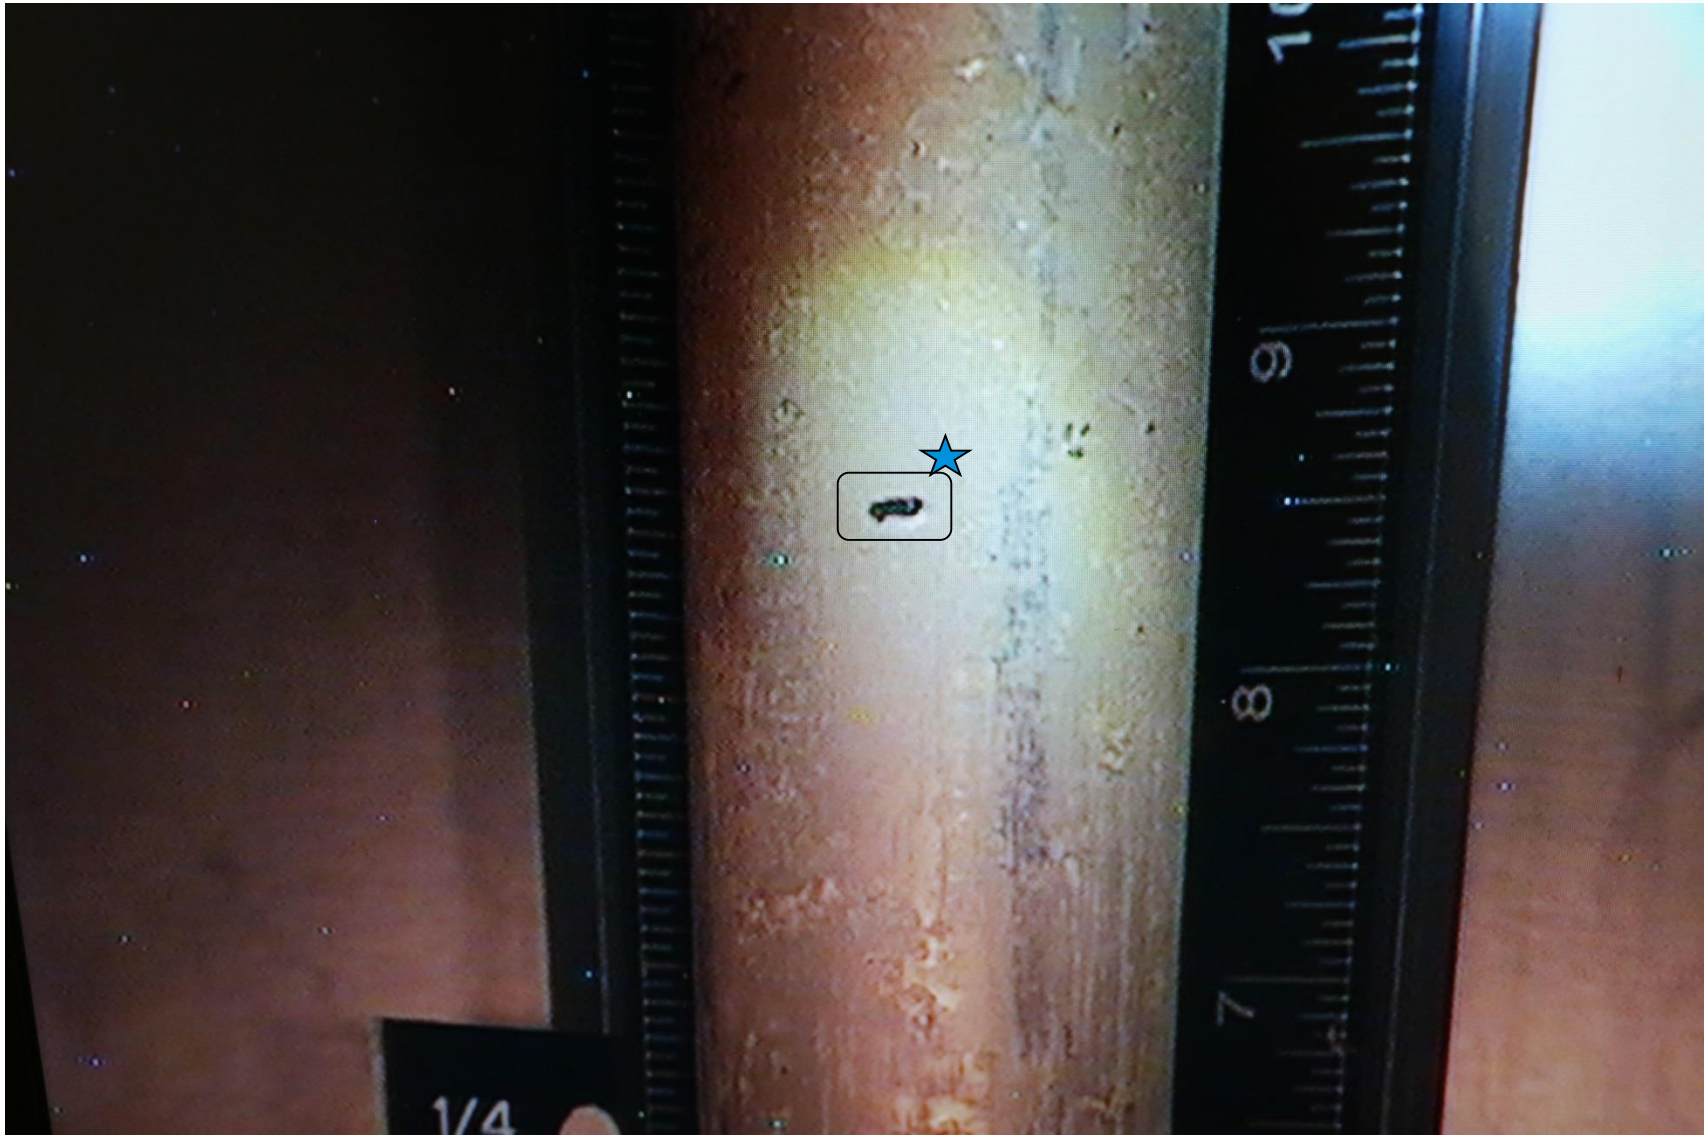
# Anomaly Found with Regular Camera System

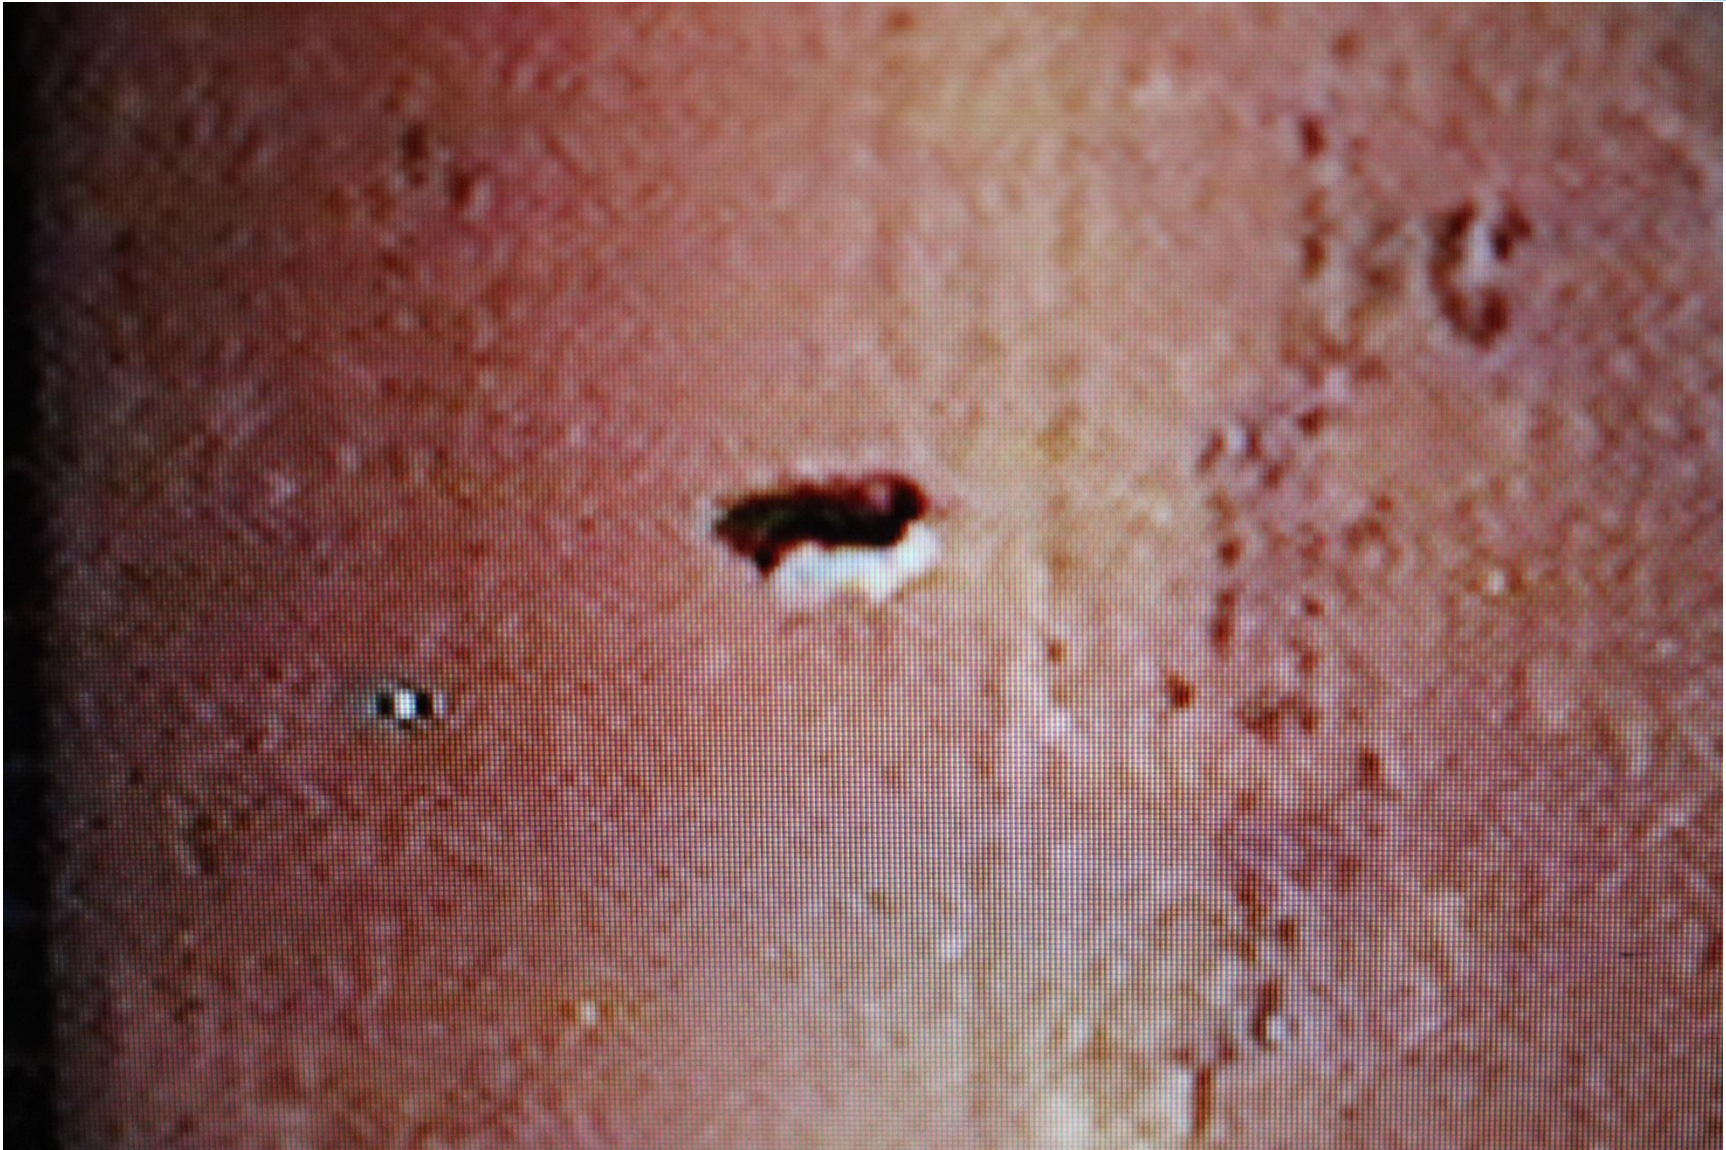
# Anomaly (Zoomed in on Camera)

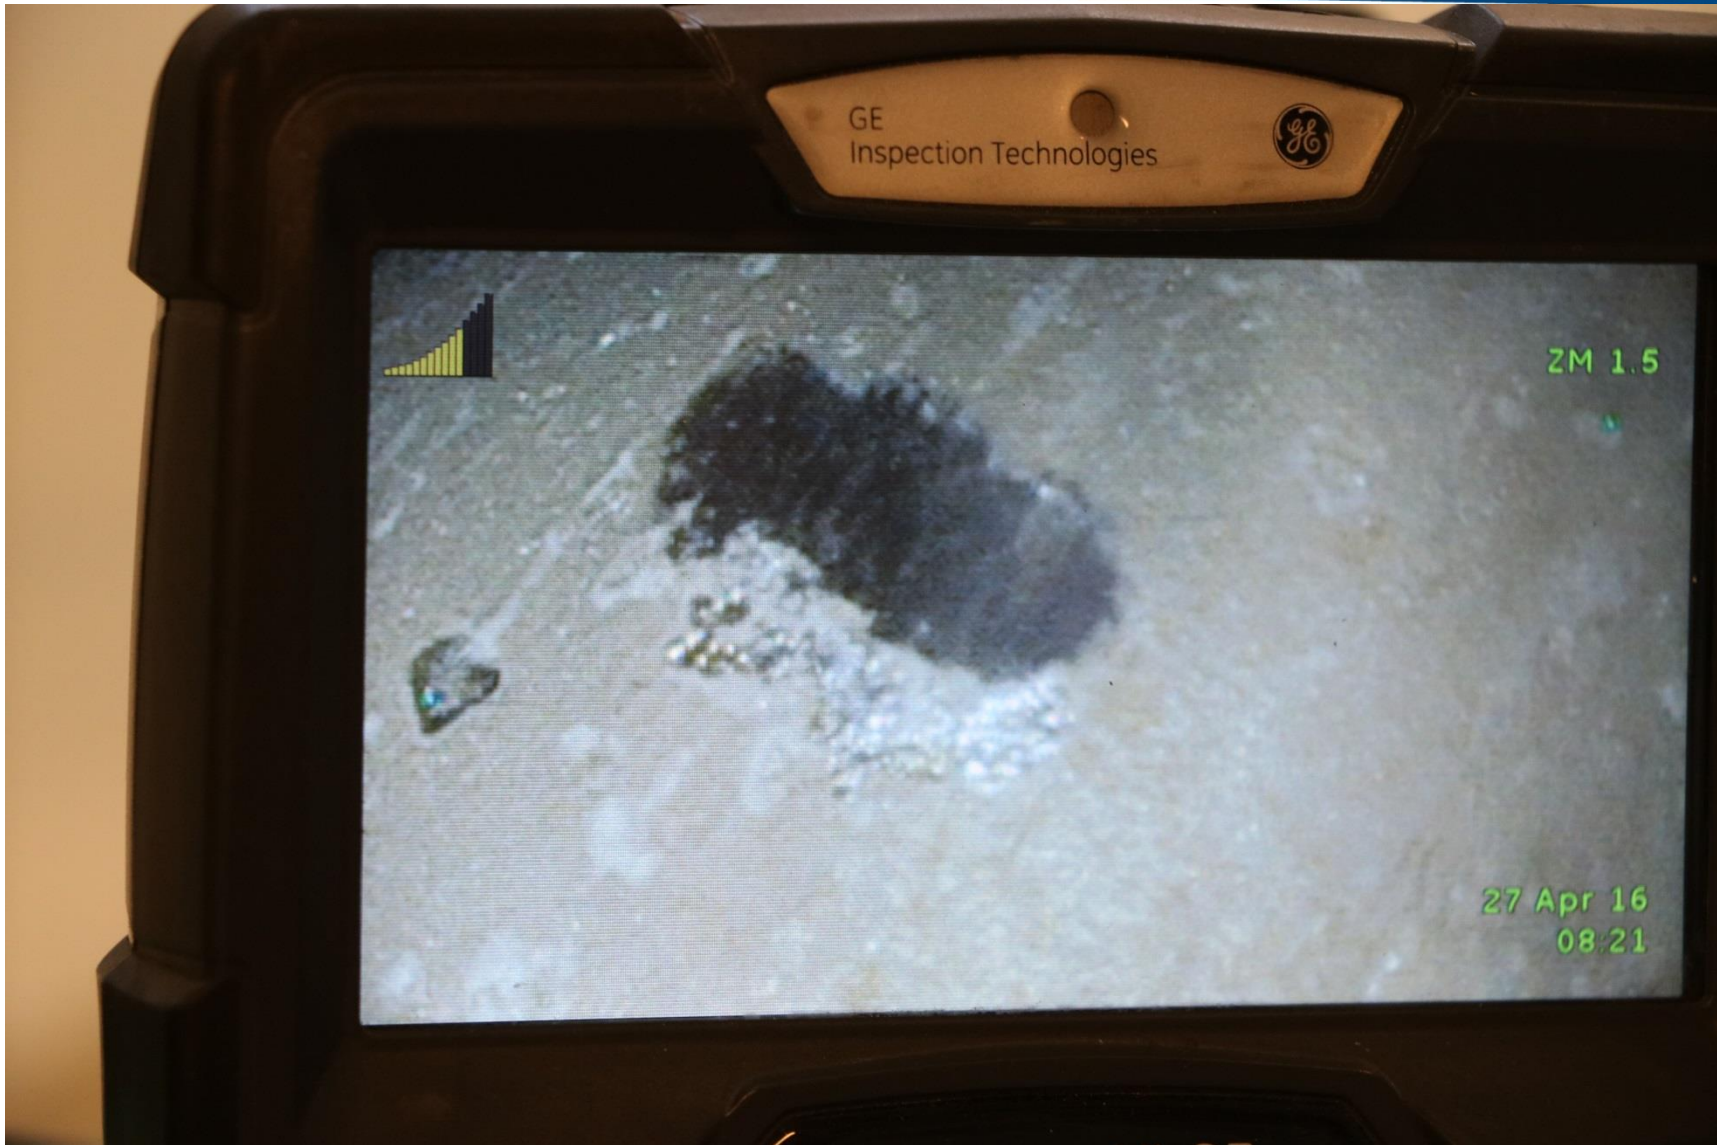
# Anomaly Seen with Video-Probe
