# TRIGA FUEL EXAMINATION USING A GE EVEREST XLG3 VIDEOPROBE - WHAT IT MEANS FOR THE FUTURE OF FUEL INTEGRITY DETERMINATION (& OTHER POSSIBLE USES)

TRTR 2016 – Albuquerque, NM  
Dale Luke & Alan Robb  
August 22, 2016

# SNF Examinations

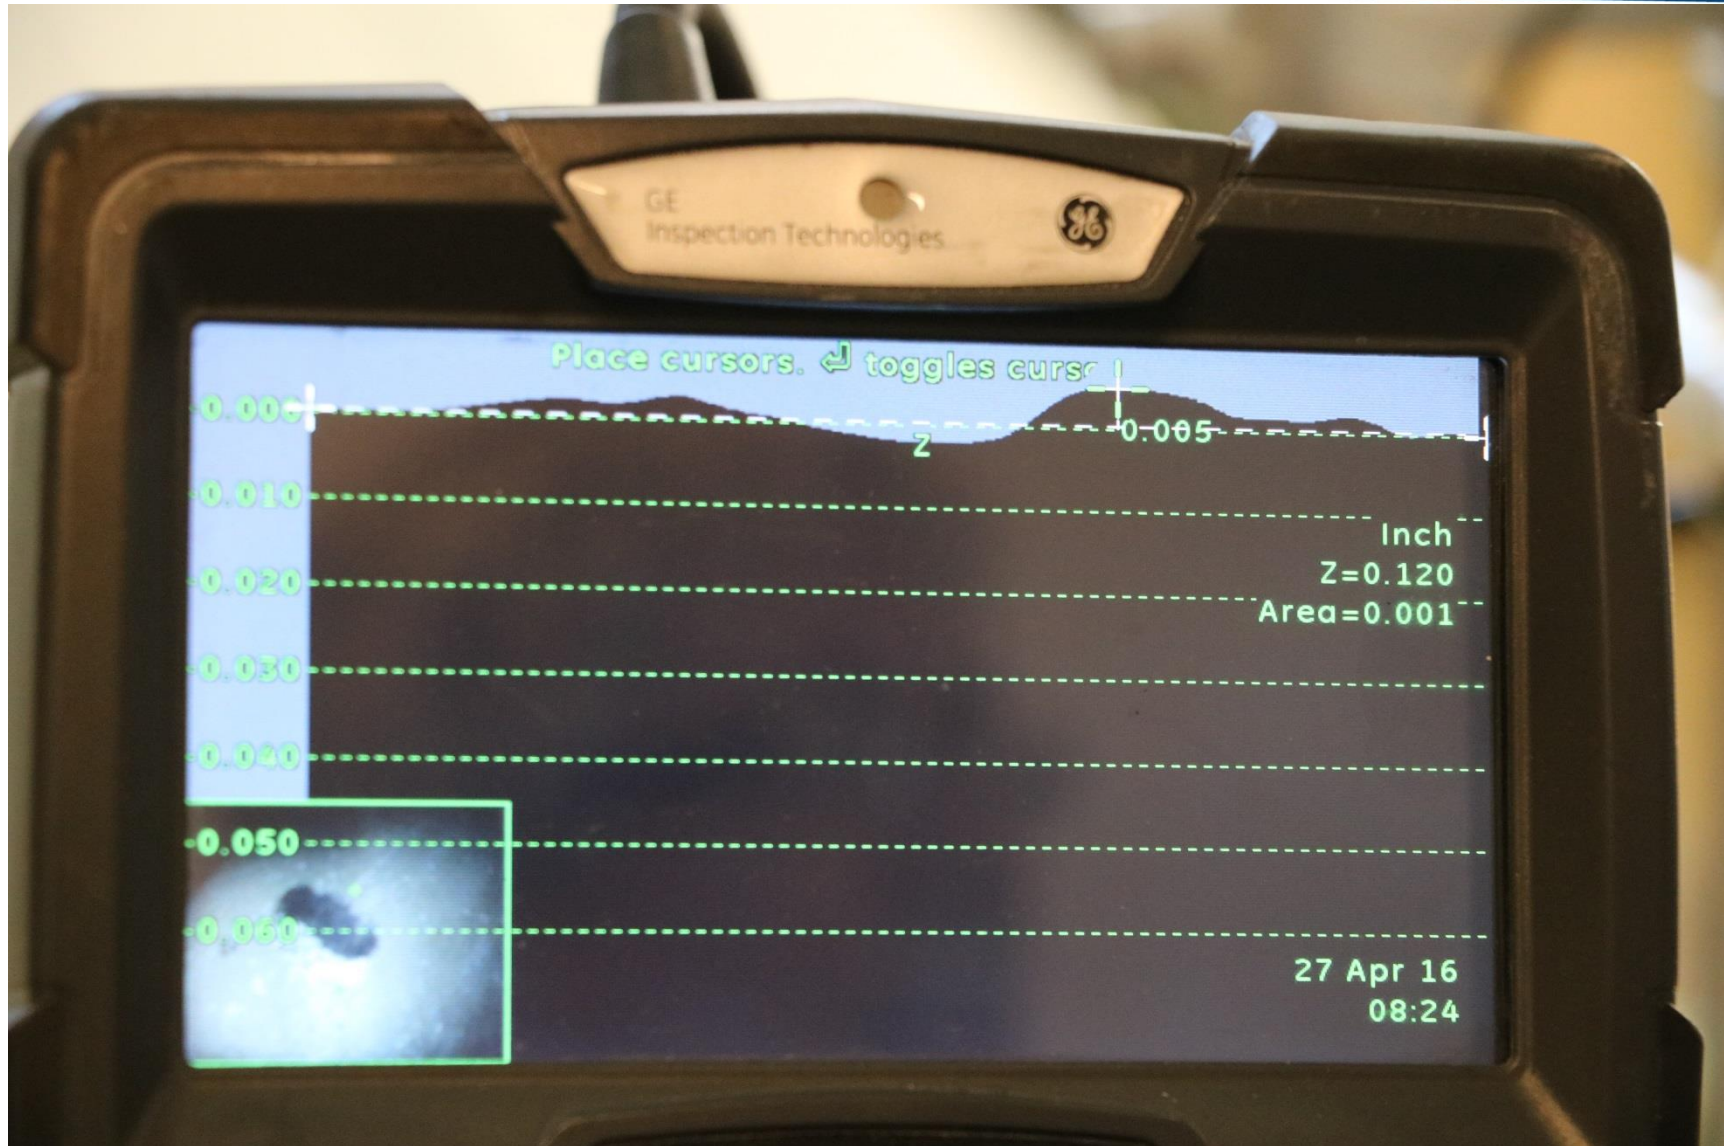
# Depth Profile from the GE Video-Probe

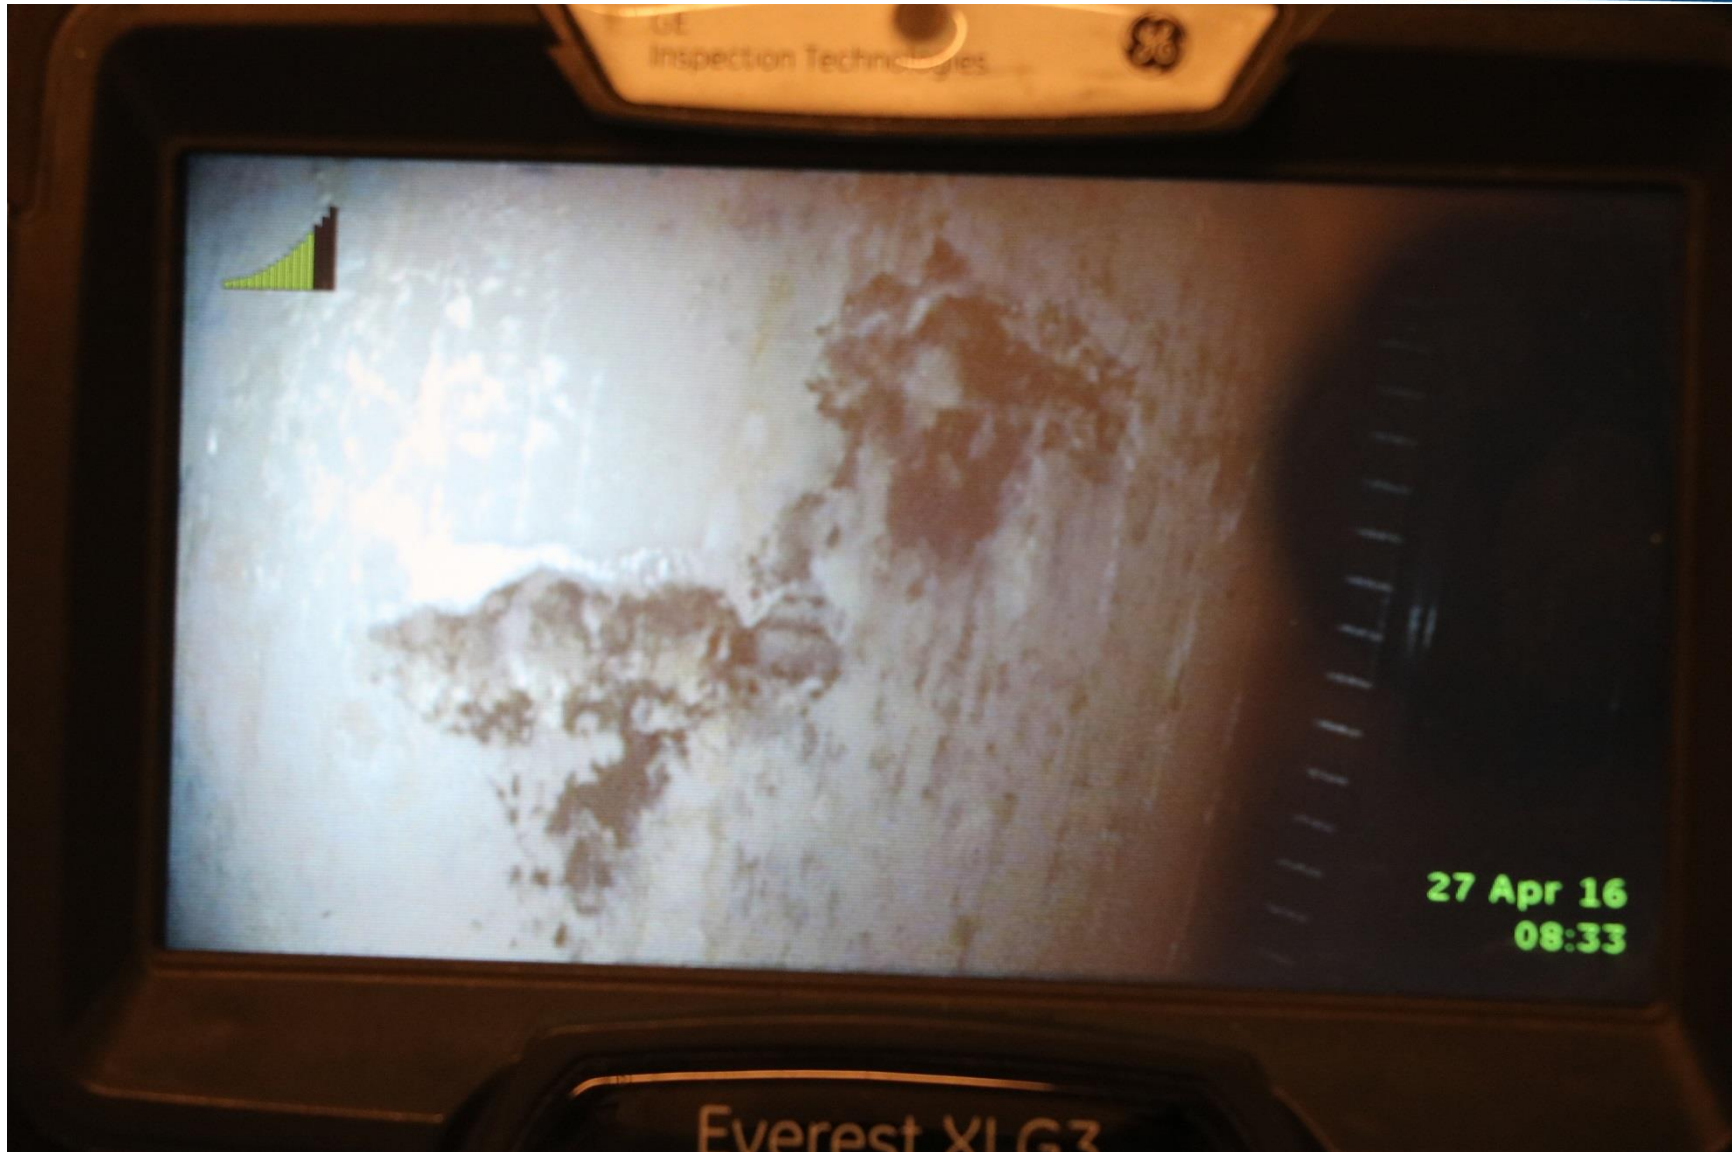
# Anomaly Seen with Video-Probe

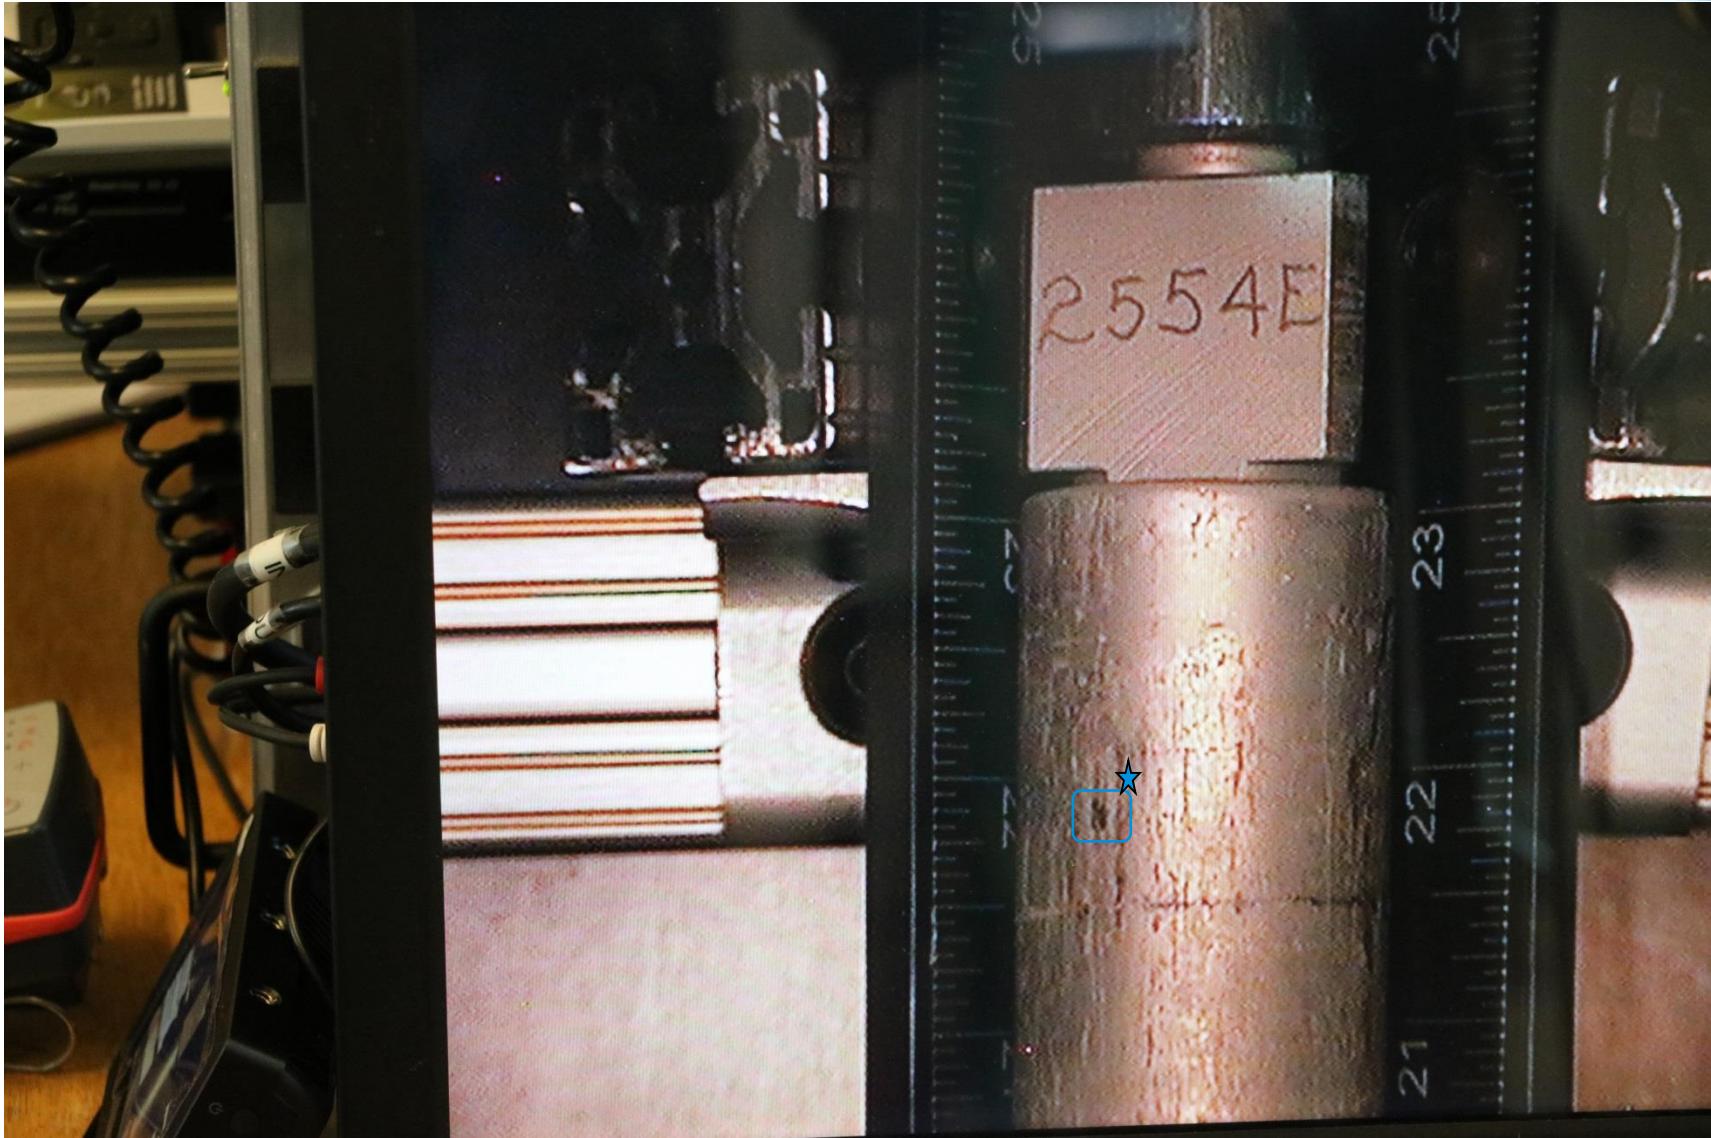
# Anomaly Found with Regular Camera System

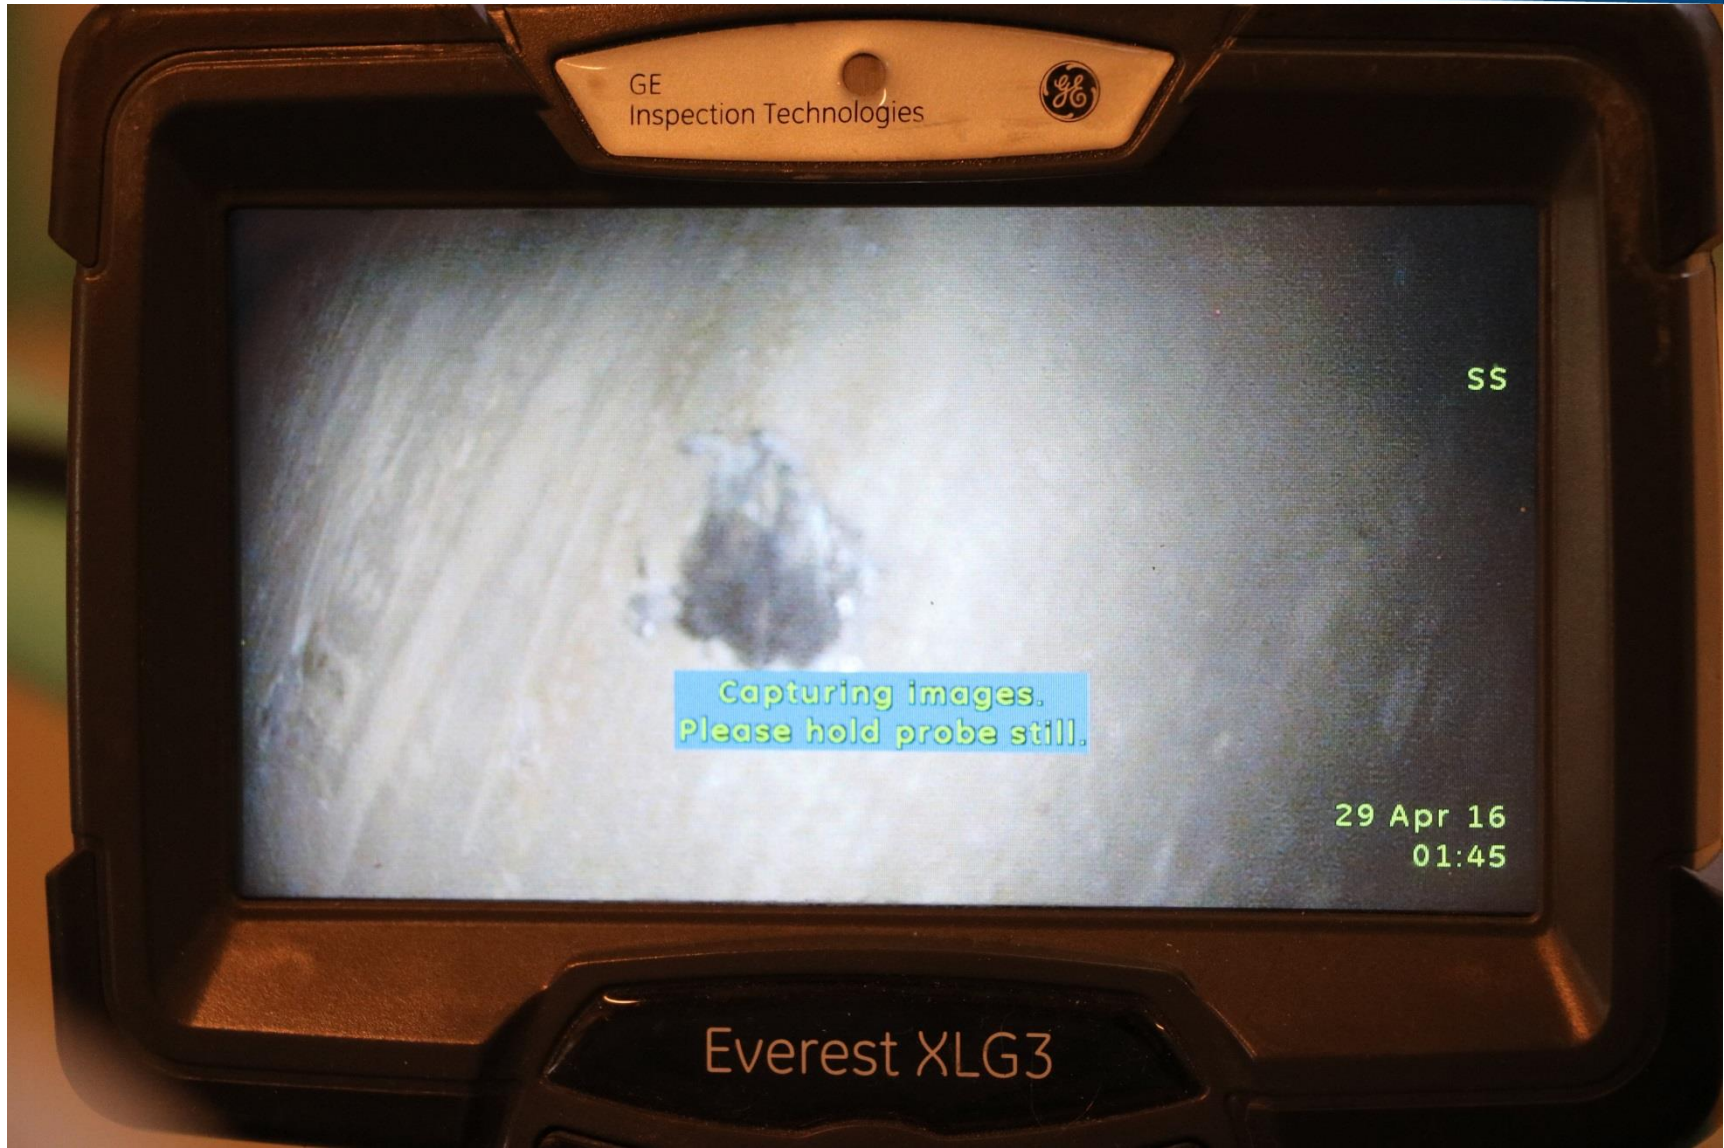
# Anomaly Seen with Video-Probe

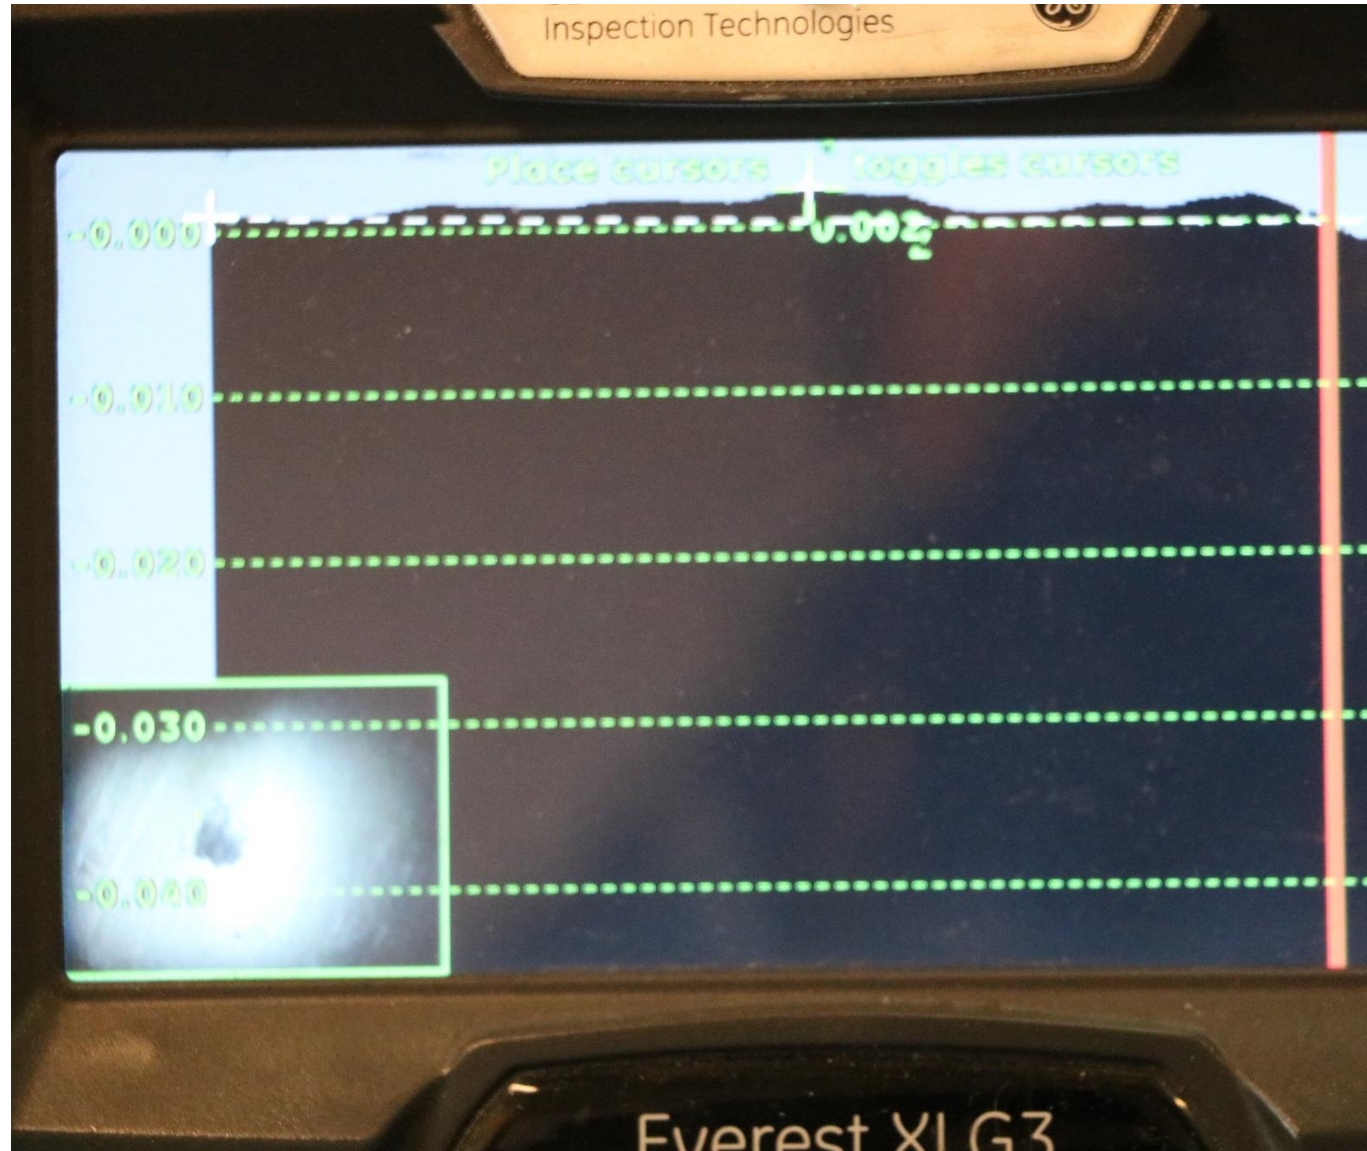
# Depth Profile from the GE Video-Probe

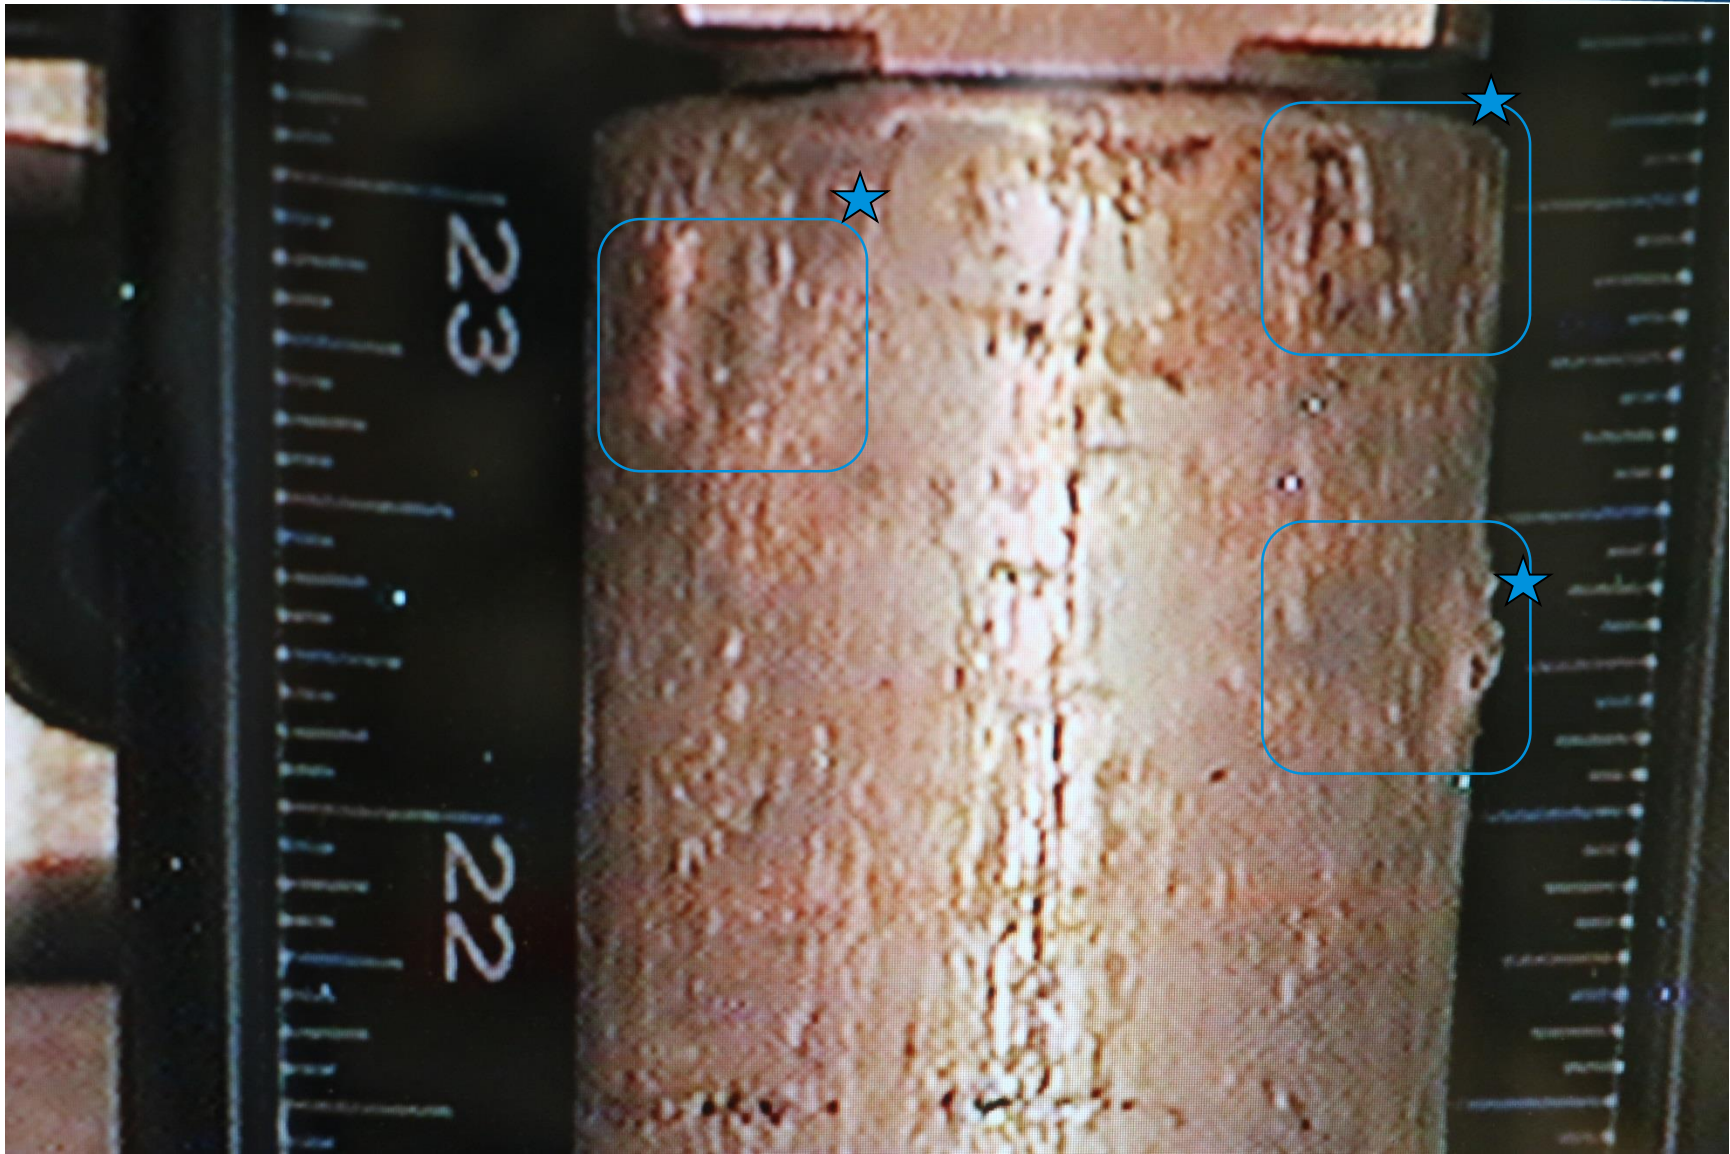
# Swelled Cladding Found w/ Regular Camera System

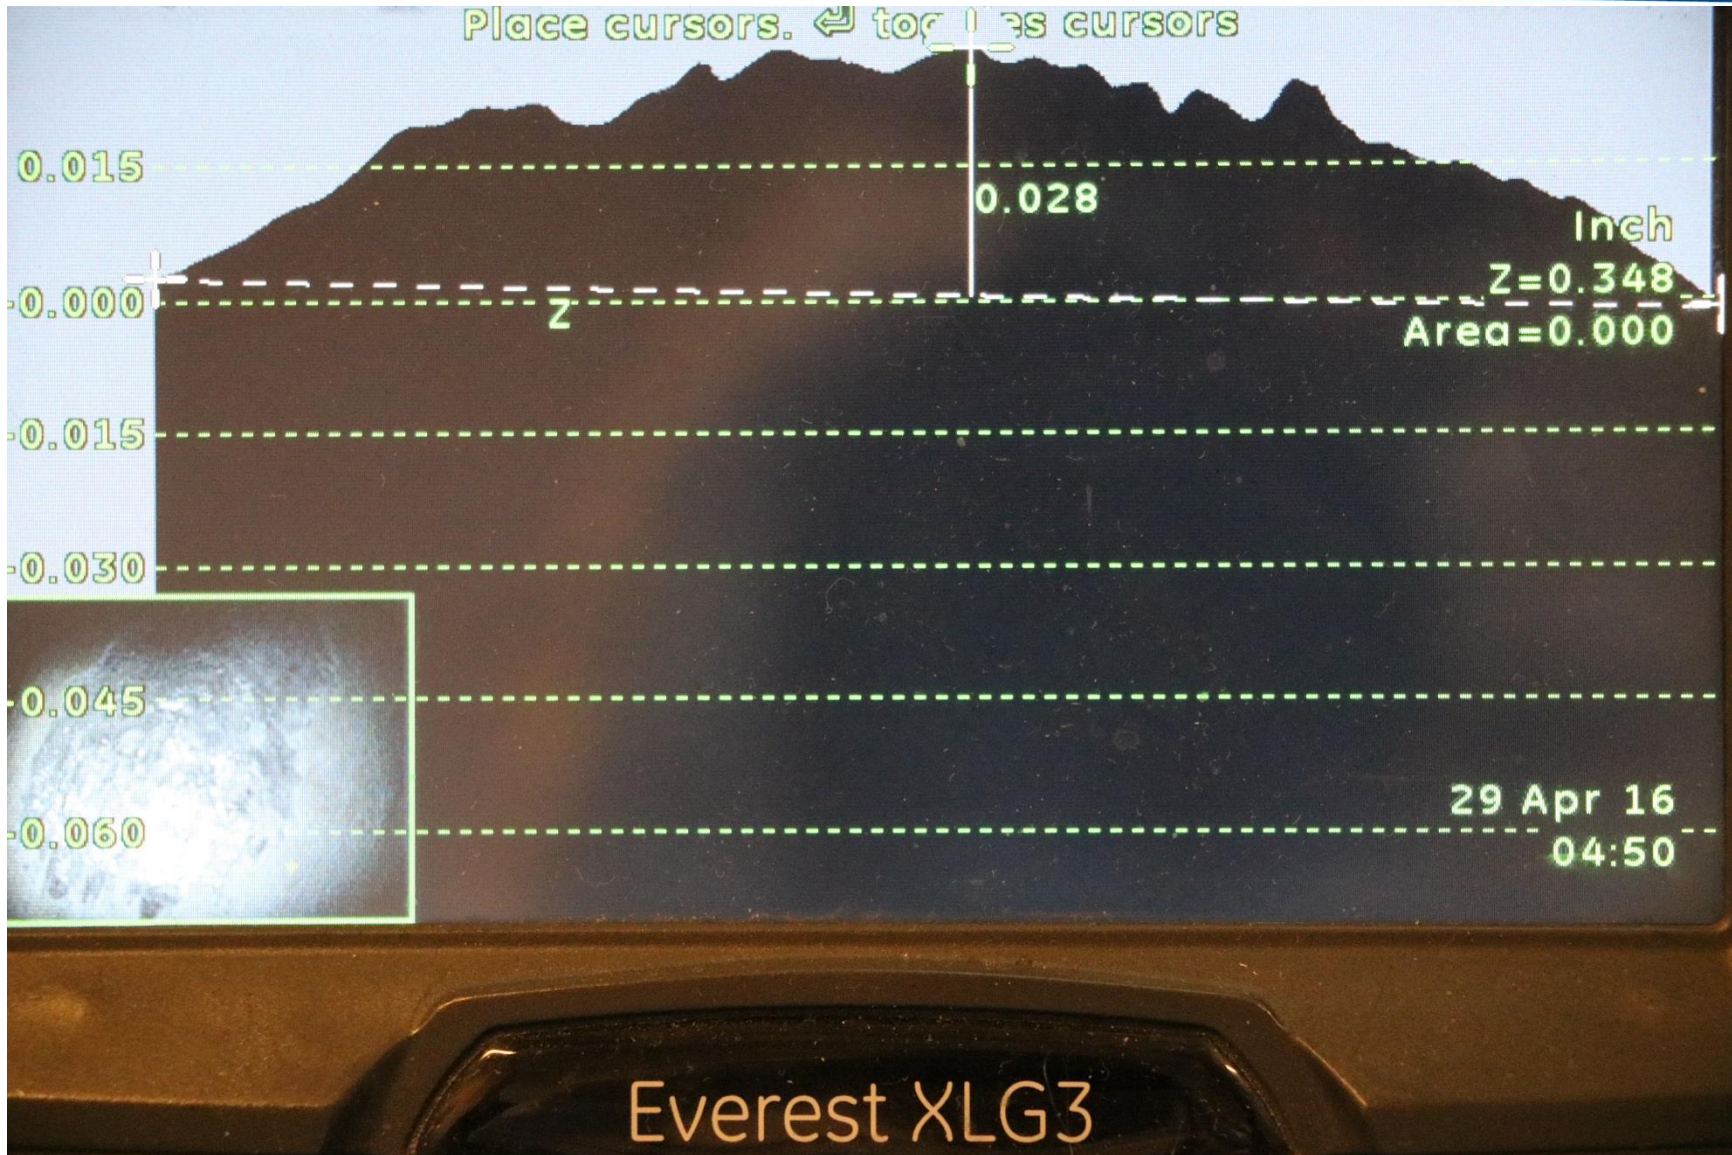
# Swelled Cladding Depth Profile from Video-Probe

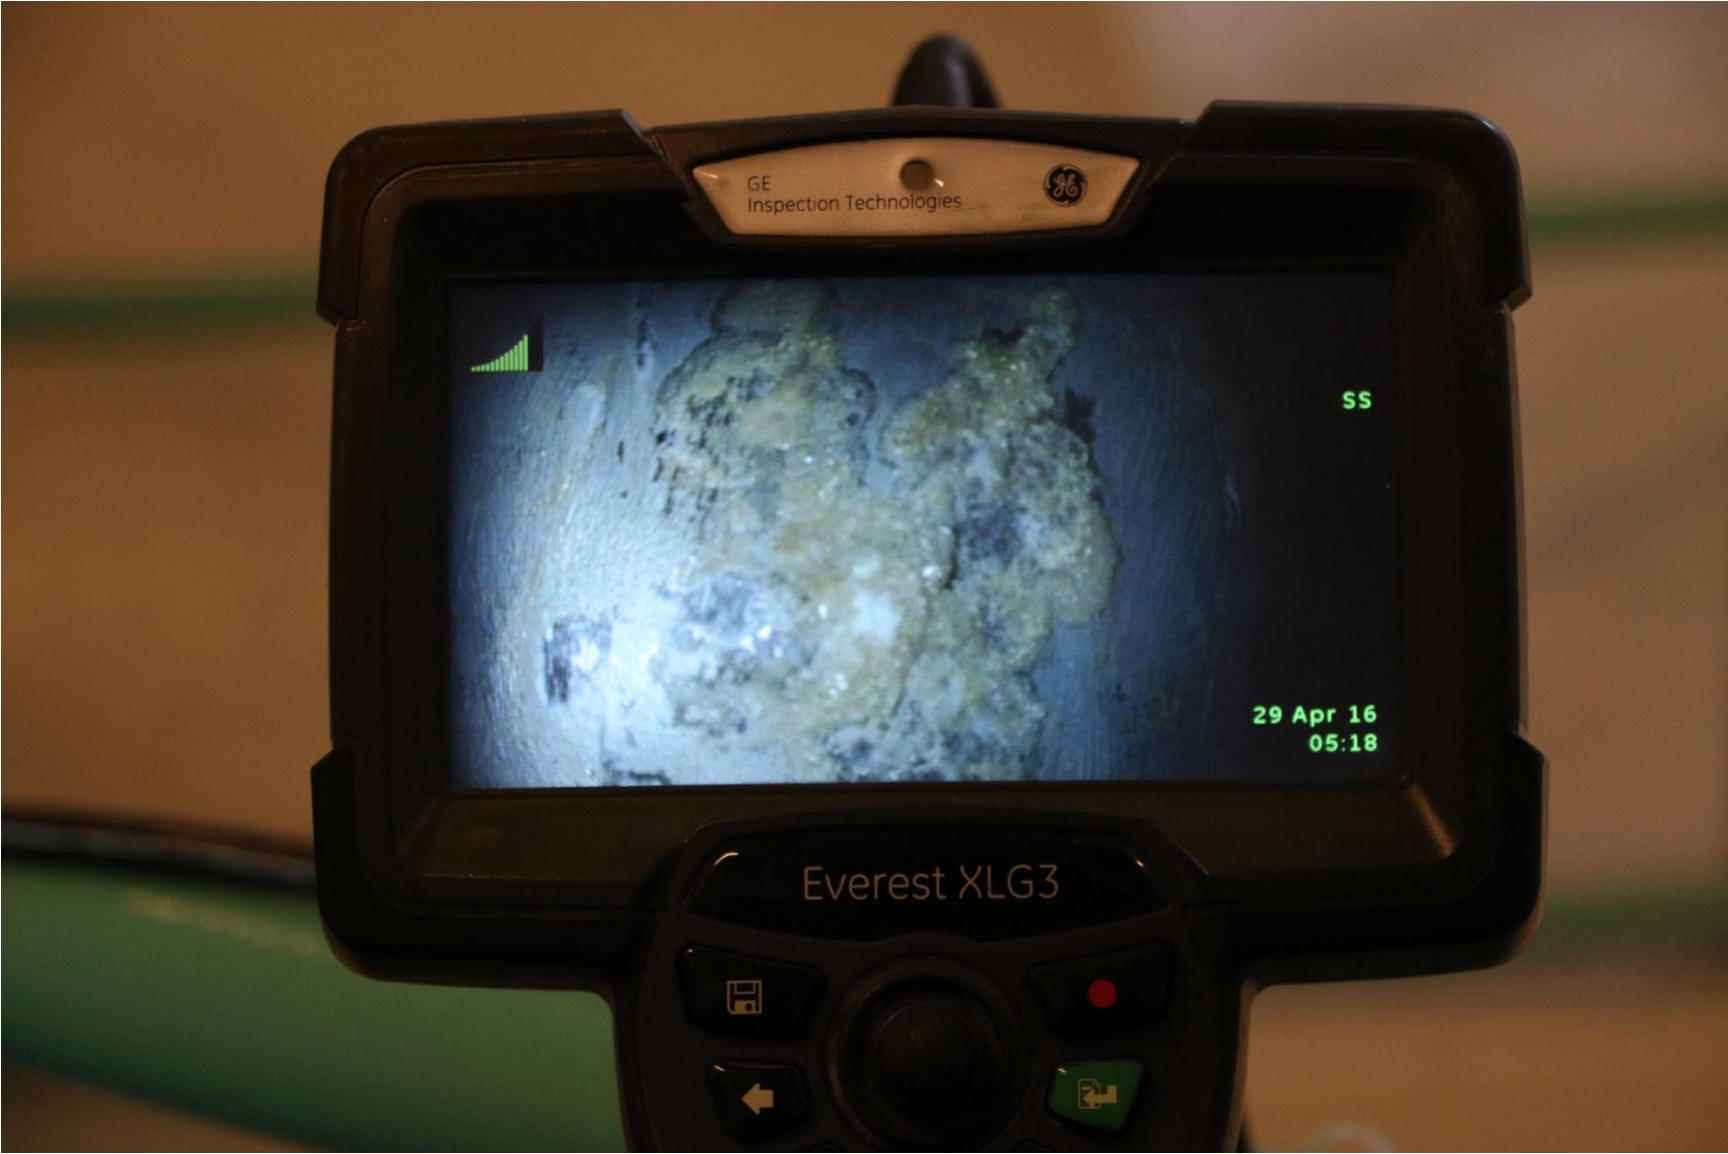
# Section of Swelled Cladding Viewed w/ Video-Probe

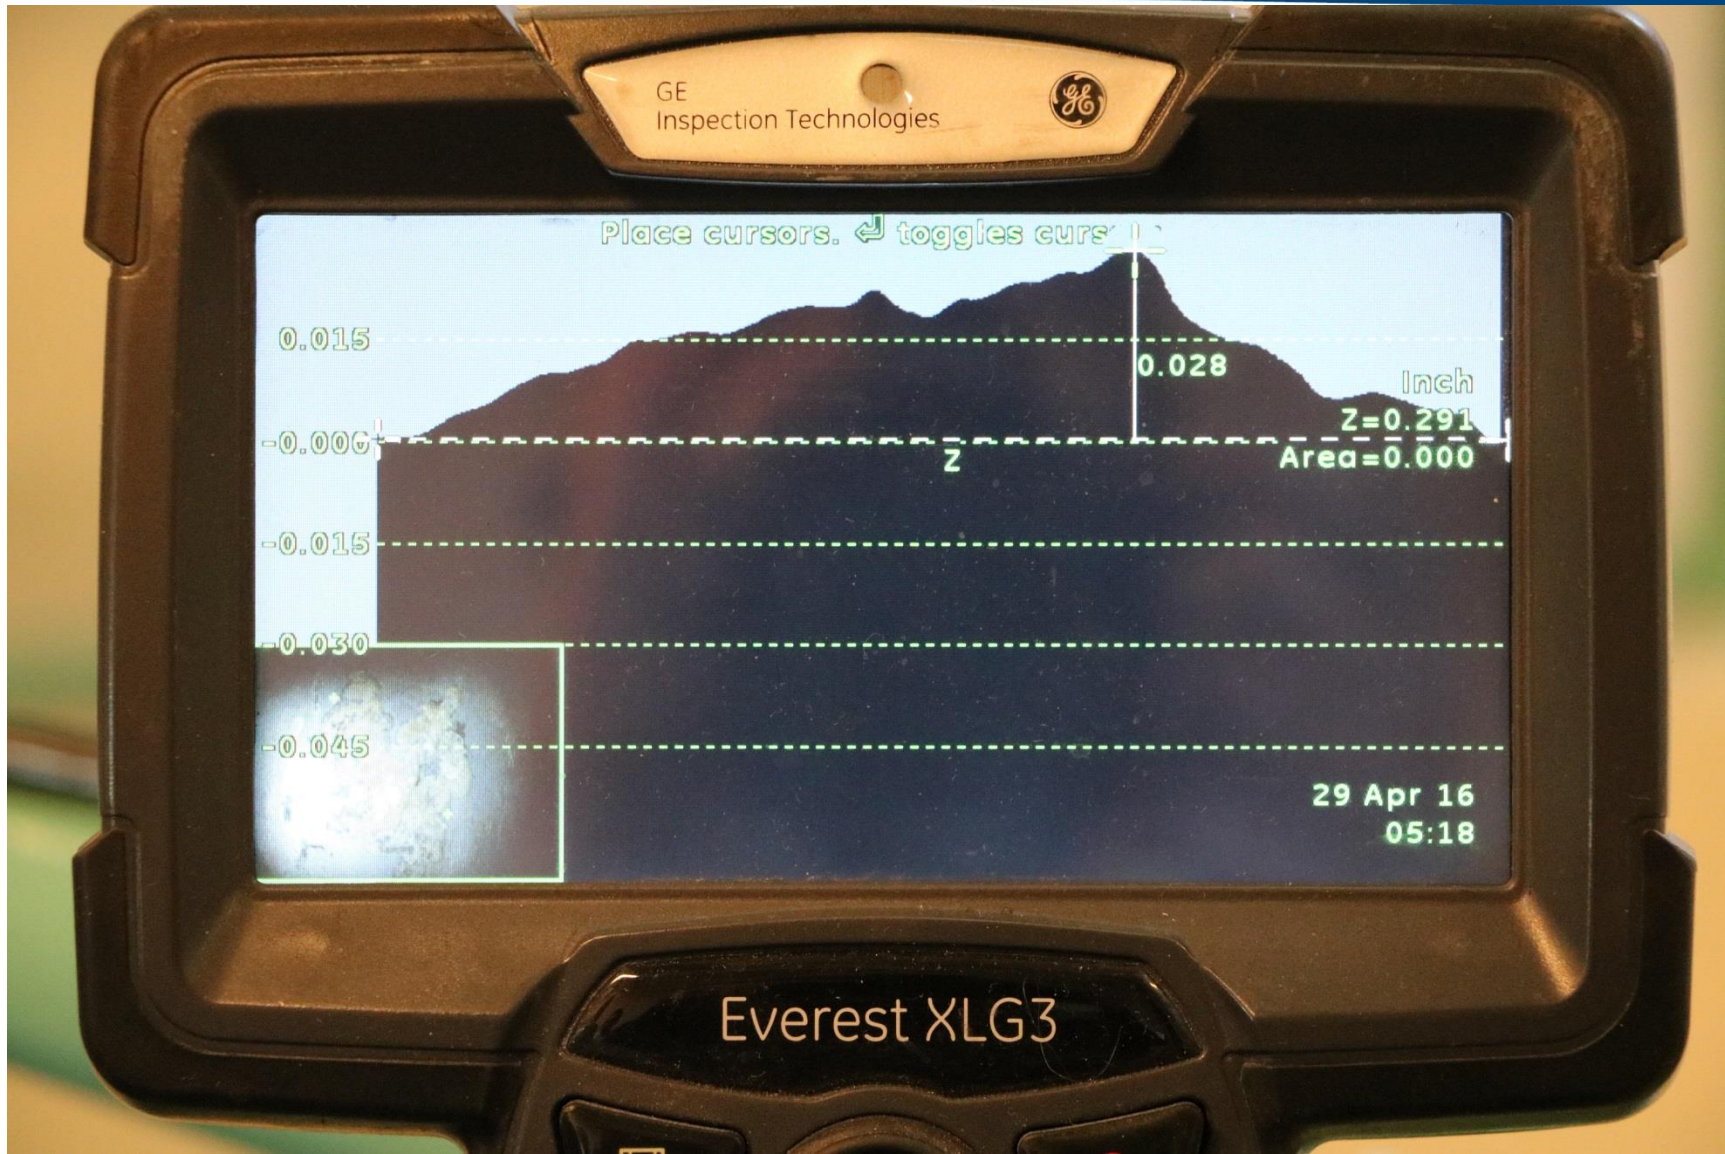
# Swelled Cladding Depth Profile from Video-Probe
