Replacement of a Leaking Beam Port Bellows in the UT-Austin TRIGA Reactor

Tracy N. Tipping
Nuclear Engineering Teaching Laboratory

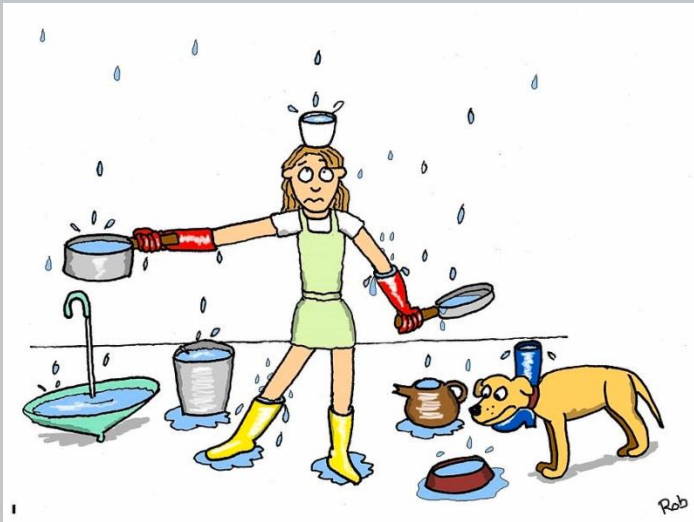
Initial Discovery

- November 2013
 - BP5 shutter track wet
 - Roof leak history

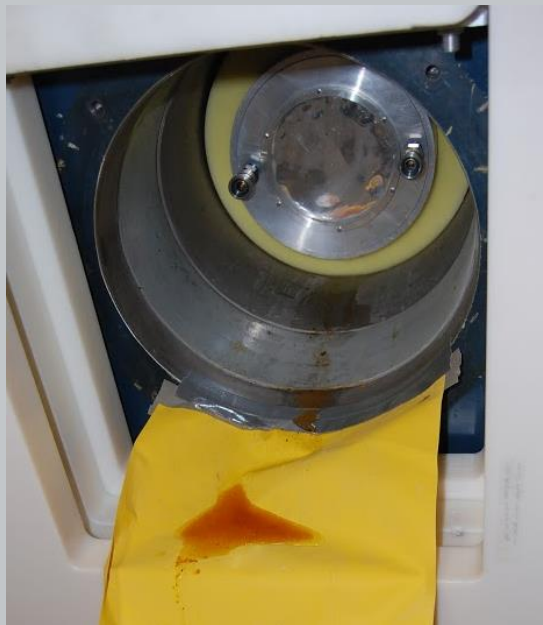
Further Investigation

- Water originating inside beam port
- Radiological analysis confirmed pool water

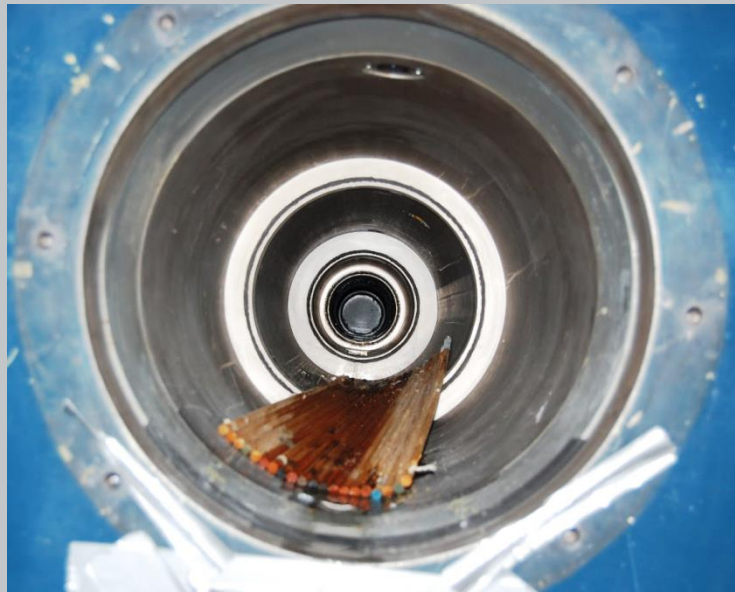
Detailed Investigation

- January 2014
 - Pulled collimator out of BP5
 - Water was not coming from BP5

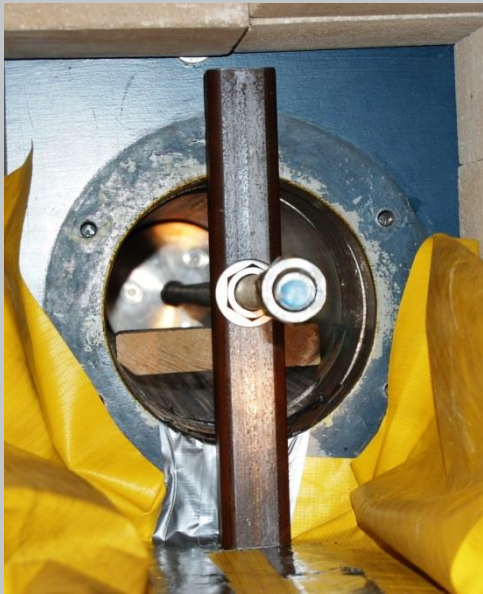
More Investigation

- No water on the BP1 side
- Attempted to pull collimator out of BP1
 - It was stuck
 - Required some convincing

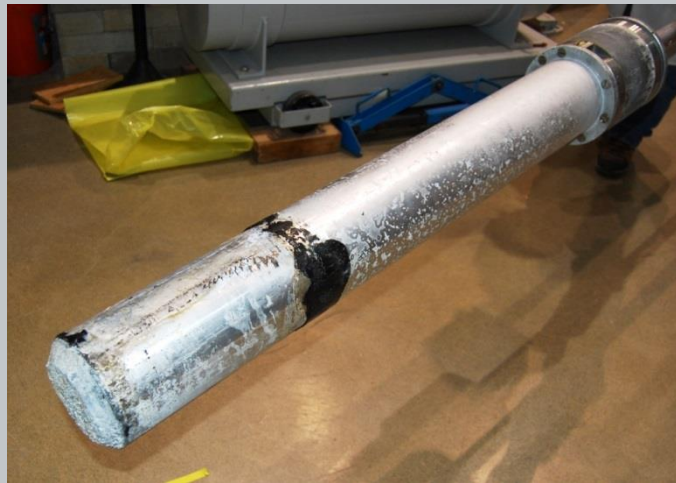
Sticky Situation

- Joint between tank and BP sealed with tar
- Clean up on BP1

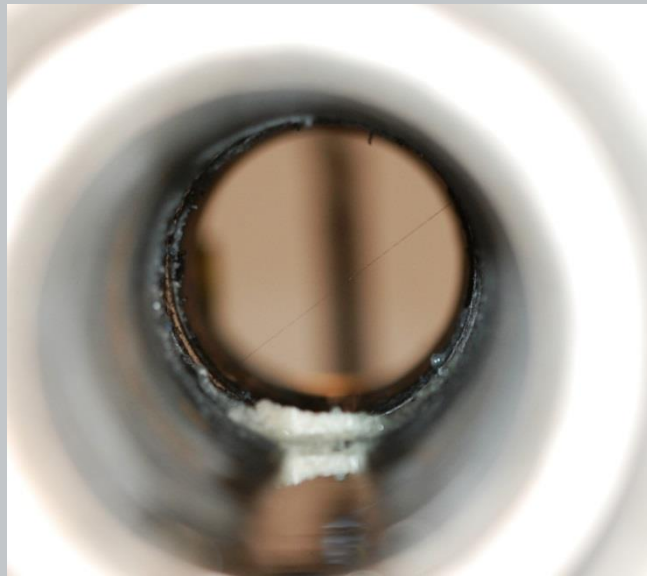
BP 1 Investigation

- Looked into BP1 with spotting scope and saw hair on lens
- Water jet from pin hole in convolution of bellows

- Patch won't work
 - Curved, flexing surface
 - Thin wall
 - Inaccessible outer surface
- Must replace bellows
- Requires time and \$\$\$

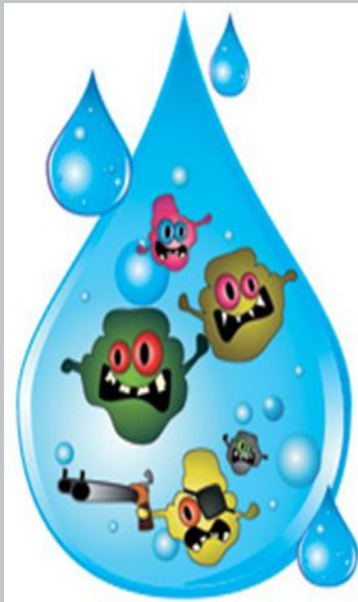
Divers are Dirty!

- Visibility down to 4 meters
- Conductivity $> 30 \mu\text{S}$
- Water biologically contaminated
 - UV treatment
 - Filtration
- Resin decomposing
