UNLICENSED/ALUMINUM FUEL EVENT AT THE UNIVERSITY OF TEXAS AT AUSTIN TRIGA REACTOR

P. M. WHALEY

The University of Texas at Austin
Nuclear Engineering Teaching Laboratory
11131 Creativity Trail, TX 78785 – US

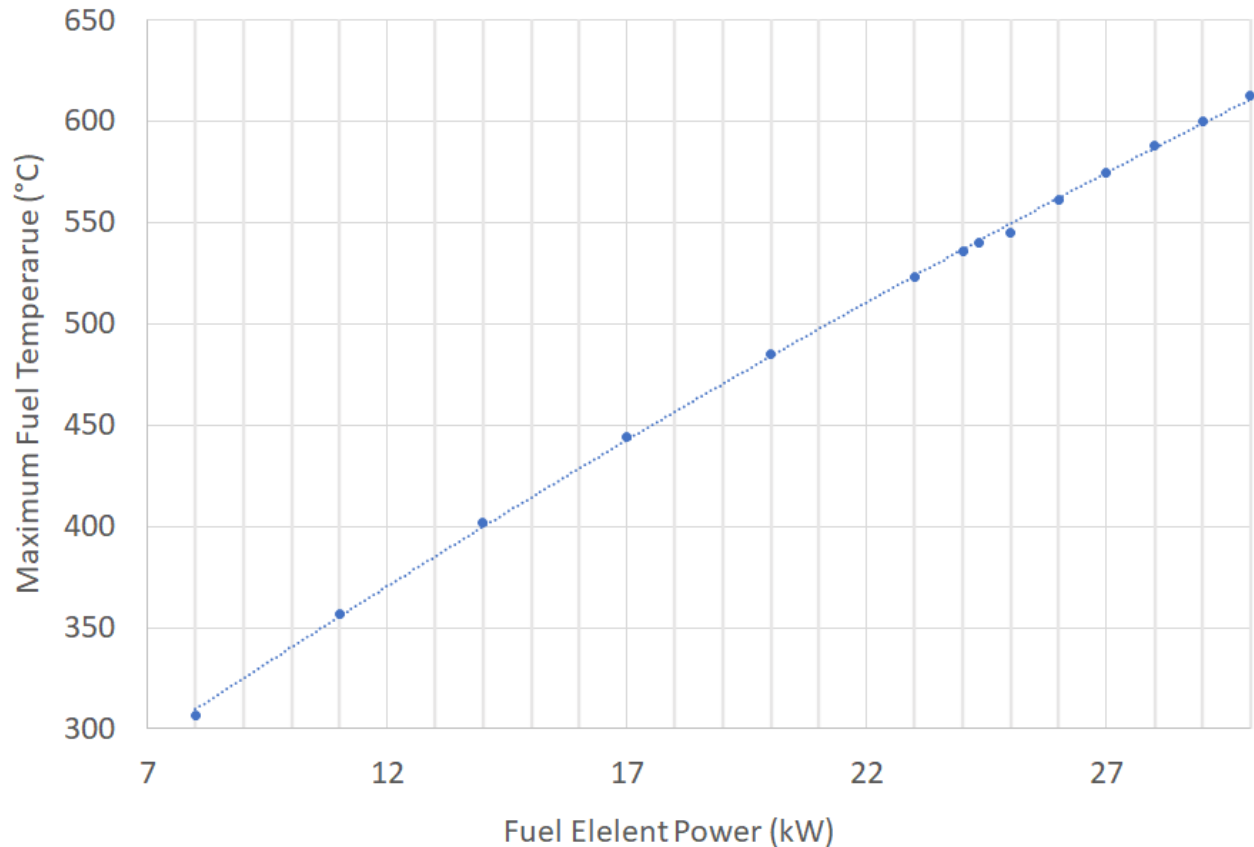
Figure 1: Maximum Fuel Element Temperature at Fuel Element Power

A recent NRC audit determined coupled NETL neutronics and thermal hydraulic analysis acceptable for technical review with the reports submitted to support relicensing [4]. The analysis used the Monte-Carlo N-Particle code (MCNP) to derive power distribution and the TRAC/RELAP Advanced Computational Engine code (TRACE) to calculate thermal hydraulic performance at fuel element power (see Figure 1). Instrumented Fuel Elements (IFEs) in the B ring have monitored fuel temperature at or near the hot channel since initial criticality. Records of the fuel temperature at steady-state full power operation over the period January to October 2022 consist of 245 readings from 382°C to 391°C. Operating records and data from the analysis were used to evaluate maximum temperatures in the aluminum-clad fuel during utilization. The aluminum clad element with the highest power generated 86% of the power generated in the IFE. The current IFE and the hot channel element power levels differ by 0.9%. Coupled TRACE and MCNP simulations indicate that, with a maximum temperature of 386°C in the core, the fuel element in position C6 had a maximum temperature of 352°C and in position D1 a maximum temperature of 335°C. With 391°C maximum fuel temperature during full power steady state operation, the aluminum-clad fuel integrity was not challenged. Even at the maximum fuel temperatures recorded in the IFEs there was no potential challenge during steady state operations.

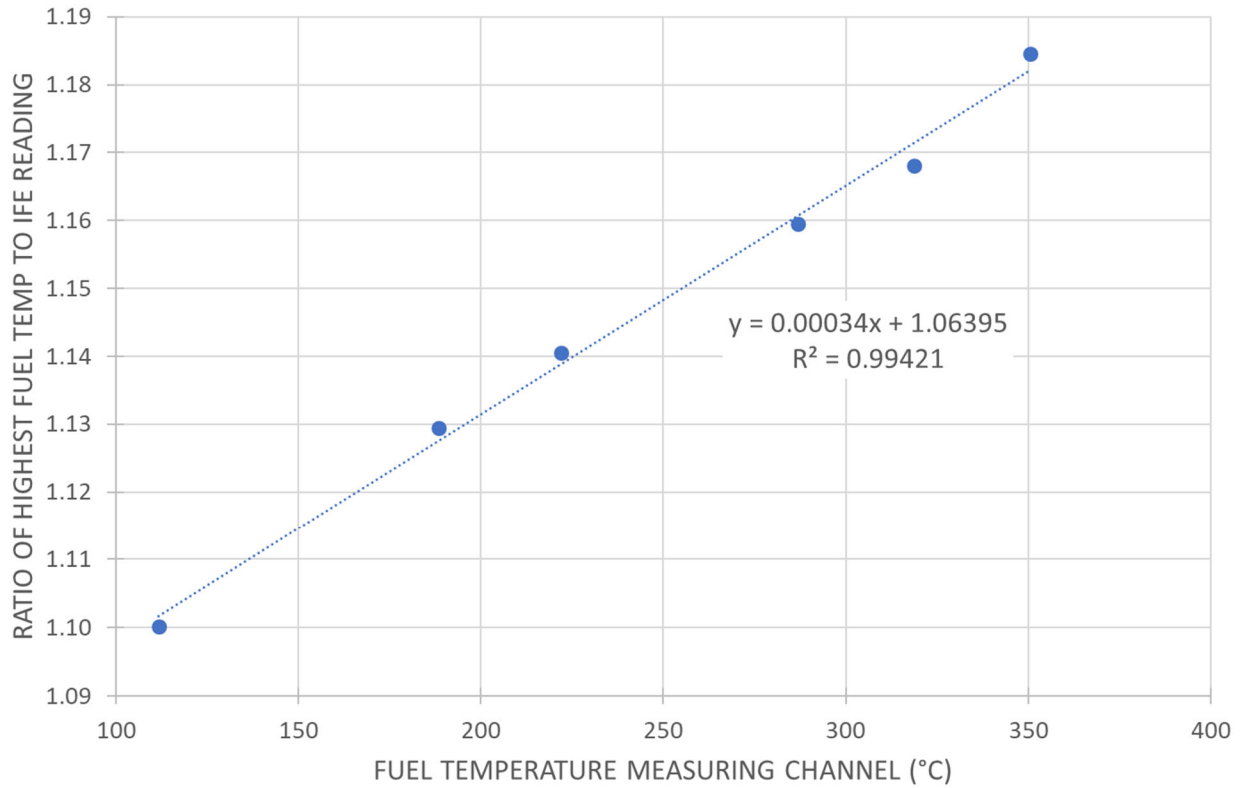
Figure 2: Ratio of Peak Fuel Temperature to Temperature at IFE Thermocouple Position (TRACE)

The maximum temperature during TRIGA pulsing operations occurs near the surface of the fuel element while the IFE thermocouples are located near the center. TRACE calculations were used to develop a correlation between the maximum fuel temperature and the temperature at the thermocouple location during a pulse (see Figure 2). The maximum hot channel fuel temperature during pulsing at \$3.00 reactivity addition during the aluminum-clad fuel element utilization did not exceed 420°C (see Figure 3).
