# Maintenance Projects at the Oregon State TRIGA Reactor

2023 TRTR/IGORR Conference  
College Park, MD  
June 18-23, 2023

# Major Maintenance Activities

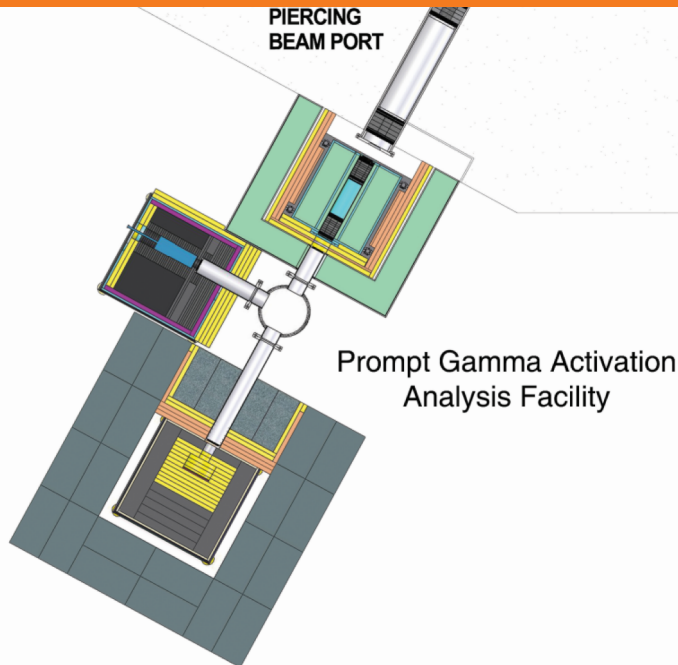
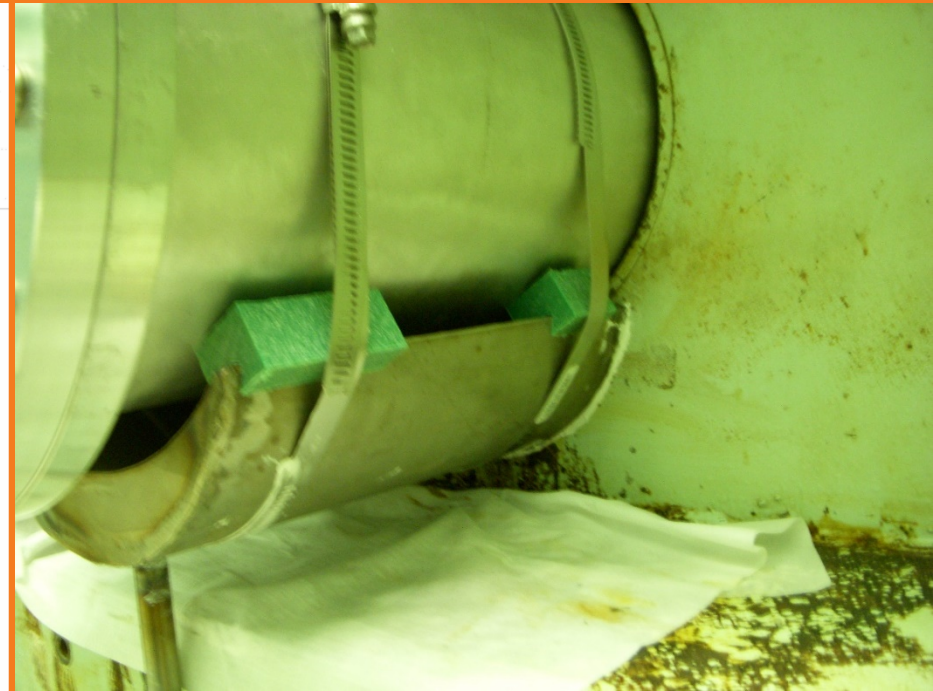
- 7/15/19 – Discovery of leak on east side of PGNAA
  - Drain had stopped leaking after reflector replacement outage of 2013
  - After 6 years, leakage returned, experimenter discovered puddle on the floor
  - Analysis of leakage indicated it was fresh reactor water, making bellows the suspect (rate  $\sim 30$  mL/hr).

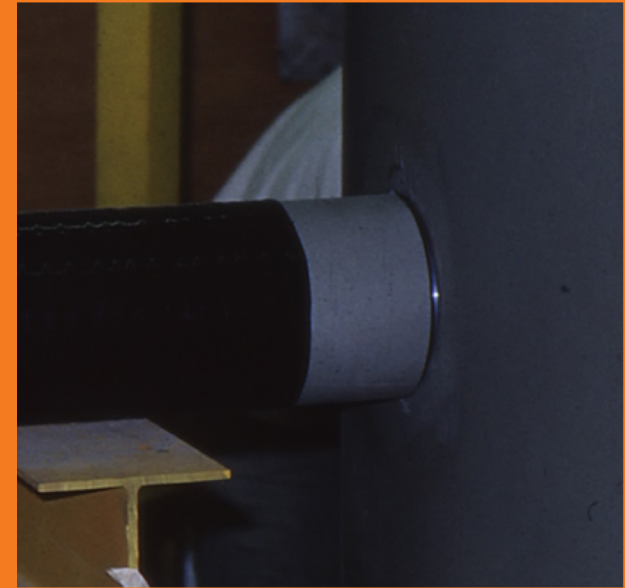
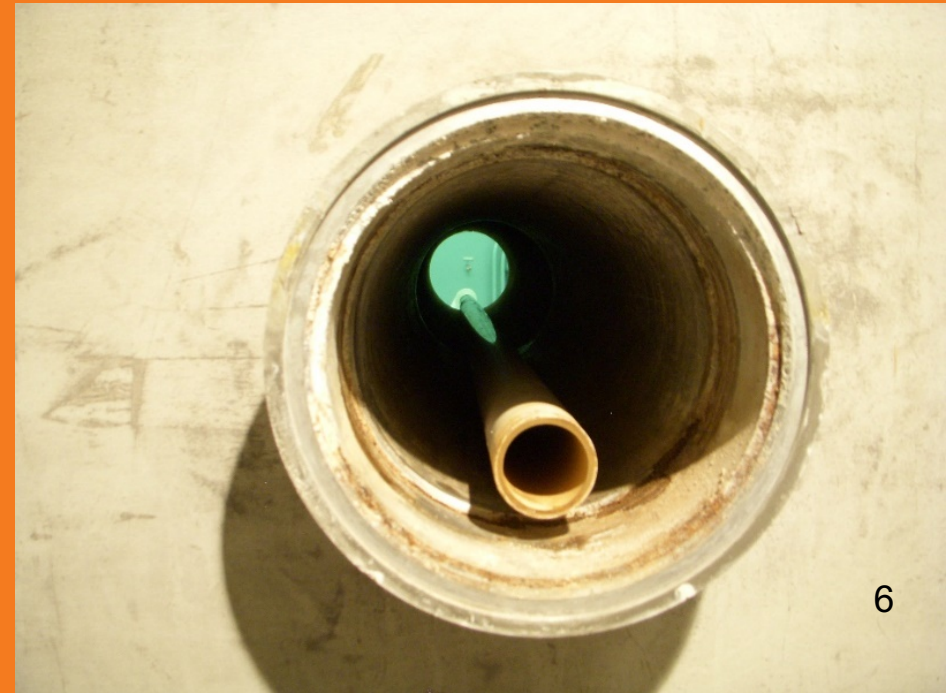
Beam port has a gap between tank and pipe embedded in the bioshield.

Bellows couples to tank via 3" pipe stub welded to inside of tank.

Leak must be sealed within this pipe stub or the leak will continue to propagate in gap.

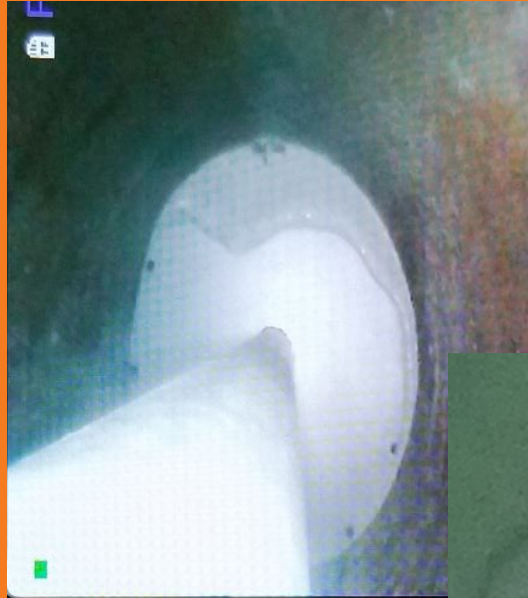
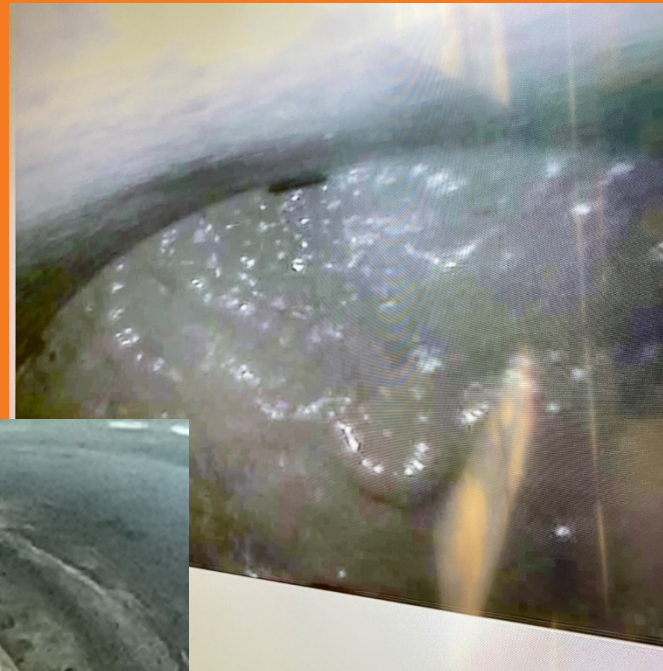
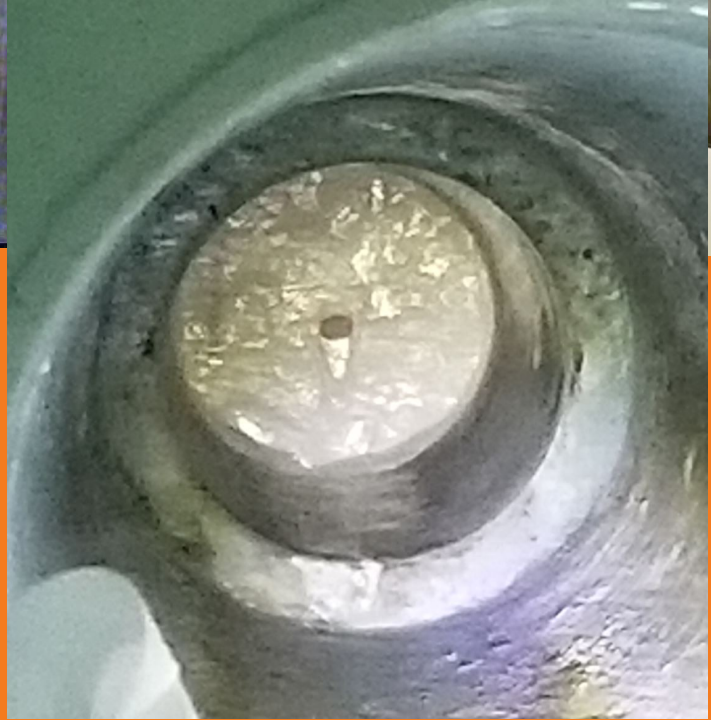
- So close! Leak continues through small gap. Epoxy not viscous enough.

Make sure you're happy with viscosity of epoxy before injecting/sealing. There is a small window before the epoxy is too thick to inject. If we had waited longer for the epoxy to thicken, we may still have a viable beam.

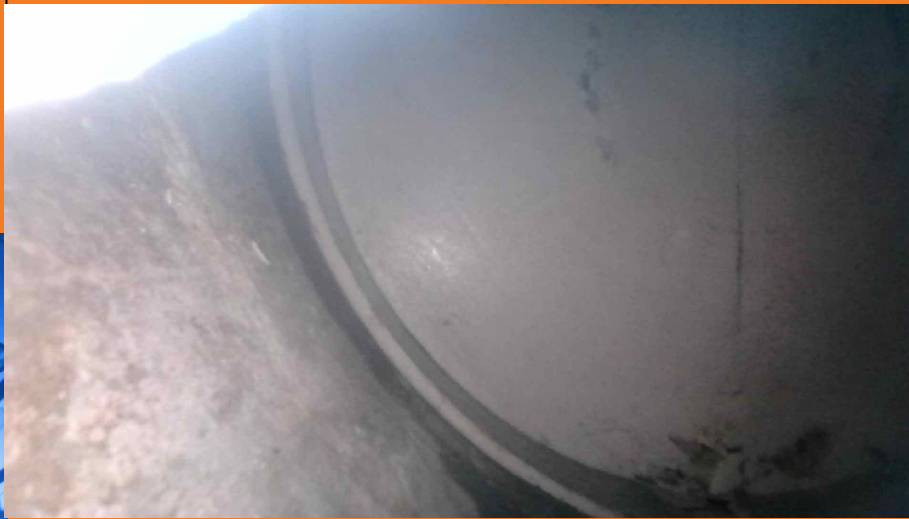
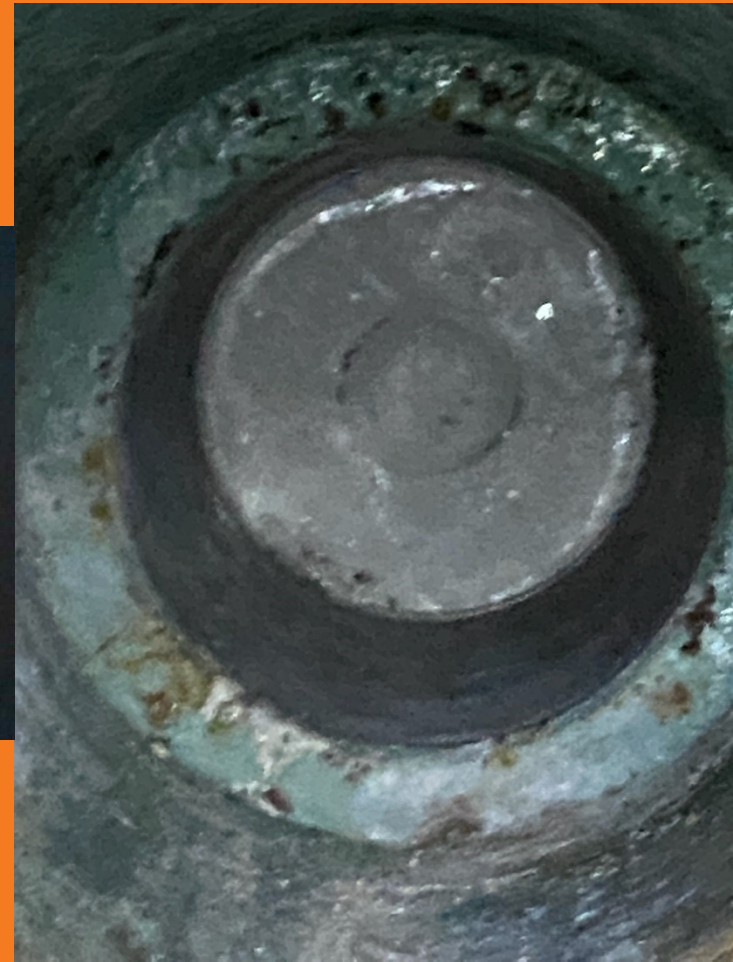
A full 360 degree seal was achieved. During epoxy injection, bubbles were seen emanating from the bellows, then bubble flow stopped.

~2 liters of epoxy were injected.

Unfortunately, the second successful attempt came at a cost: the epoxy disk effectively killed the flux coming out of beam port #4. Subsequent tests showed that the neutron flux was no longer viable. Beam Port #4 was fully decommissioned in March 2023. PGNAA parts were moved to the previously vacant Beam Port #1.

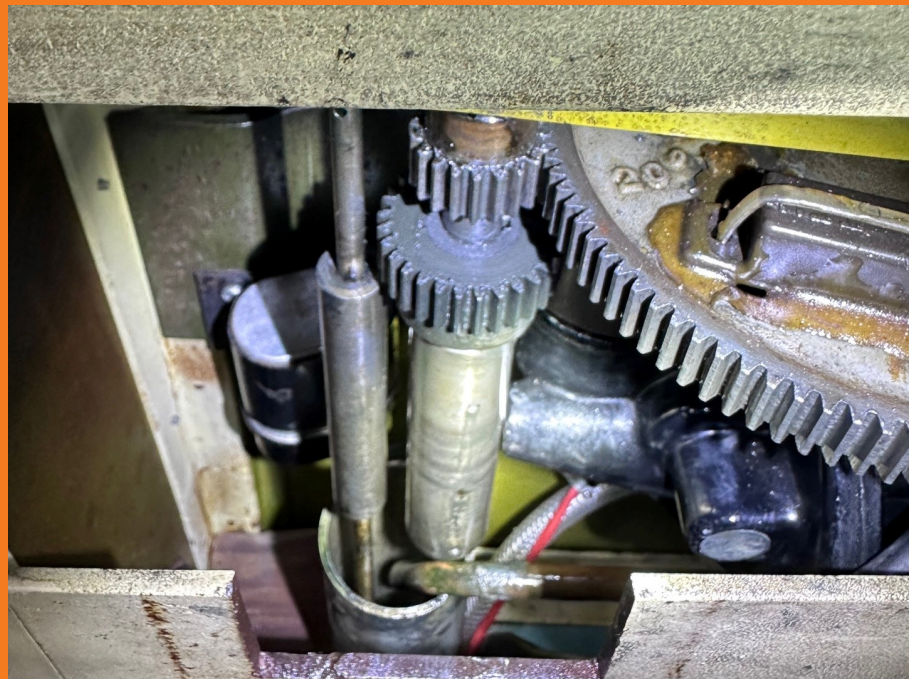
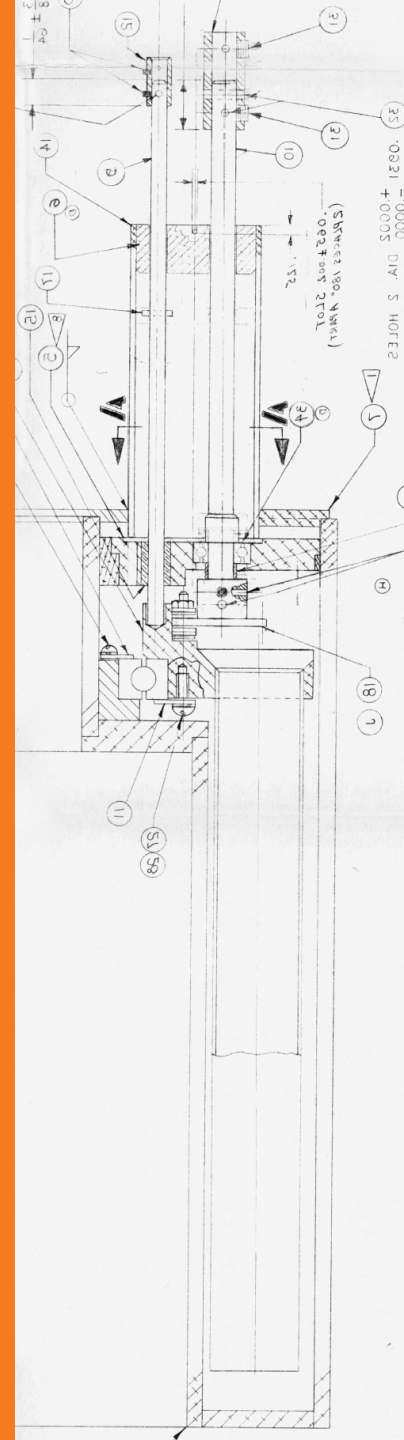
In the summer of 2022, the lazy susan rotating rack began experiencing various issues: sample tubes sticking to the bottom of the rack, and motor stoppages during operation. Both issues were attributed to the oiling regimen. For years, the staff used small amounts of WD-40 to oil the rack.

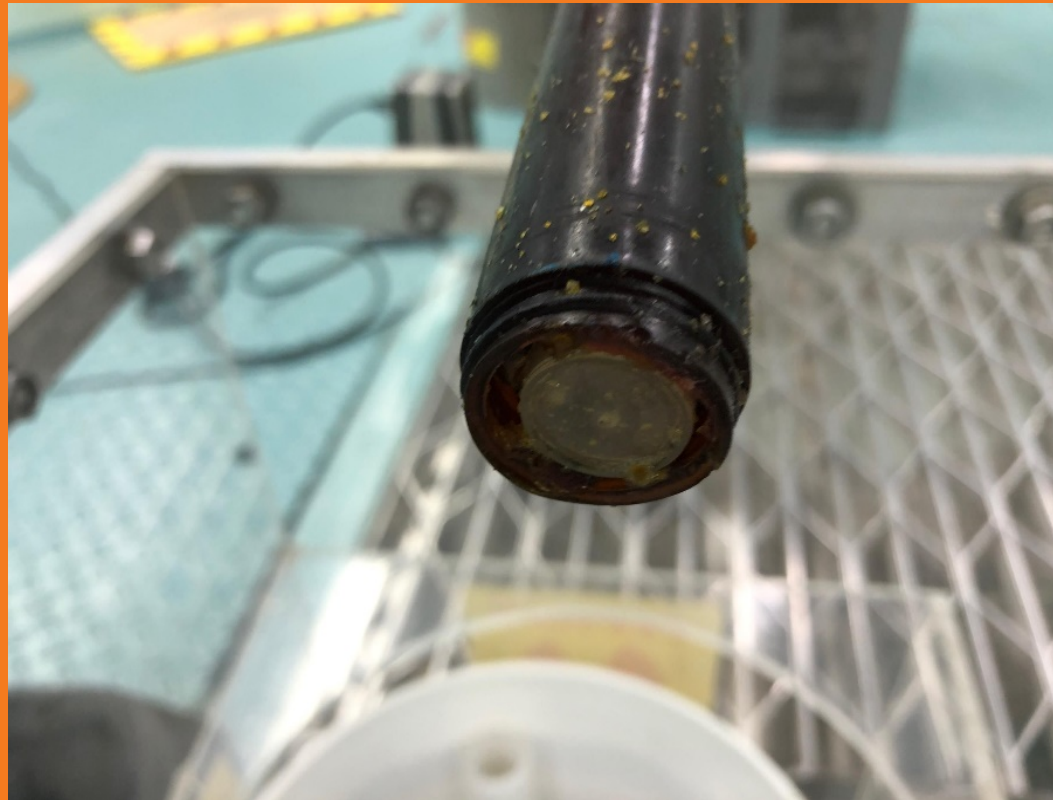
Over the years, the WD-40 began to ooze into the rack's tubes which caused TRIGA tubes to stick to the bottom. This caused multiple problems, such as a broken grapple tool, as well as broken TRIGA tubes upon withdrawal.

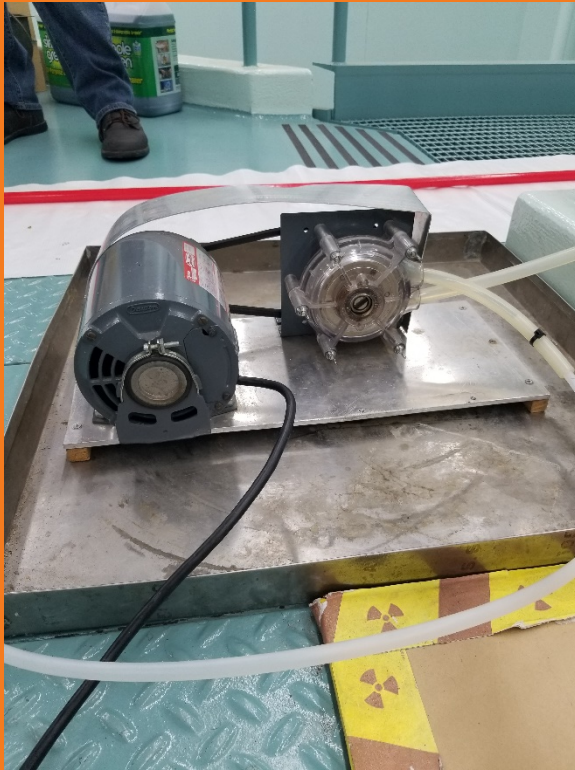
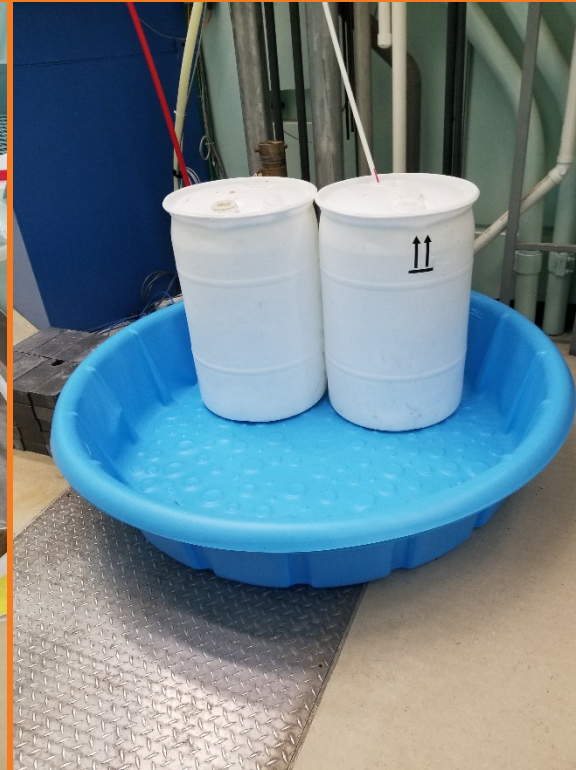
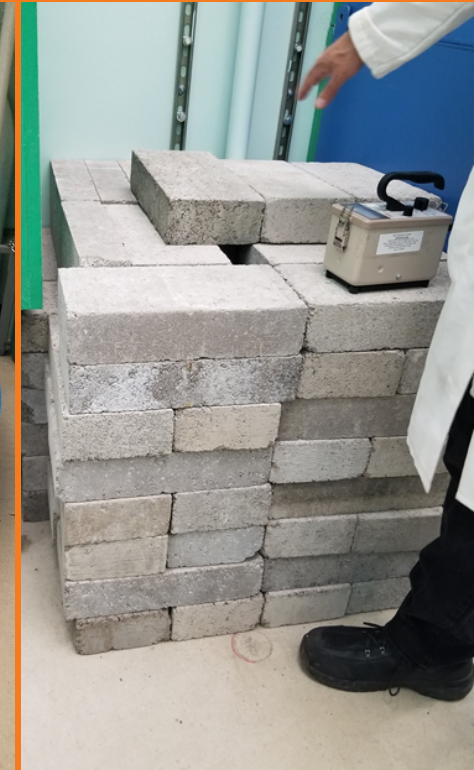
Simple Green was sucked out using a pump, then staff performed two rinses with DI water. Liquids were pumped into two 30 gallon waste drums. First drum had readings over 100 mR/hr on the side of the drum and necessitated building a brick shielding cave.

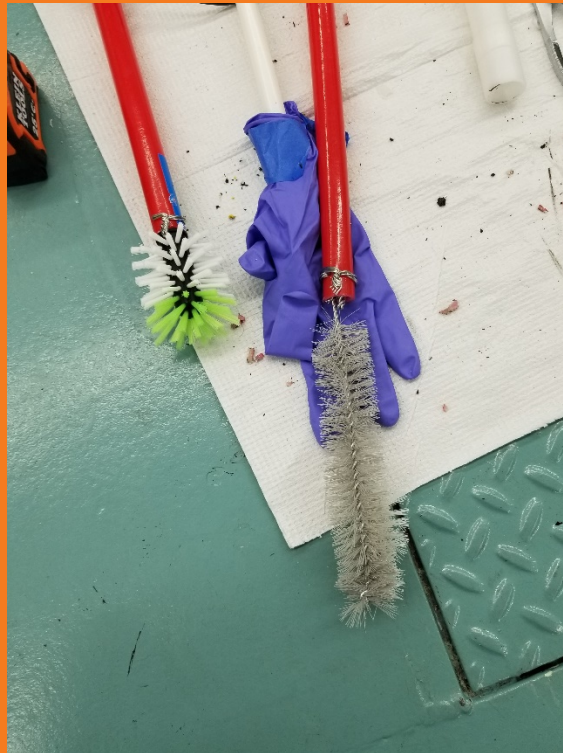
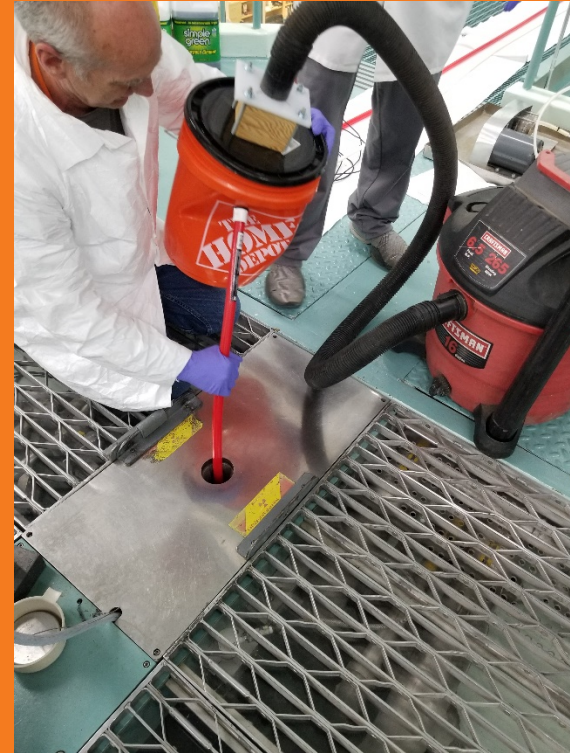
Staff performed an inspection with an endoscopic camera, found decent amount of debris. Built scrubbing tools using PEX and dryer vent brush. Built a makeshift vacuum with a HEPA filter and a Home Depot bucket (which failed) then a short metal bucket.

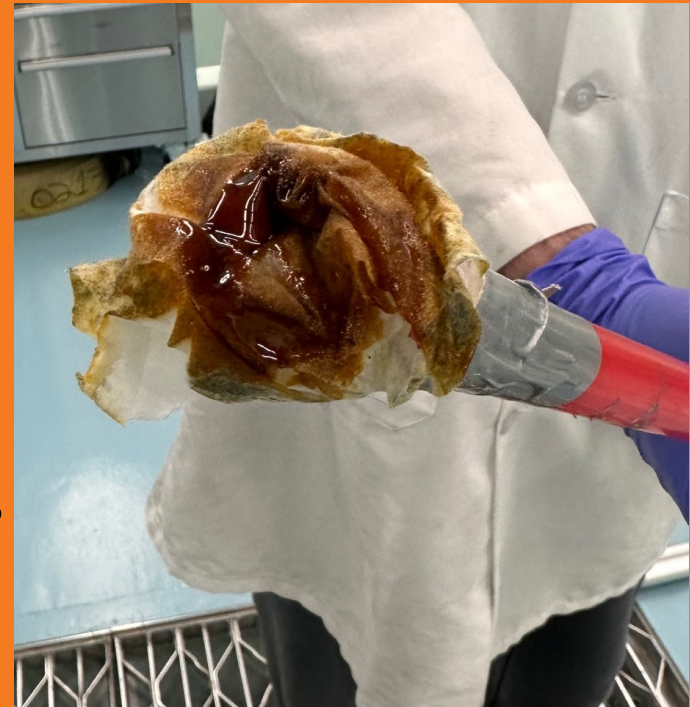
The Lazy Susan is still operable but requires constant “exercise”. If the motor is run at least once a week, it seems to keep the oil smooth enough to avoid motor stoppages.

½ cup of oil was too much. For months, oil continued to seep into the rack tubes. We performed subsequent rack cleanings but this time we used cloths dabbed with acetone. We found acetone did a great job at dissolving and removing the oil residue.
