MIT Research Reactor

Edward S. Lau

Big Impact of a Small Leak
at the MIT Reactor

19 June 2023

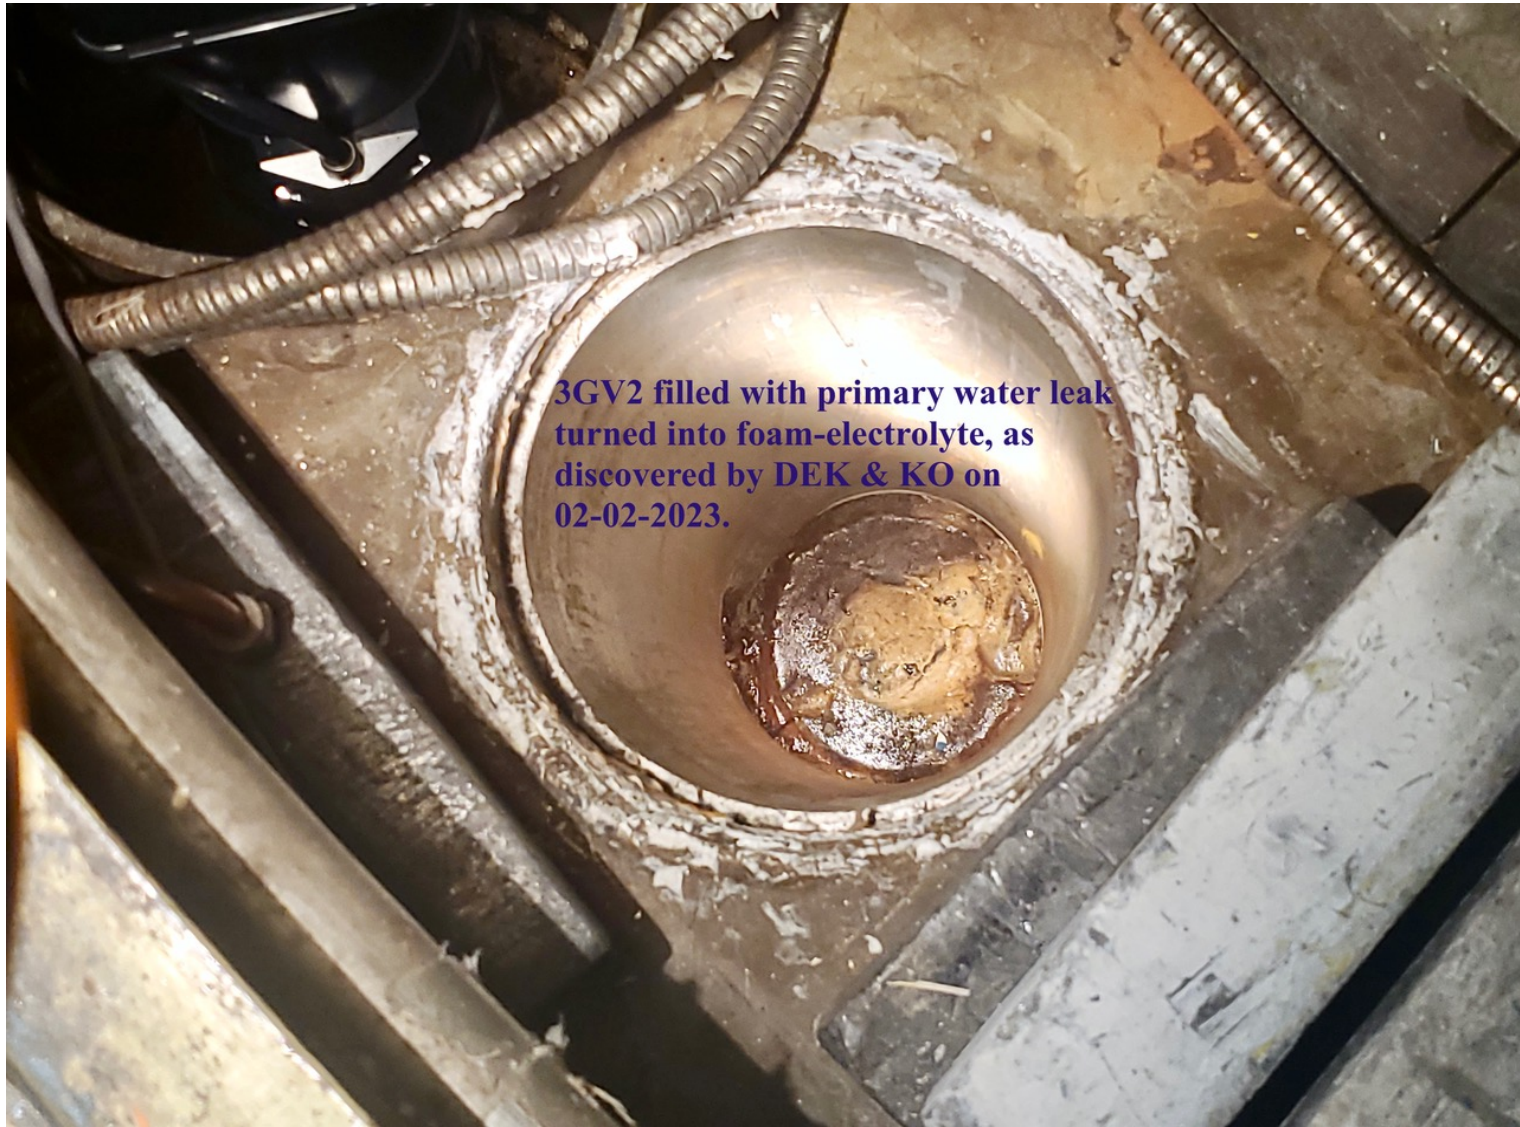
- December 12, 2022: 10% decrease in reading on one of the four nuclear safety channels
- All other neutron flux channels + thermal power channel indicate steady-state full power operation.
- Later that day: 4% decrease in a second nuclear safety channel
- The reactor was then shut down

Water in Vertical Port Attenuated Signal (Fission Chamber removed in photo)

**3GV2 filled with primary water leak
turned into foam-electrolyte, as
discovered by DEK & KO on
02-02-2023.**

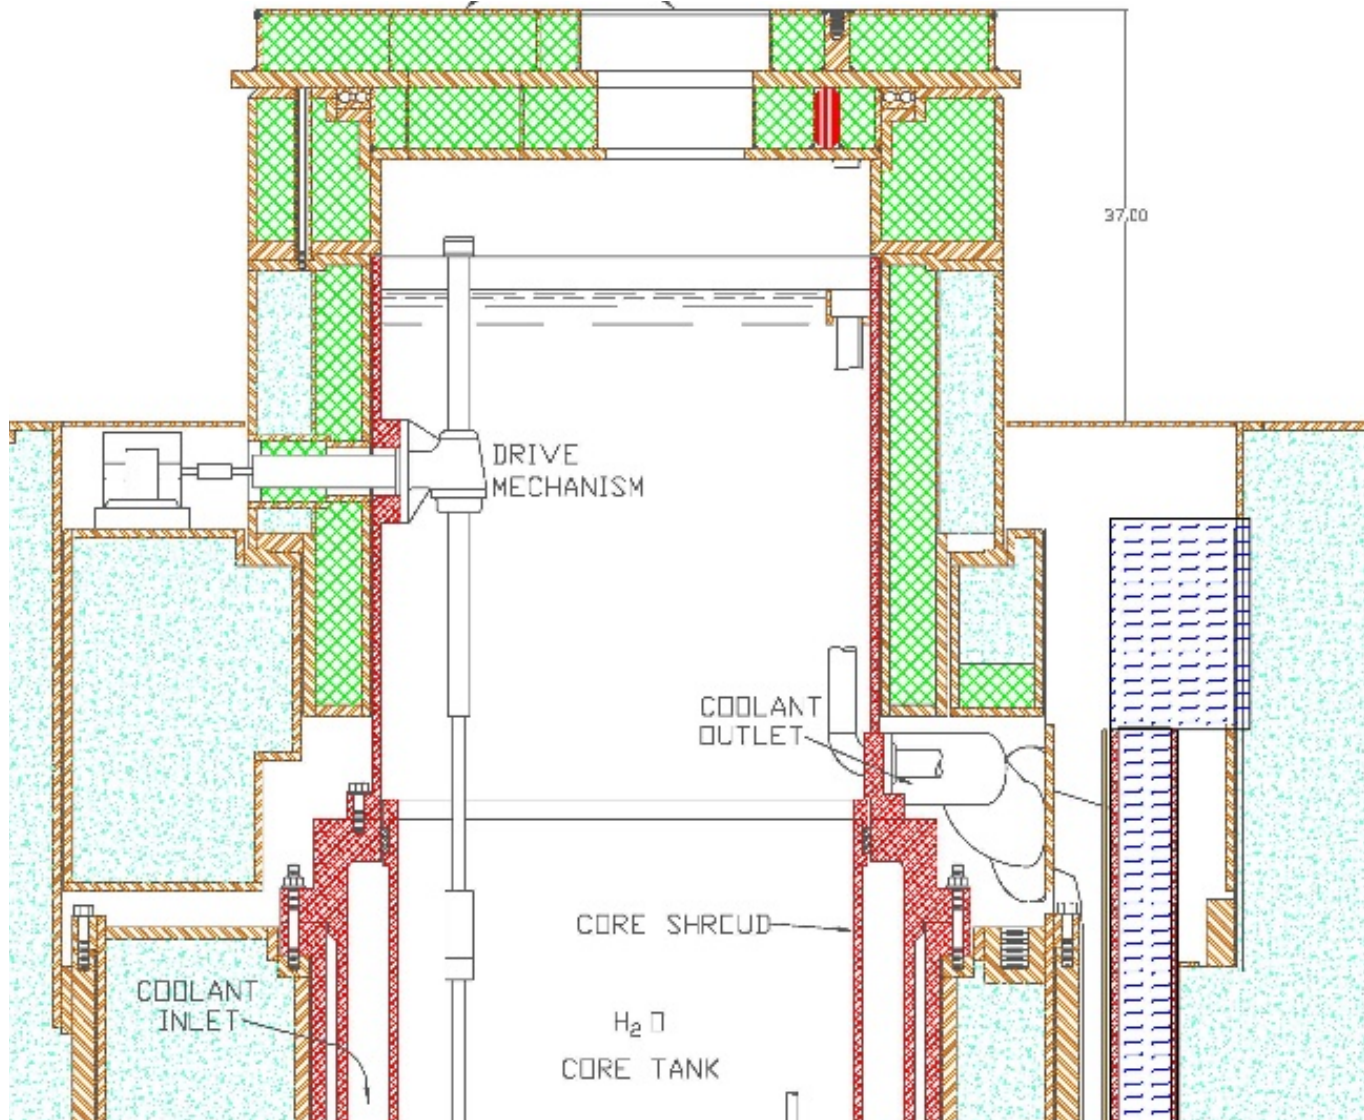
Cross-Section of MITR (Upper Tank)

There were nine possible sources of primary water leakage at the level of the coolant outlet:

- Coolant outlet pipe/manifold
- Coolant inlet pipe/manifold
- Inlet differential pressure gages MP-6 and/or MP-6A
- Core tank overflow line/flange
- Core tank flange for core purge system piping
- Core tank level probes ML-3A and/or ML-3B
- Upper core tank gasket

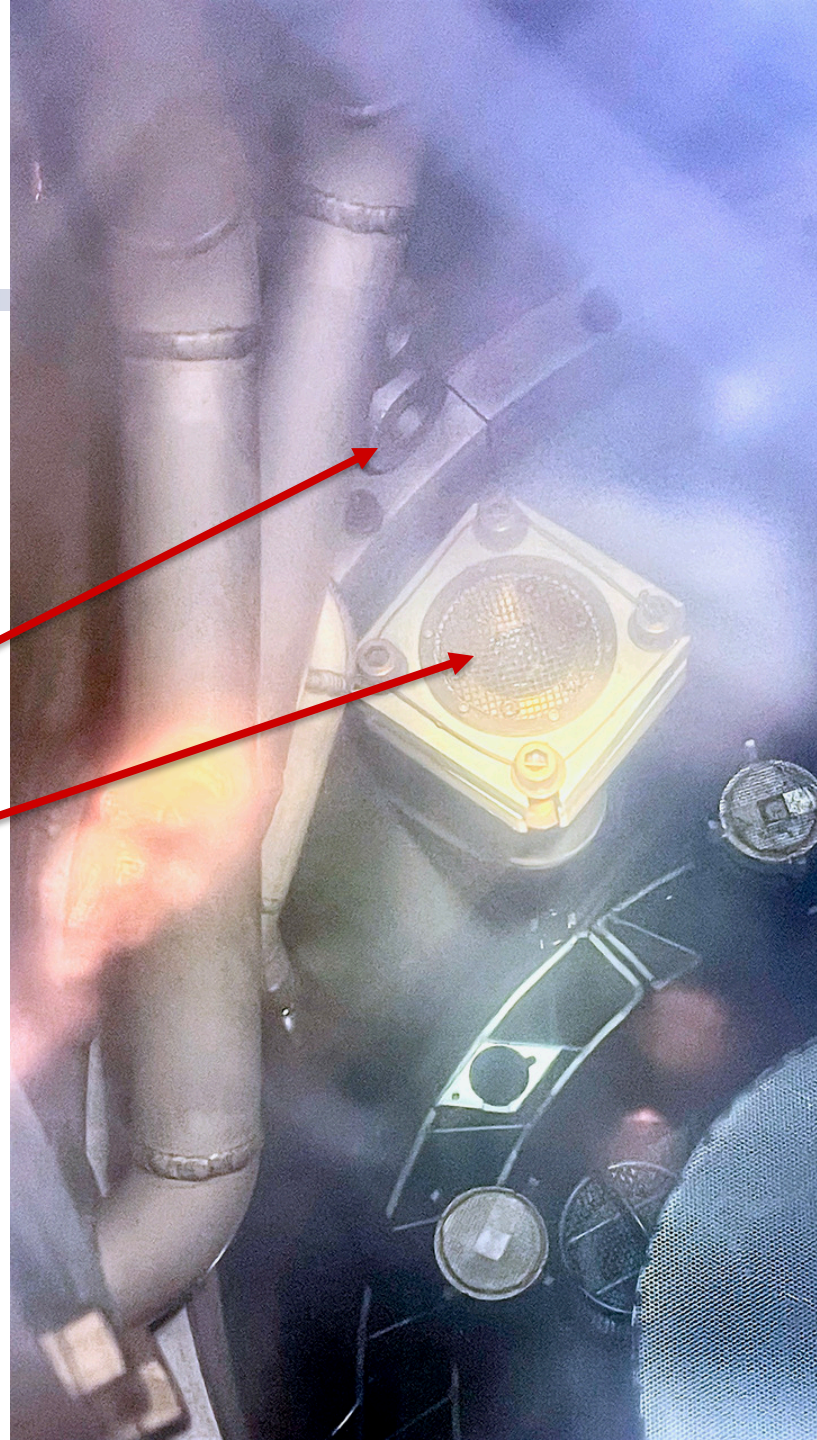
[Core Tank (Interior)

- One pressure gage penetration visible
- One anti-siphon valve visible

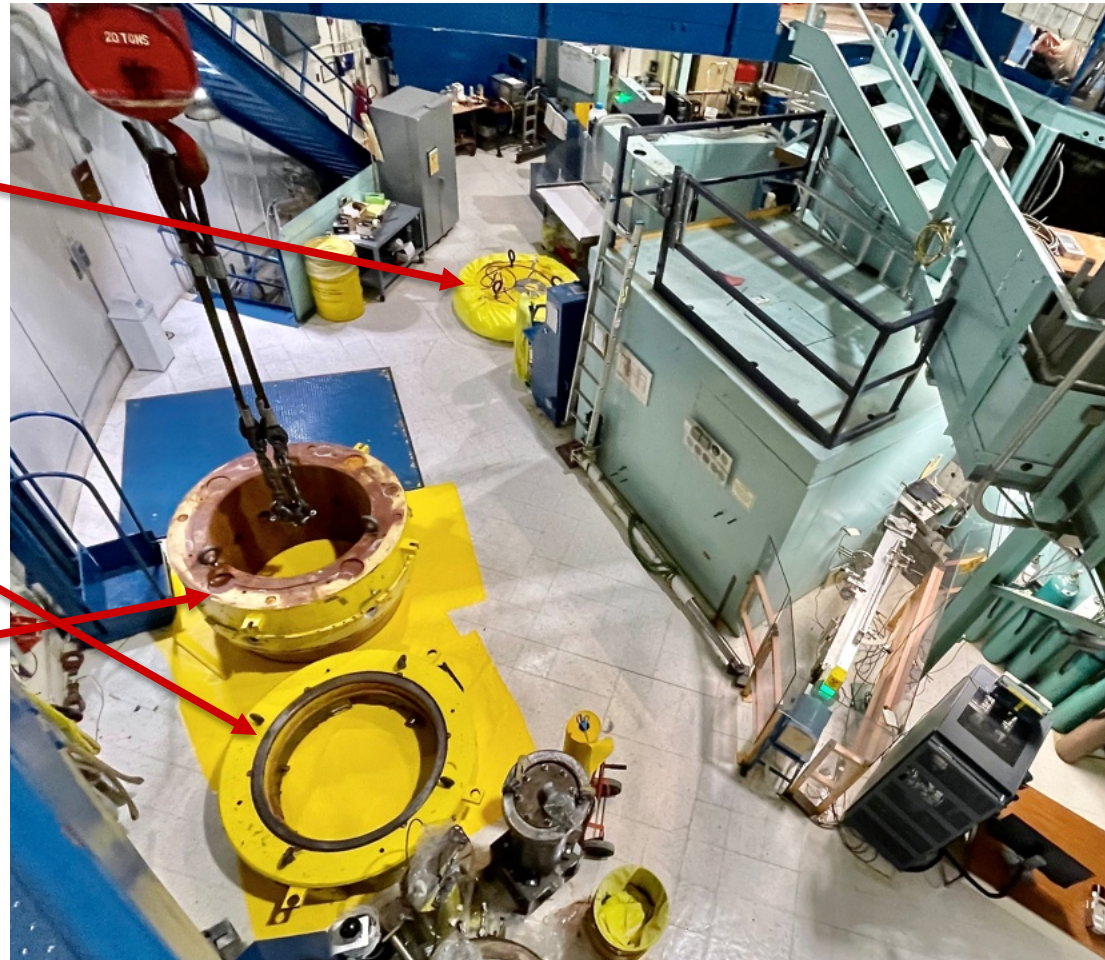
Shielding Removal After Defueling

- 1) Top shield lid (+ protective bag)
- 2) Upper shield access ring
- 3) Upper shield ring
- 4) Upper annular ring is not yet removed in this photo

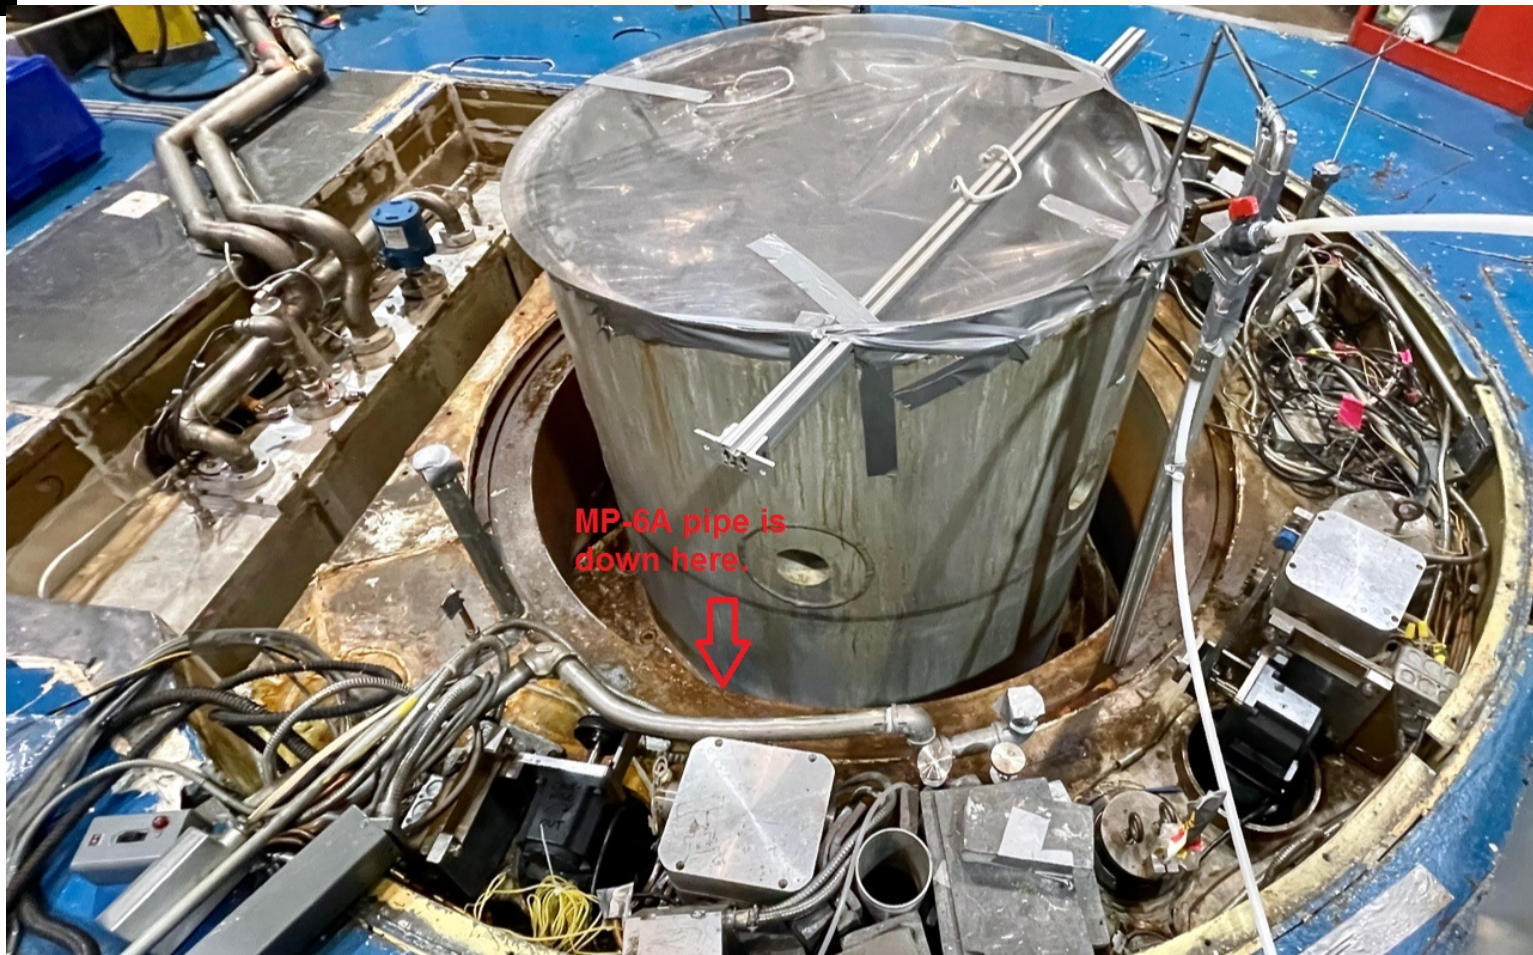
Leak is at Base of Upper Annular Ring

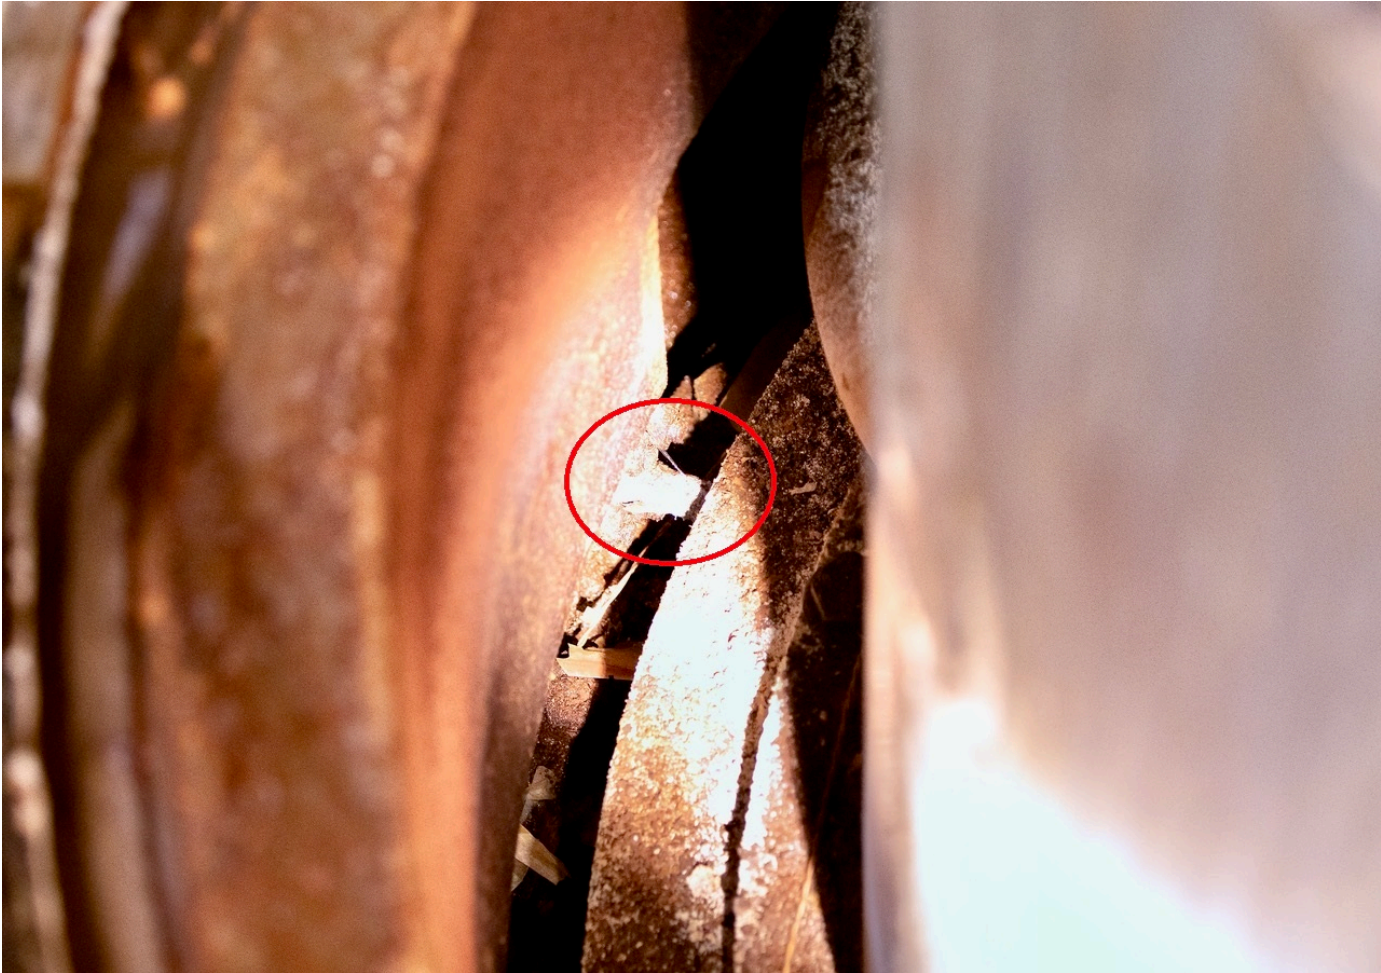
[Angled View from Above (with Leak)]

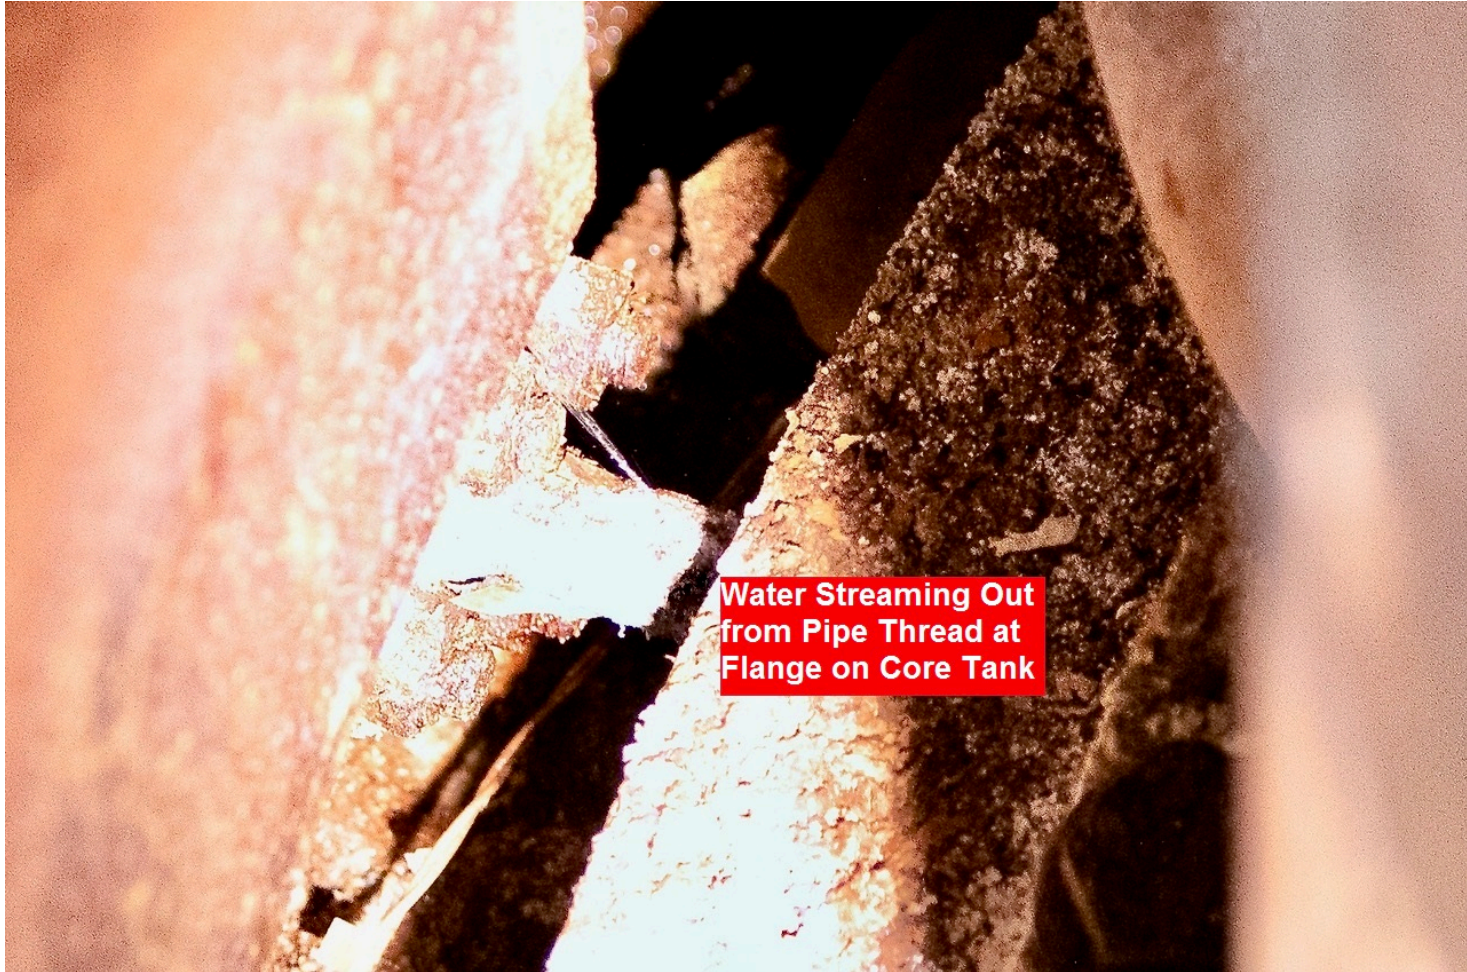
[Close-Up View from Above
(with Leak – 7.5 gallons per day)]

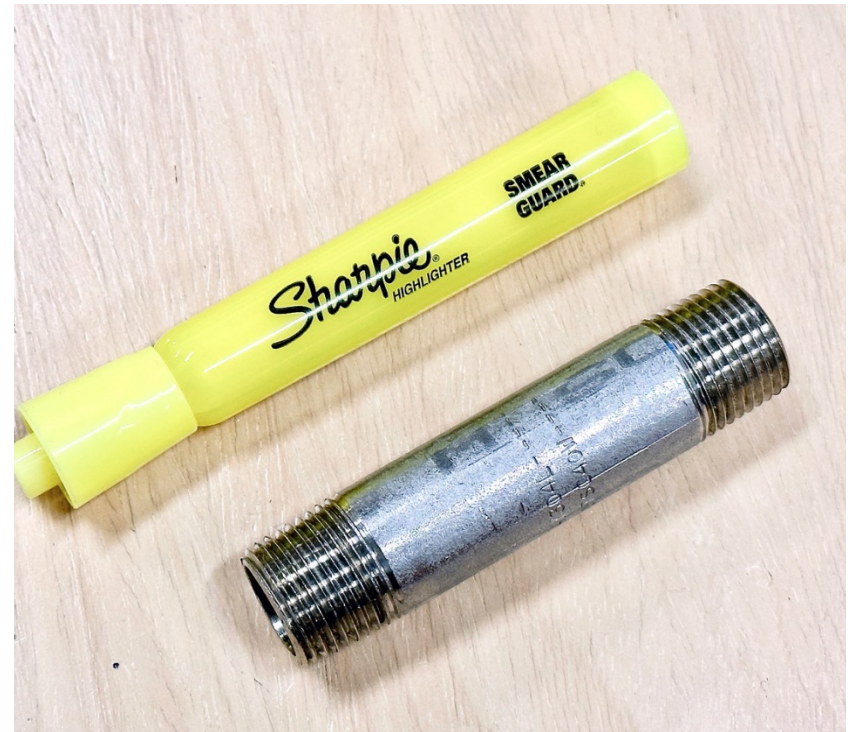
- Corrosion to a 1/2" threaded aluminum pipe section for the MP-6A flow sensor
- Humid conditions prolonged in the area
- Iron rust covered the aluminum pipe!
- The rust acted as an oxygen reduction site, polarizing the aluminum above its corrosion potential, resulting in general localized corrosion.

*Standard catalog part
costing about \$5 !*

- The leaking aluminum threaded pipe was replaced with a 316 stainless-steel threaded pipe.
- Other threaded piping in the area was similarly replaced as a preventive measure
- The piping area was cleared of iron rust.
- The inner and outer surfaces of the shield rings that sit above the piping area were carefully cleaned by grinding and sanding, and then coated with rust inhibitor.
- All gaskets in the area were inspected; some were replaced.
- Leak detectors added in many locations for early detection. Use of humidity sensors is being considered as well.
- Inspection tubes added for future use.
