# Failure, Evidence, Redesign

Resolving Retaining-Ring Fractures in the NBSR Refueling Plug

David Hix, Sahar Rubin  
September XX<sup>th</sup>, 2026

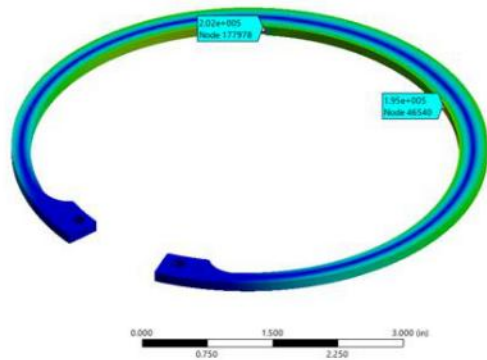
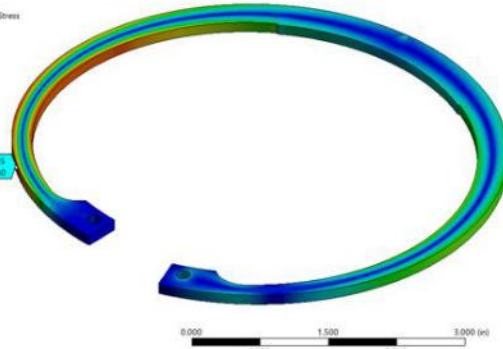
- Seating in the groove creates sustained tensile stress in the ring.
- Bounding groove-contact loading raised local OD stress at the observed fracture location.
- Mechanical loading produced localized plastic deformation, but no fracture.

**Interpretation: Mechanical Load Was A Contributor To Stress State, Not A Standalone Failure Mechanism.**

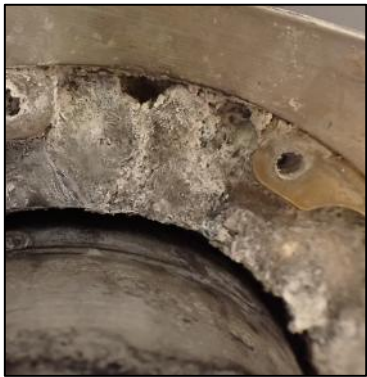
## **Deposit retention**

White/gray deposits built up around the bearing and retaining-ring groove.

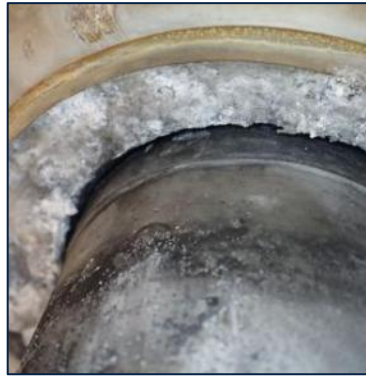
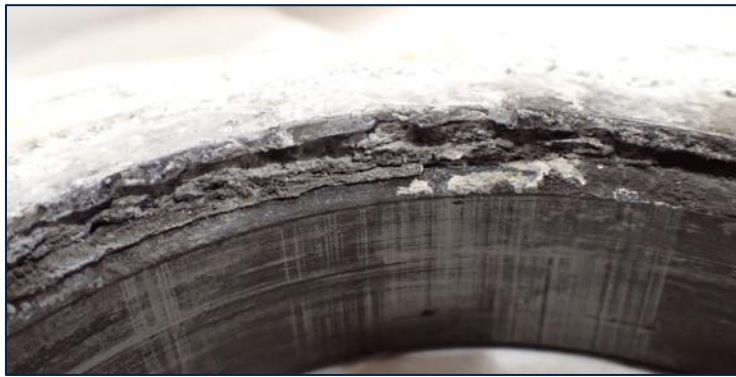
## **Localized attack**

Aluminum degradation concentrated at the aluminum–Graphitar interface.

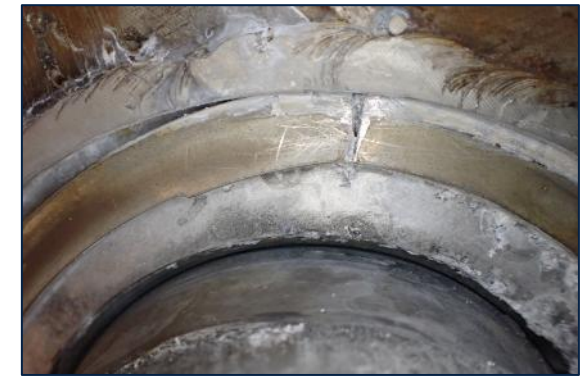
## **Constrained groove**

Corrosion bands and fracture geometry suggest repeated buildup and possible incremental ring displacement.

**Environment was not just background noise - it provided the local chemistry and constraints needed for SCC.**

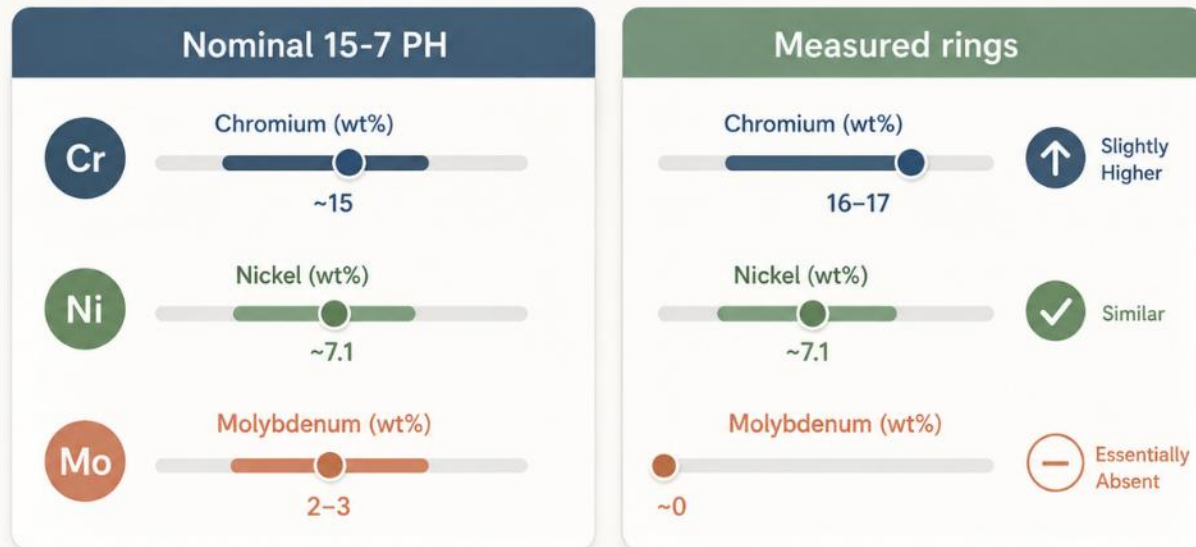
### Nominal 15-7 PH vs Measured Rings

Measured rings are inconsistent with nominal 15-7 PH and are more consistent with **17-7 PH**.

Mo is effectively absent in the measured larger rings.

- Molybdenum strengthens the passive film and improves resistance to localized corrosion.
- Its absence increases susceptibility to pitting and crevice-corrosion initiation in chloride-bearing environments.

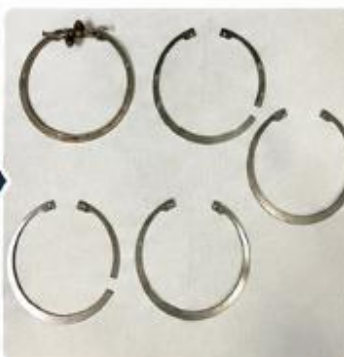
4. After 14.5 h Post-test

🔍  
Two of three compressed rings fractured

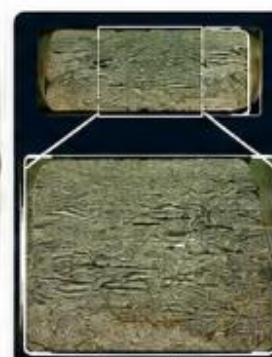
5. Fracture Detail

📷  
Fracture surface consistent with SCC morphology

Only when rings were stressed did chloride exposure lead to cracking—consistent with a stress corrosion cracking (SCC) mechanism.

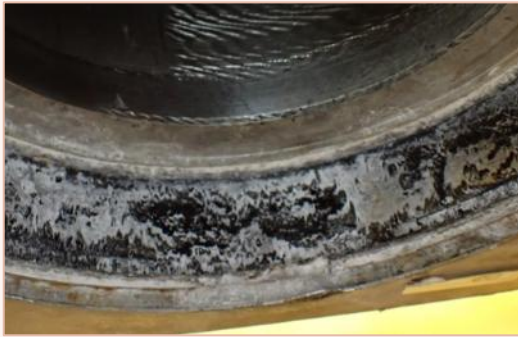
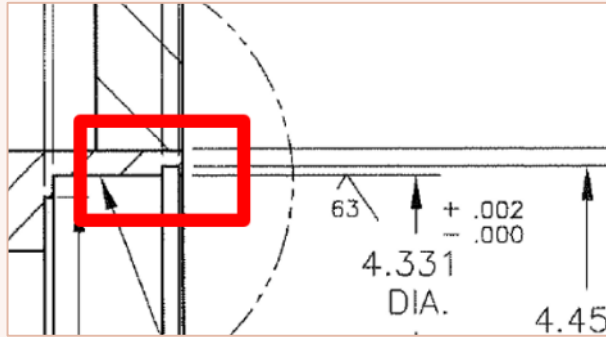
As-built geometry overruled the standard design - G8 Required a dedicated solution

**Shallow groove with small worn support shoulder**

A custom external holder replaced the groove-retaining concept
