# **Annular Core Research Reactor**

## **ACRR Advanced In-Service Fuel Inspections**

**SAND # TBD  
TRTR Conference 2021**

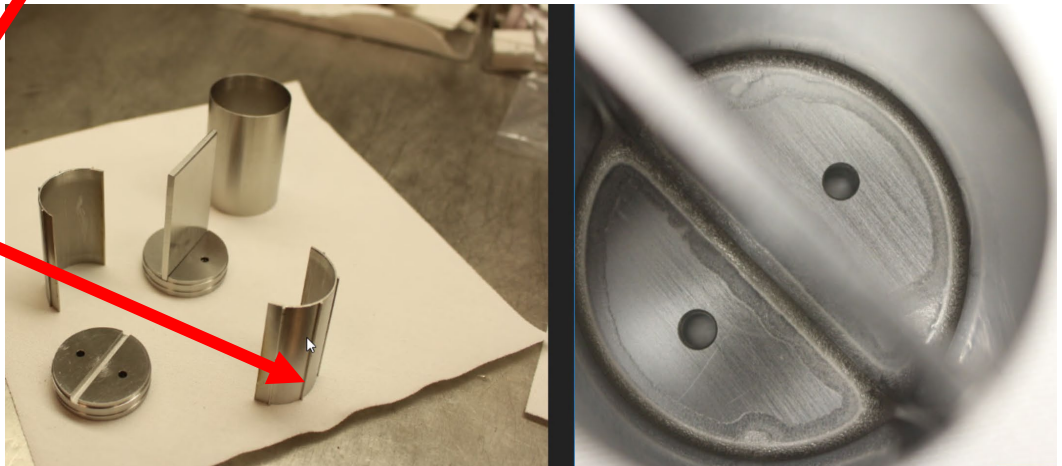
Niobium cup ridges will only be detected when water is present

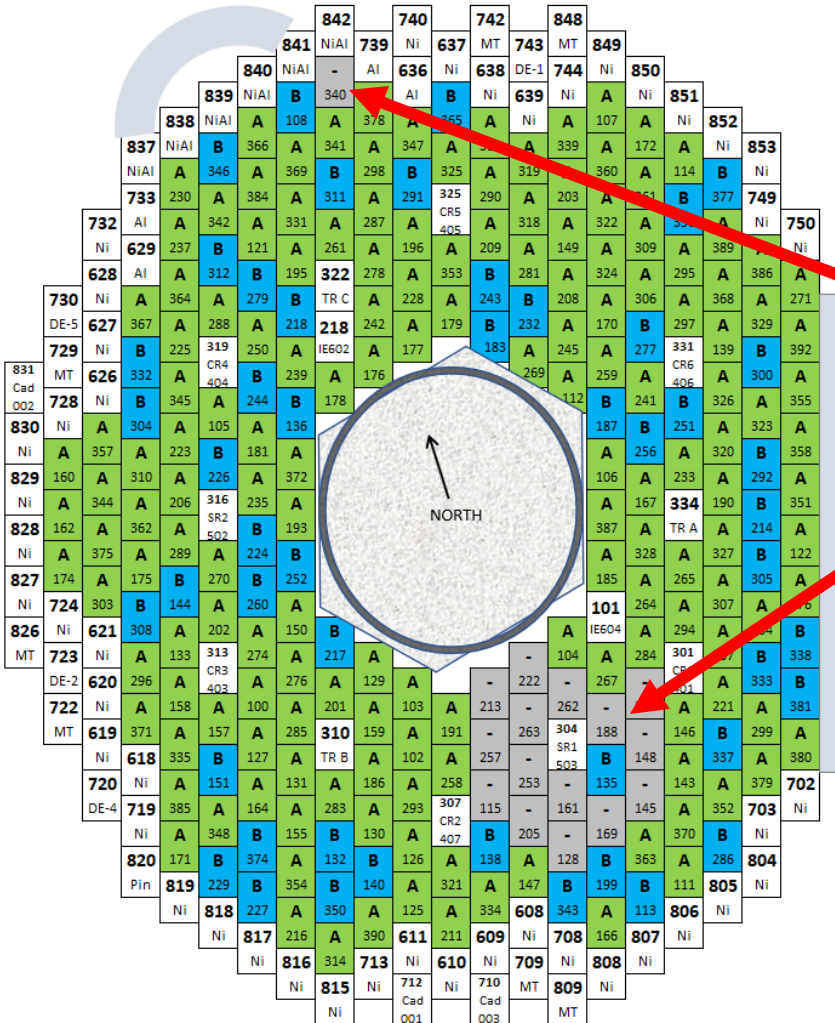
# Distribution of Grades

Year	"A" Grades	"B" Grades	Total
2020	35	8	43
2021	128	40	168

- One element could not be physically removed from the core due to an obstruction
- 15 elements were inspected prior to the grading criteria being developed, therefore no grades were assigned
