# Sandia National Labs Annular Core Research Reactor Outage Lessons Learned

(July 04 – Feb 05)

R.D. Clovis, Department 1381 September 16, 2005

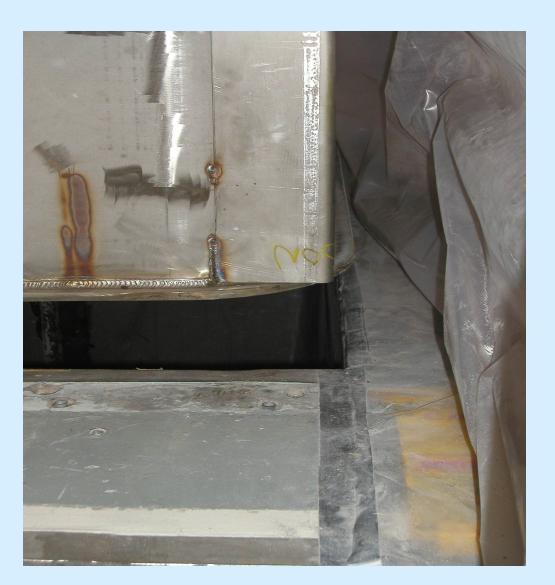
#### Pool liner doesn't fit!

- Original Engineering drawings correct.
- •Vendor's Fabrication shop drawings were rotated 90°.
- •Vendor agreed to build another liner.

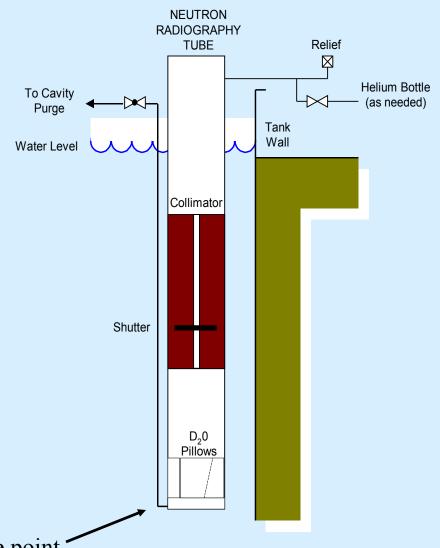
#### ACRR Tank View from West side

- •NR facility not incorporated in the original ACRR design, causing some design constraints.
- Cavity Purge piping appears to be the source of the leak.
- Leak caused damage to the collimator rendering it inoperable.

Suspected leakage point

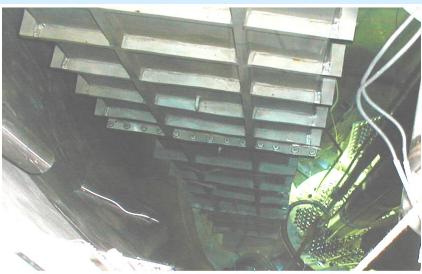
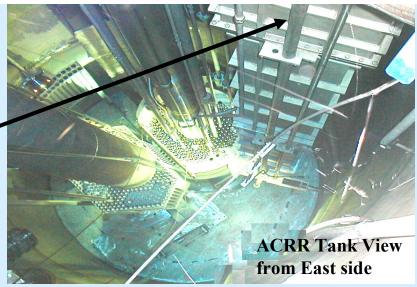
Cavity Purge Piping

•On the lower image note the two inch diameter steel pipe.
This steel pipe connects to the lower chamber of the NR tube so that radioactive gases can be removed during operation. This connection was the source of the water leak and subsequent damage to the collimator.

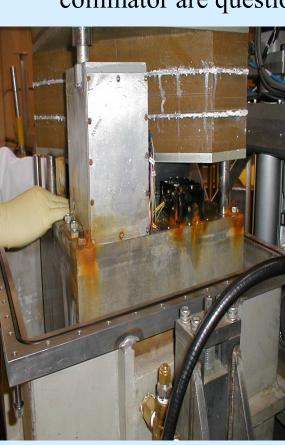
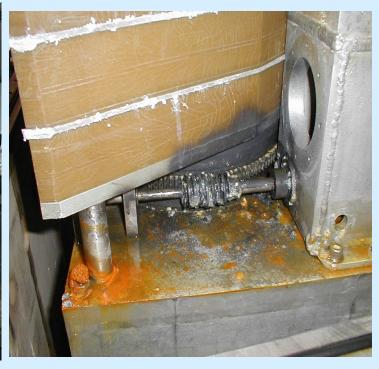
- Damage is clearly visible.
- Operating mechanisms and structural strength of the collimator are questionable.
