Corrosion of Dummy "EE" Plate 19 in YA-M Type ATR Fuel Elements During PALM Cycles INL/EXT-16-38324

Jeffrey O. Brower, Michael V. Glazoff, Aleksey V. Rezvoi, and Thomas J. Eiden Idaho National Laboratory

TRTR Conference August 2016

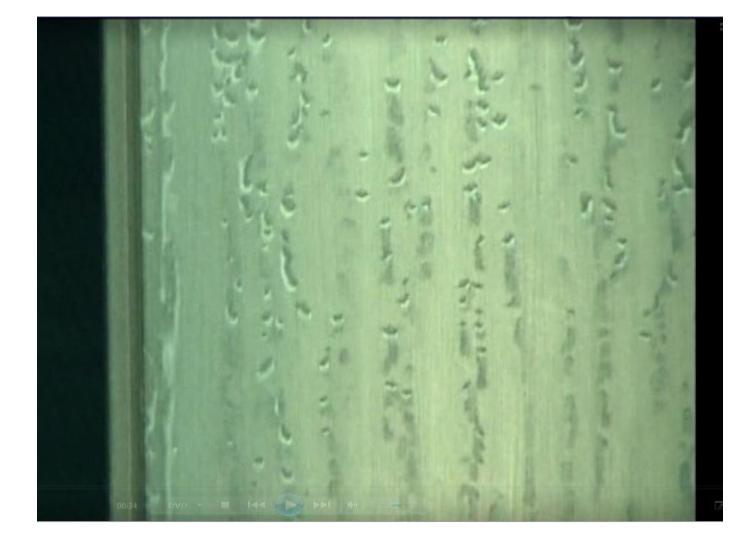
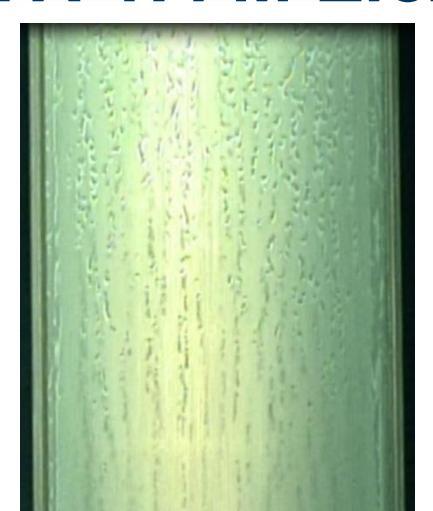
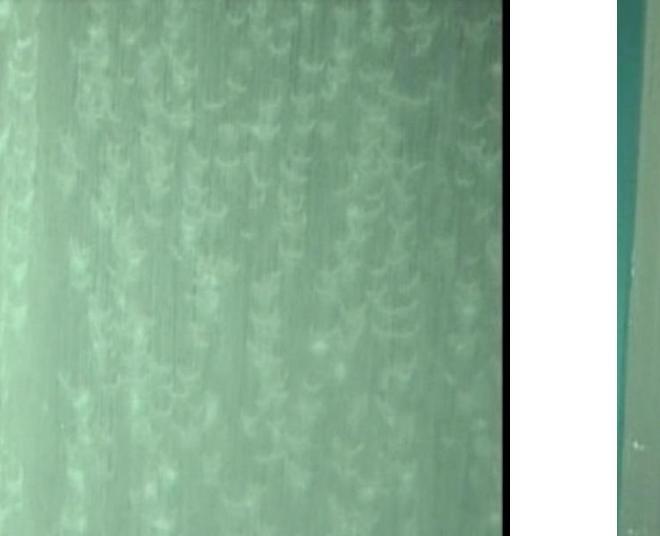
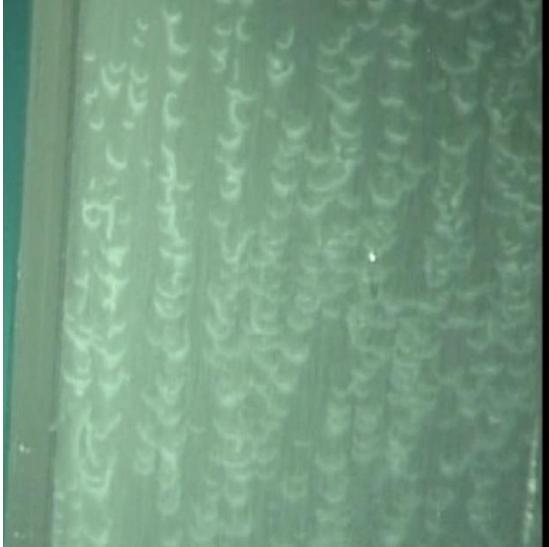
# **Pitting Degradation on ATR YA-M Elements**

- After the cycle was over, all 40 fuel elements were removed from the core and inspected. Several thousand flow-assisted erosion/corrosion pitting and "horseshoeing" defects were readily observed on the surface of the aluminum dummy "EE" plate 19 on all eight of the previously new YA-M type fuel elements.

- Similar pitting degradation was observed after PALM cycle 156A-1.

- The observed pitting degradation appears to be the result of a combination of higher reactor power levels, higher primary coolant flow rate, and narrowing of the coolant channel 20 due to modified side plates on YA-M type fuel elements and possible swelling of the beryllium reflector blocks late in life prior to core internal changeout (CIC).
- The chamfer at the edge of the horizontal saw cuts in the Beryllium reflector blocks created the turbulent flow conditions that contributed to the flow erosion/corrosion pitting degradation of the aluminum dummy plate on YA-M type fuel elements. Modeling showed that a wider coolant channel 20 or larger chamfers would have reduced the potential for this flow erosion/corrosion.

- The fabrication process was revised to include an additional blister anneal at 900°F (482°C) for 2 hours to allow for additional crystal growth during production of the dummy EE plates. The first YA-M fuel elements to be fabricated using the revised process are scheduled to be fabricated in 2016, and are expected to be loaded in the ATR core in 2017.
- Many of the affected YA-M type fuel elements have been recycled and loaded into the ATR core for additional operating cycles with no detrimental effects.
