IDAHO NATIONAL LABORATORY ADVANCED TEST REACTOR

**LACK OF CONFIGURATION AND CONTROL
RESULTING IN CATASTROPHIC FAILURE OF VALVES**

September 2013
Jeffrey O. Brower

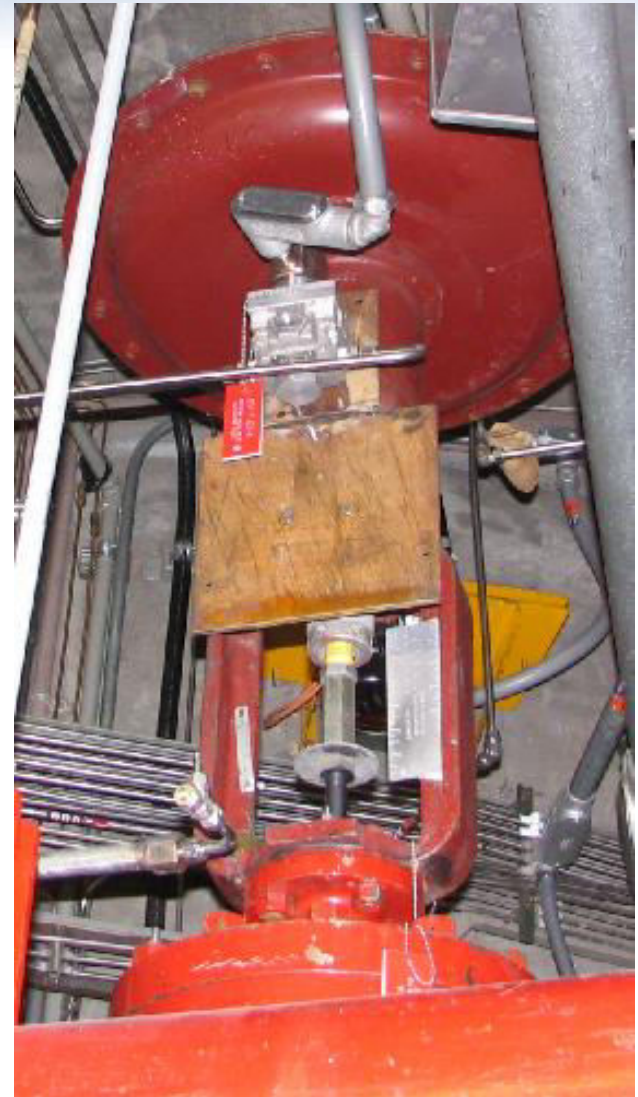
Level Control Valves

- The ATR EFIS LCVs are safety-related.
- Spring-to-open and air-to-close.
- Two valves provide dual redundant capability.
- Bottom Head EFIS subsystem provides dual redundant capability to the Upper Vessel EFIS subsystem.
- Either valve in either subsystem is sufficient to supply adequate cooling water.

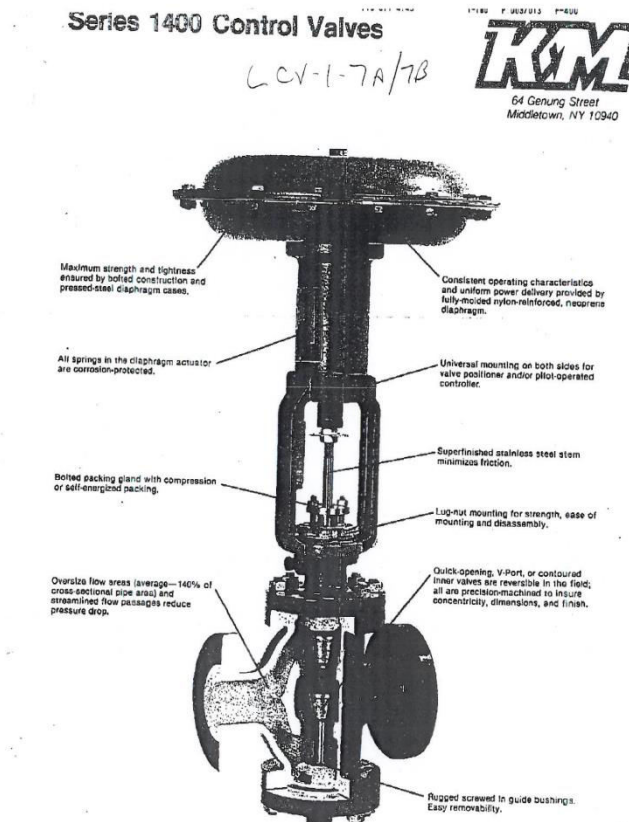
- Documentation identifying nameplate data from the valve body and actuator.

ATR VALVES LCV-7A, 7B Certified 7/21/51
 Mfg. Kelley Mueller
 SERIAL # ~~Model~~ V-3392-4 Type 1450 size B"
 DIAPHRAGM MOTOR
 (Actuator: Model 60 DN 222 SP 176 (air to close))
 Diaphragm No. 222
 Effective area: 250 in²
 Max. air pressure on diaphragm ^{plus housing} - 50 psig
 Max. shaft load: 10000 lbf
 Spring constant - 1100 lbf/in
 Length of travel 1.75 inches
 Spring length - 14"
 Will compress to 5"
 Spring adjustment ~ 3"
 Area of valve plug - 50.3 in²
 Valve pressure rating 300 lb
 KM-11229 60D
 QUICK OPENING PLUG C_v = 760
 PO # 4079-70-027-2 ITEM 4 LCV-1-7A
 STEM SIZE 3/4"

DIAPHRAGM
 PRESS
 RANGE
 0-30 psi
 FOR FVLC
 STROKE WITH
 NO BODY
 PRESSURE

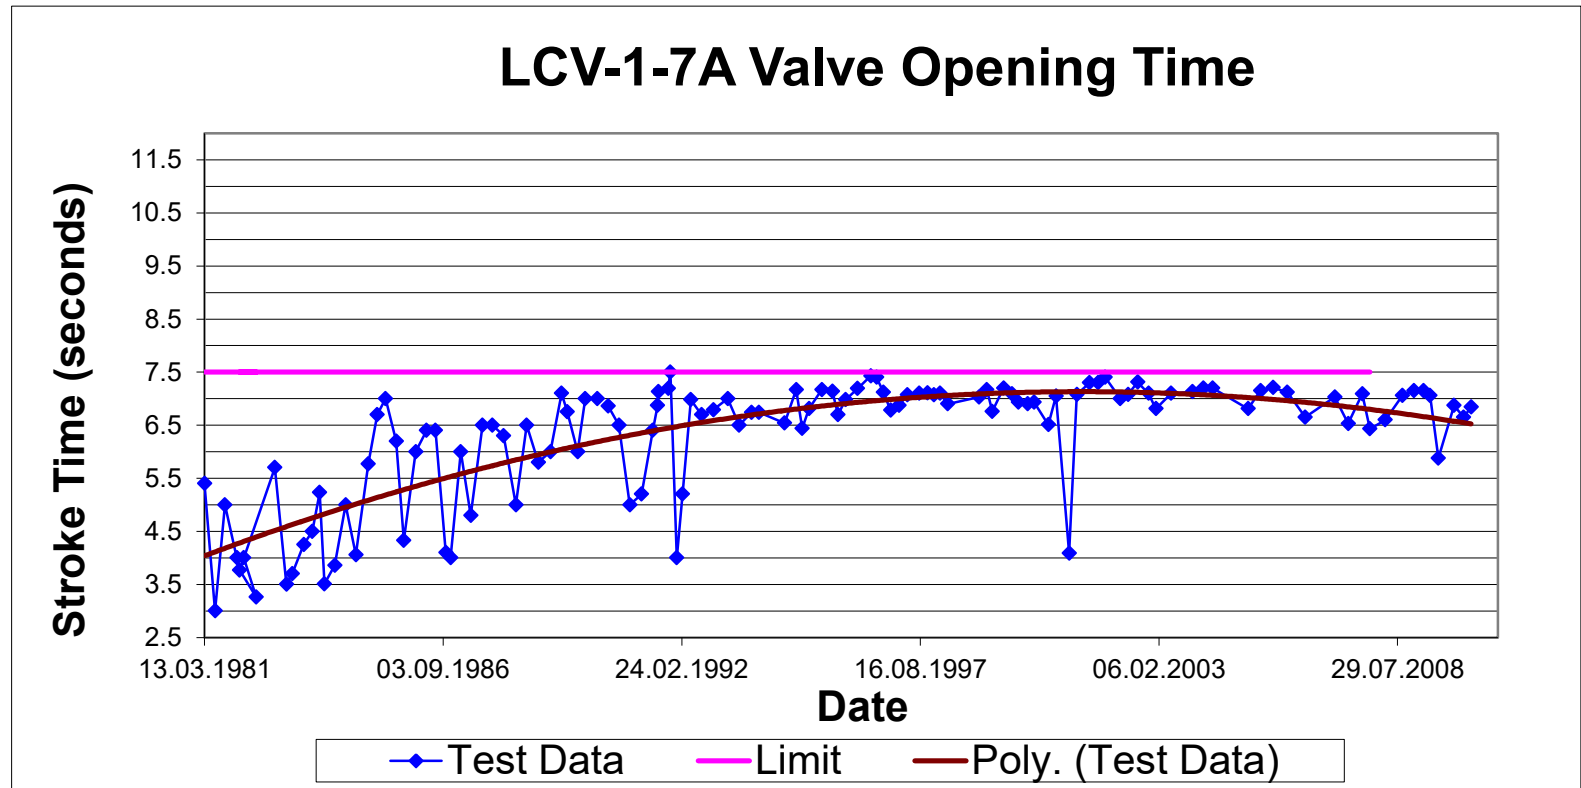
- ATR Operations performs functional testing of these valves every 100 days.
- This plot shows the trend as the air pressure was increased prior to 1997 and reduced after 2003.

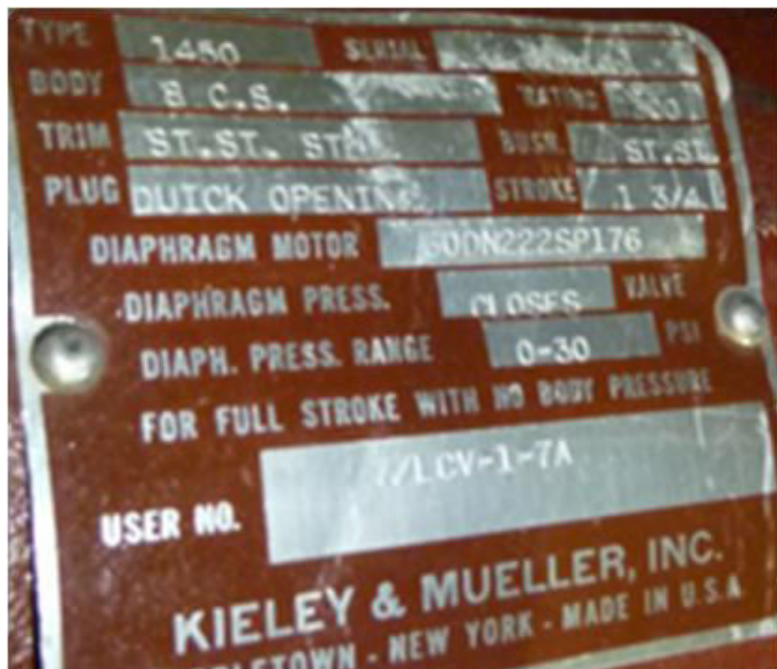
- Actual nameplate for the valve with “DIAPH. PRESS RANGE” 0-30 psi
- Operators round sheet with supply pressures of 60-80 psi.

Fire Water Injection System - (PSIG)					
LCV-1-7A & 7B			LCV-1-615 & 616		
Nitrogen Supply		Instrument Air	Nitrogen Supply		Instrument Air
PI-6-1079 Bottle	PI-6-1078 Regulator	PI-6-35	PI-6-1081 Bottle	PI-6-31 Regulator	PI-6-30
>100	60-75	75-80	>100	60-70 (7)	60-70 (7)

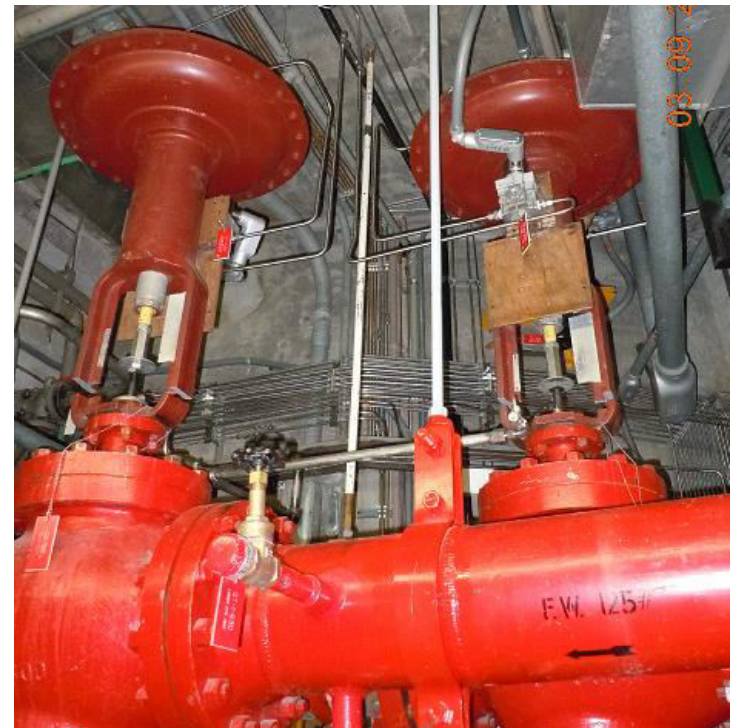
- While the valves were shut, there was one loud sound, similar to a shotgun blast.
- Both valve actuators were jumping around above our heads.
- All four valve yokes had failed simultaneously.
- The valve actuators were unsupported except for the valve stem, the instrument air tubing, and control power to the solenoid valves.

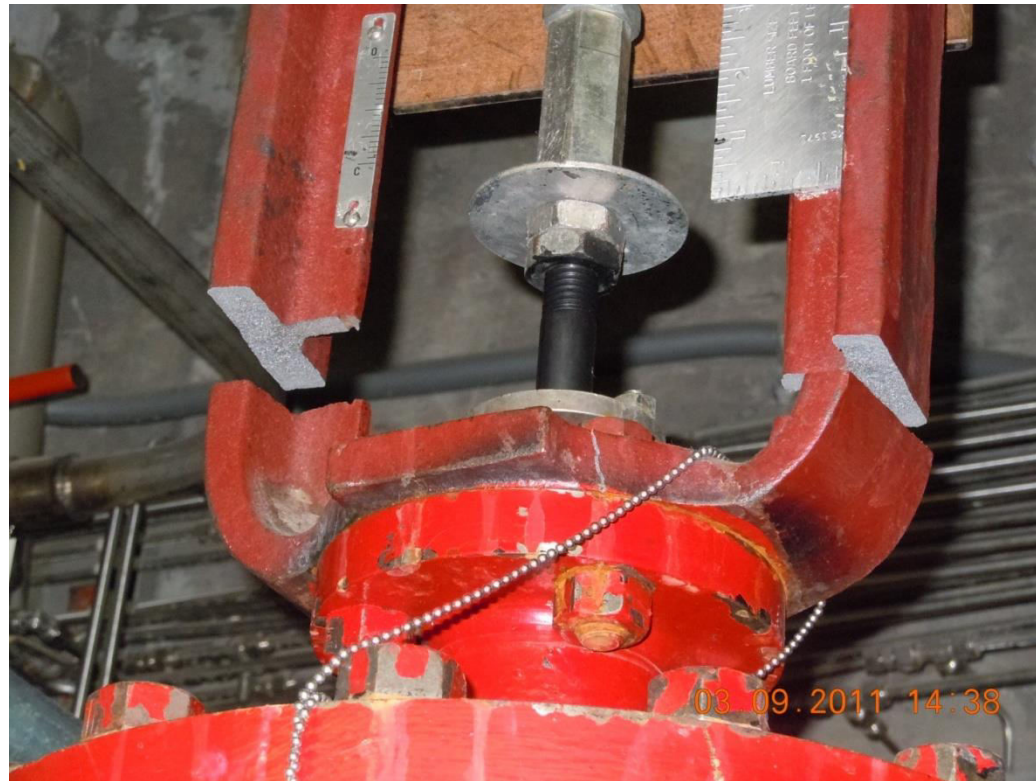
- The yokes failed at a drilled hole in one of the valve yokes, and at the bolt holes in the valve yoke bolting ring.

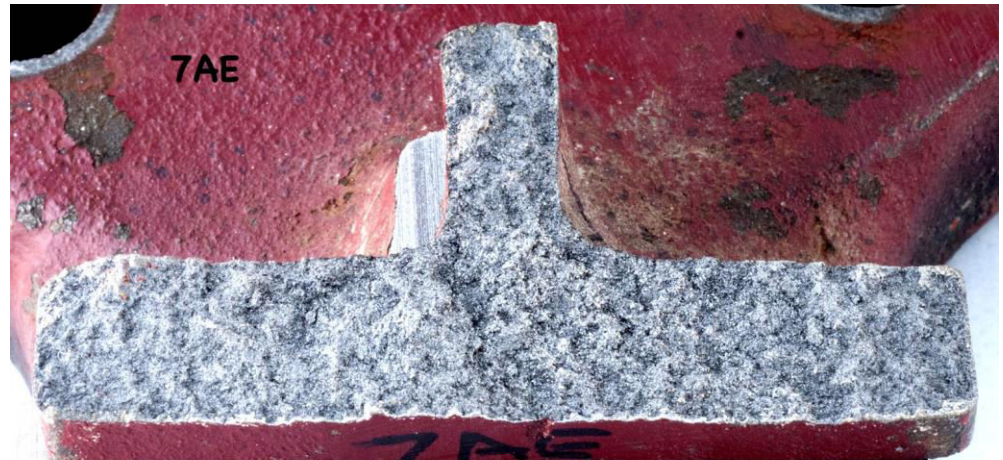
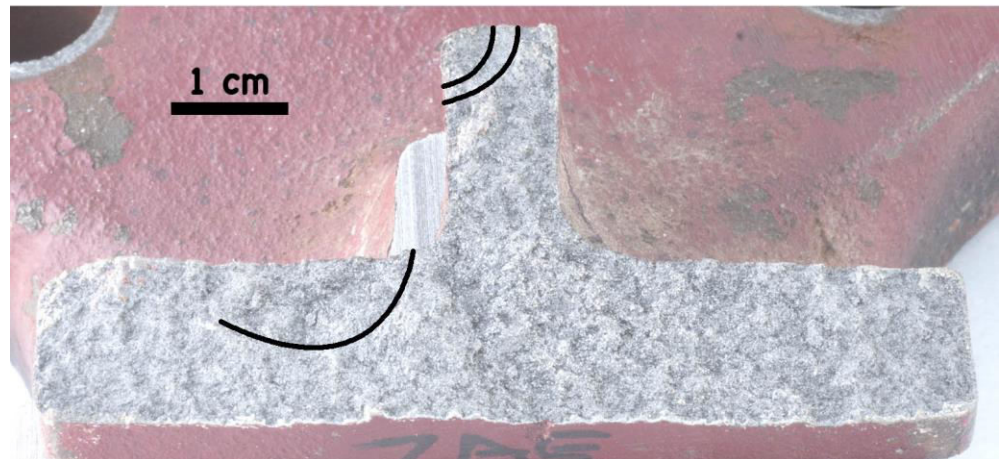
- Fracture at the valve yoke.

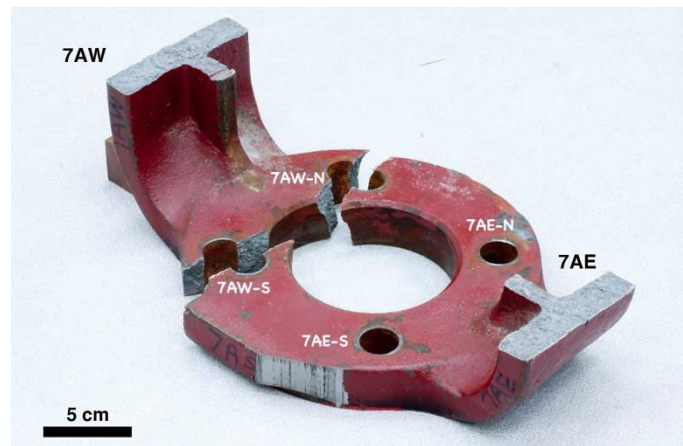
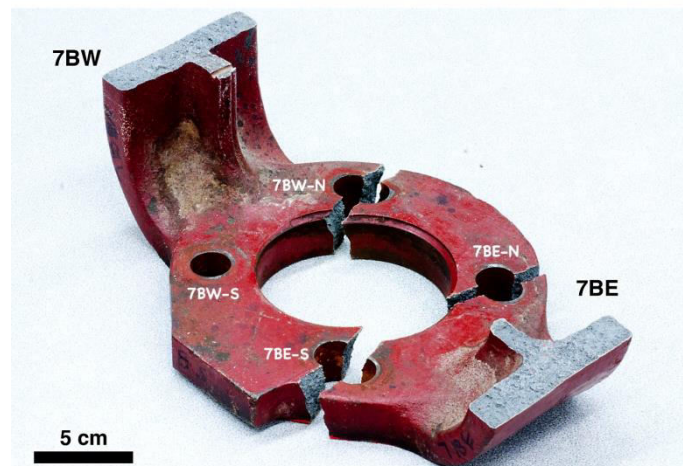
- Fractures at the bottom of the yoke, where it is bolted to the valve body.

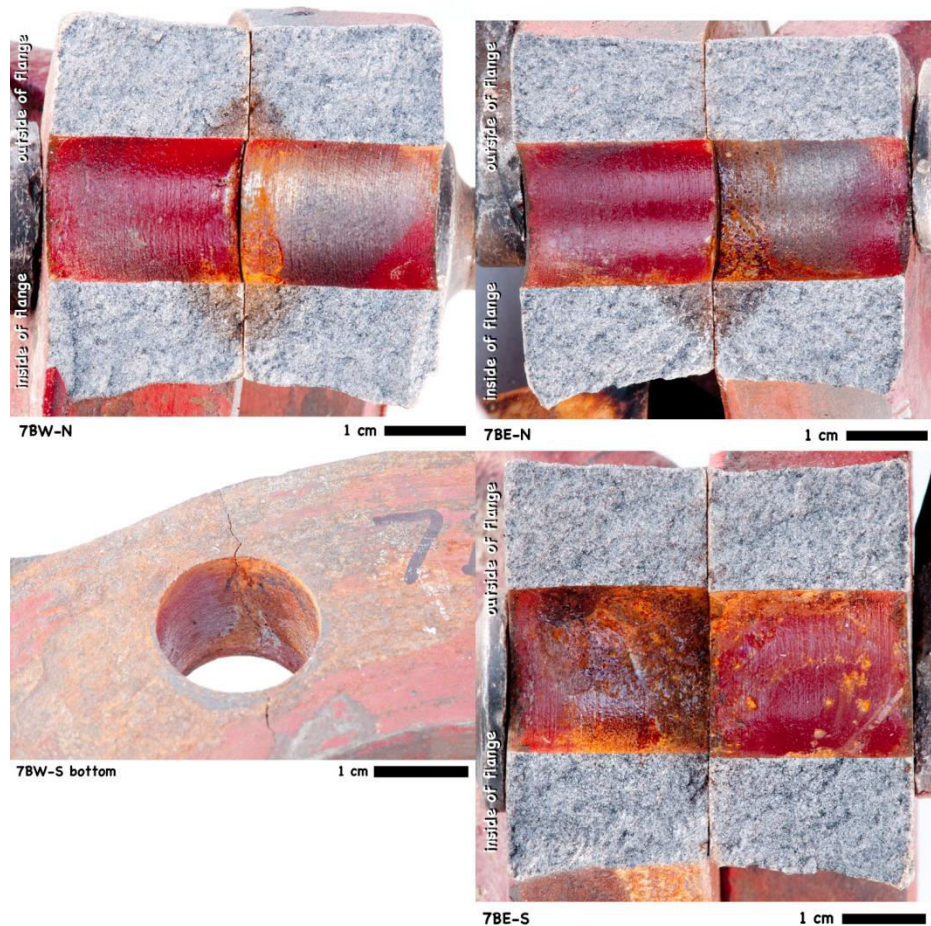
- Rust that had developed in the pre-existing cracks in the yoke bolting ring.

- The more likely failure location was at the pre-existing flaws on the bolting ring - pre-existing cracks with oxidation (rust).

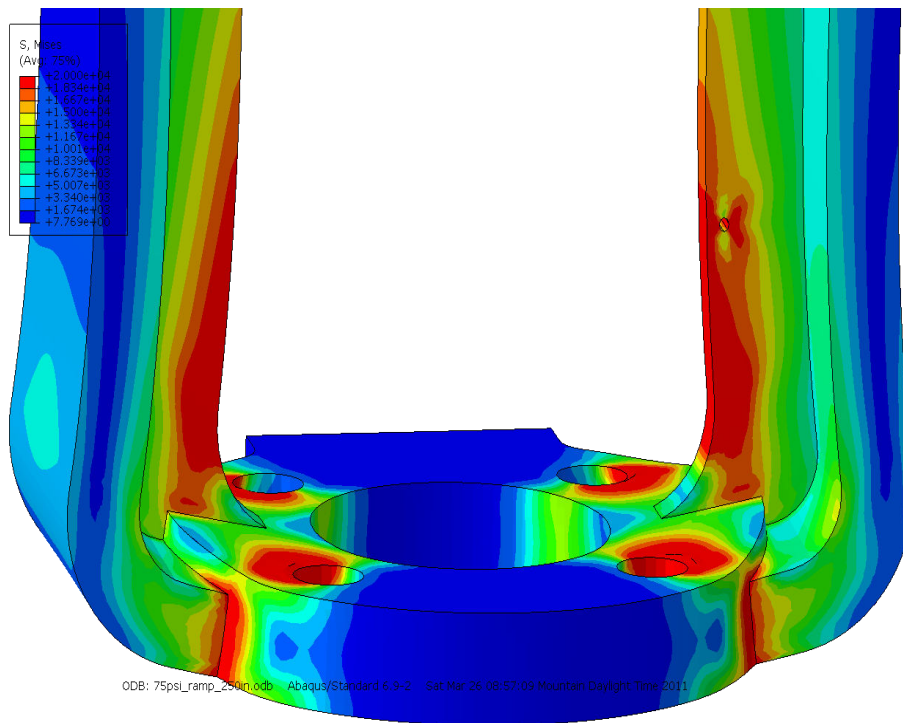
- Finite element models were developed to determine potential failure locations.
- The initial failure point was never positively identified, but was either the drilled hole on the yoke or the cracked bolt holes.

Step: Step-1
 Increment: 10; Step Time = 1.000
 Primary Var: S, Mises
 Deformed Var: U - Deformation Scale Factor: +3.000e+01

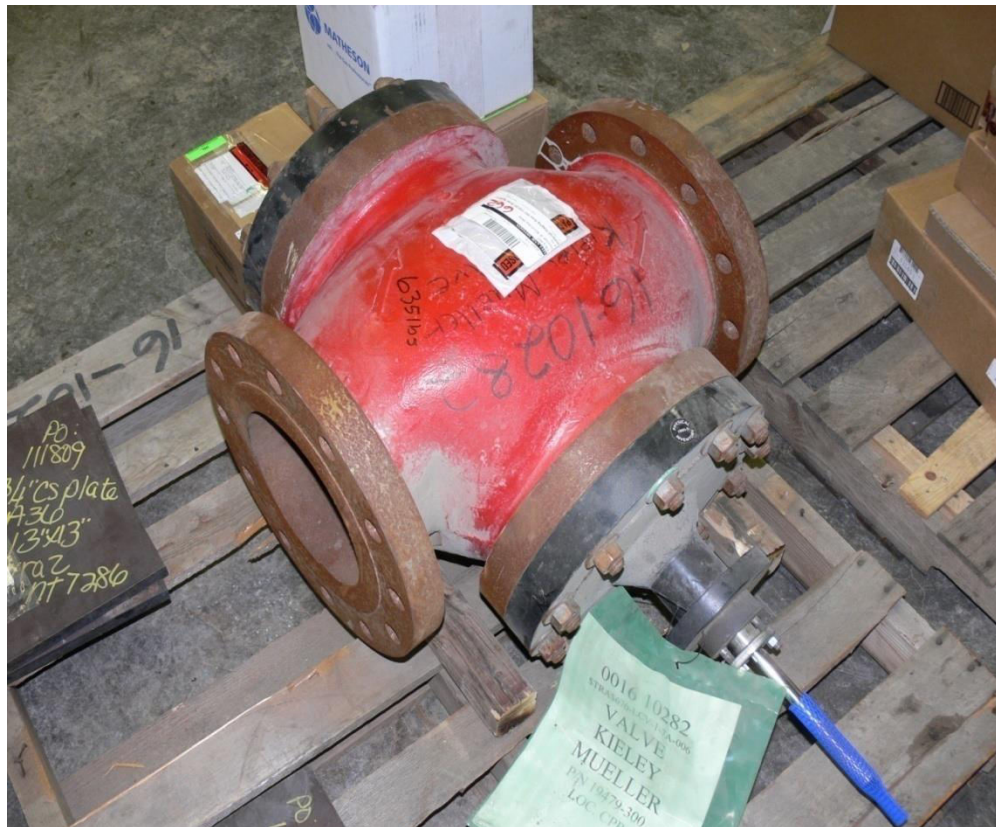
- Spare valve body in the warehouse.

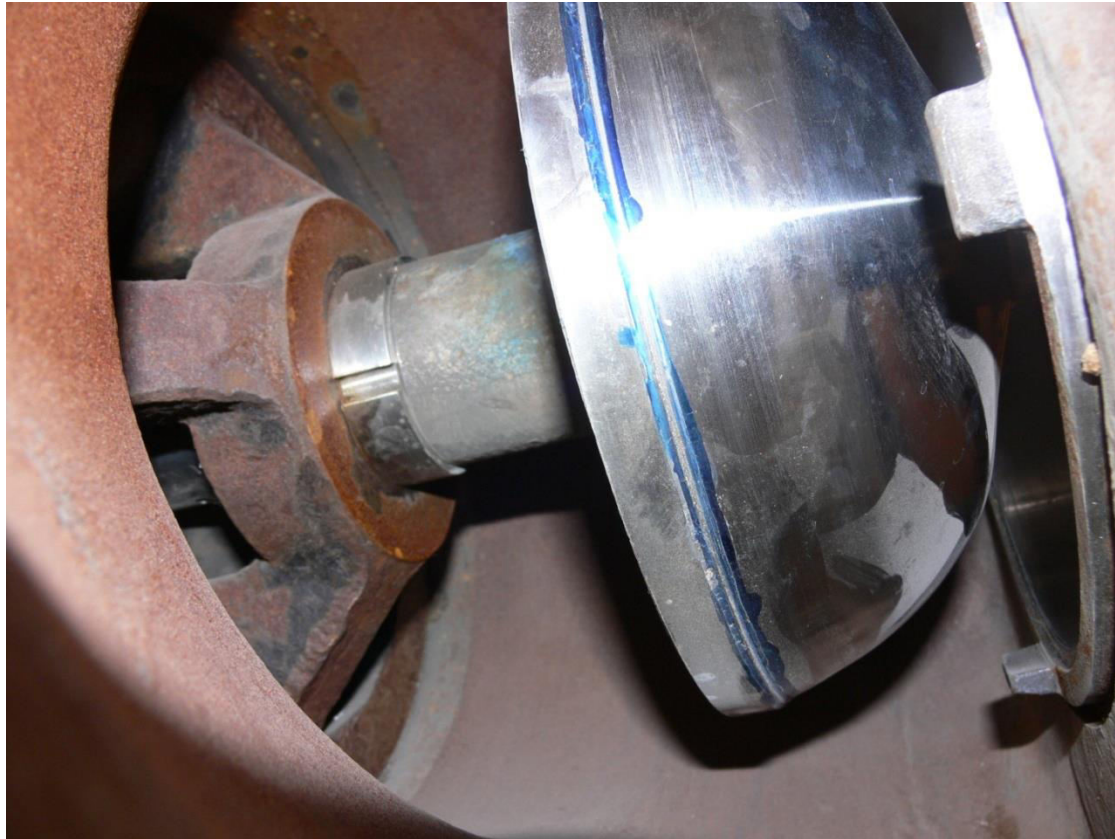
- Disc in the spare valve body.

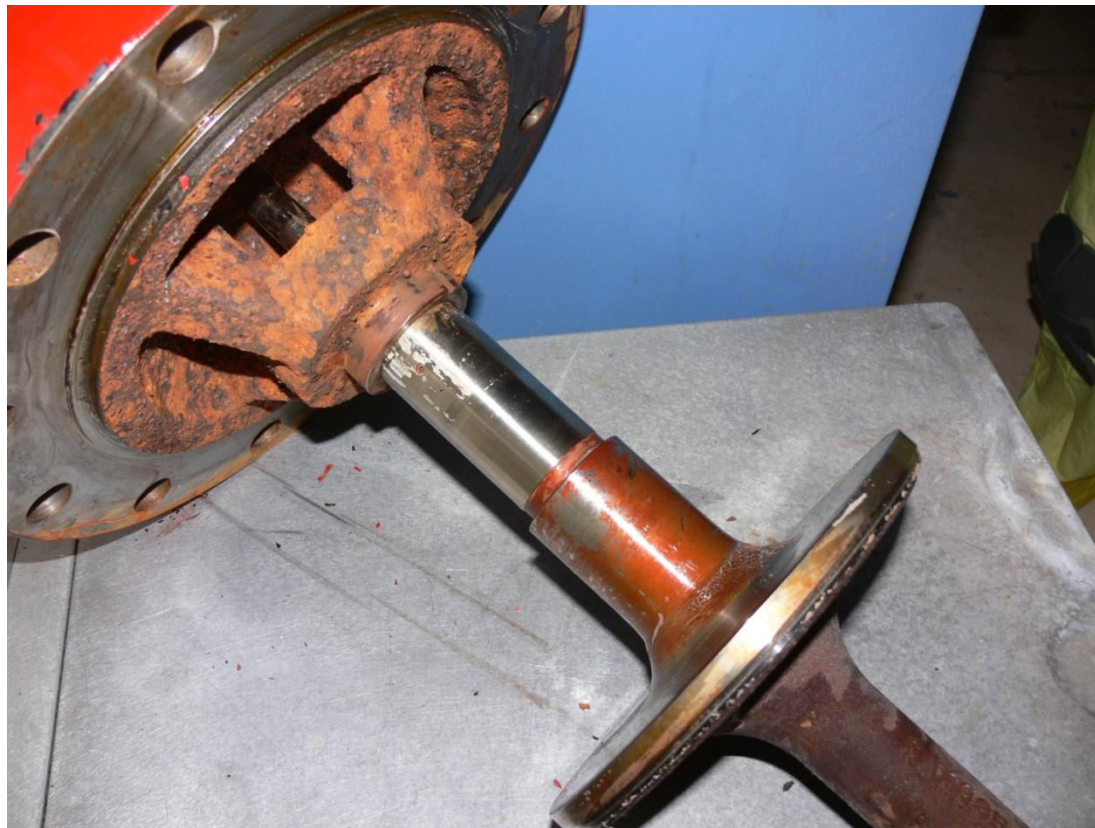
- Disc in the failed valves was a different design than the disc in the spare valve body.
- Make sure you have the correct spare parts.

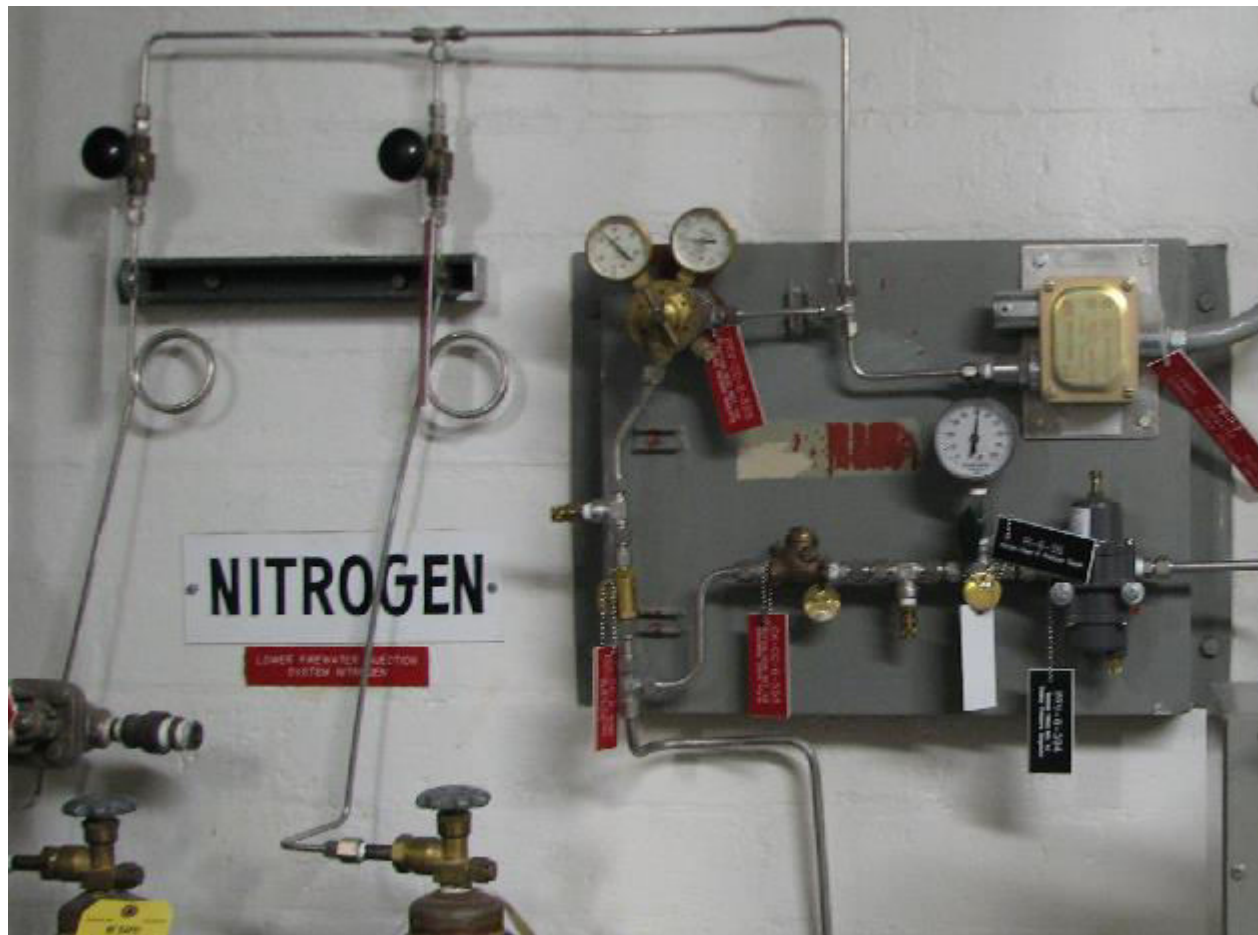
- Compressed air and backup nitrogen control panel before modification.

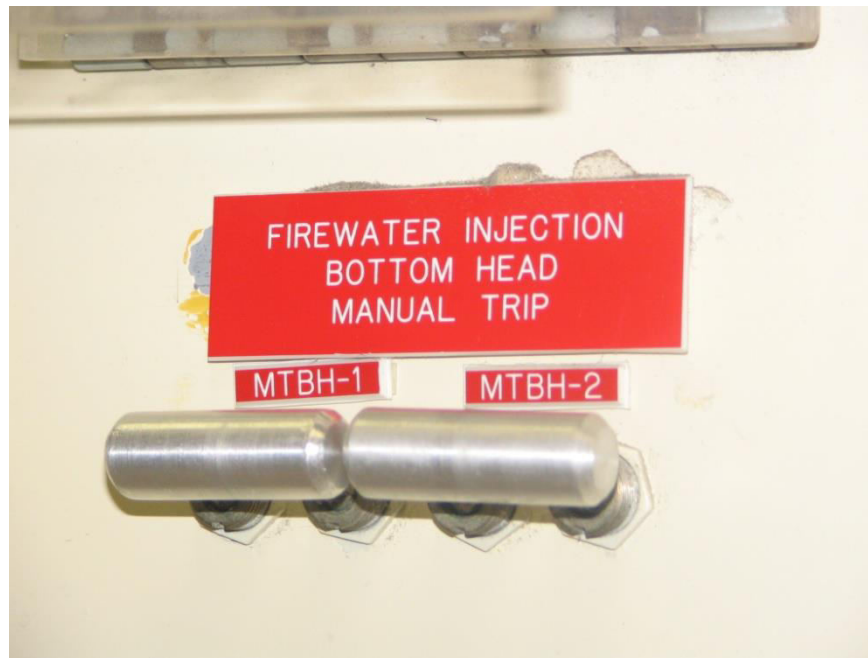
- Manual control switches for the level control valves had no labels.
 - Open/Close
 - Manual/Auto
 - Normal/Reset

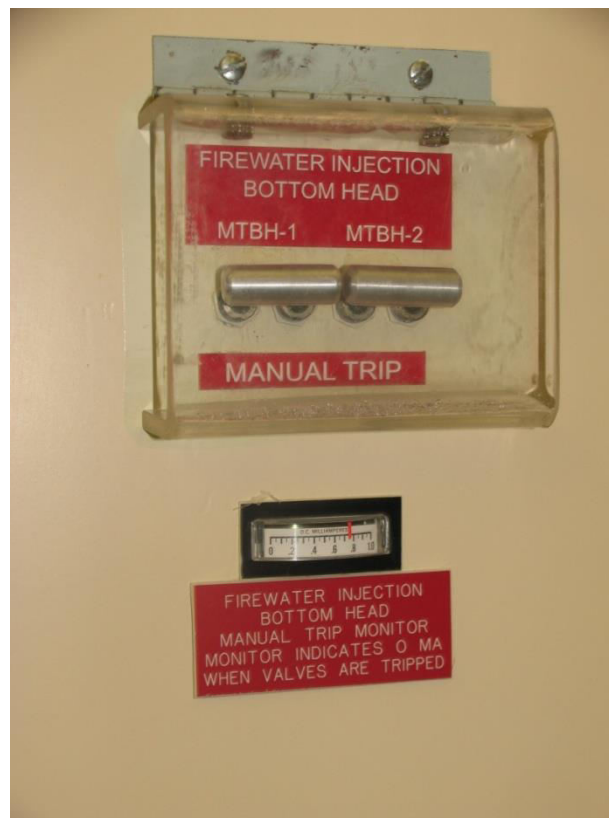
- Control switches can only be used to manually trip the valve open.
- Switches cannot be used to shut the valves unless the automatic trip signals have cleared.
