TRTR Conference:
College Park, Maryland

Results of Irradiated TRIGA Fuel Furnace Tests

Dennis Keiser and Eric Woolstenhulme

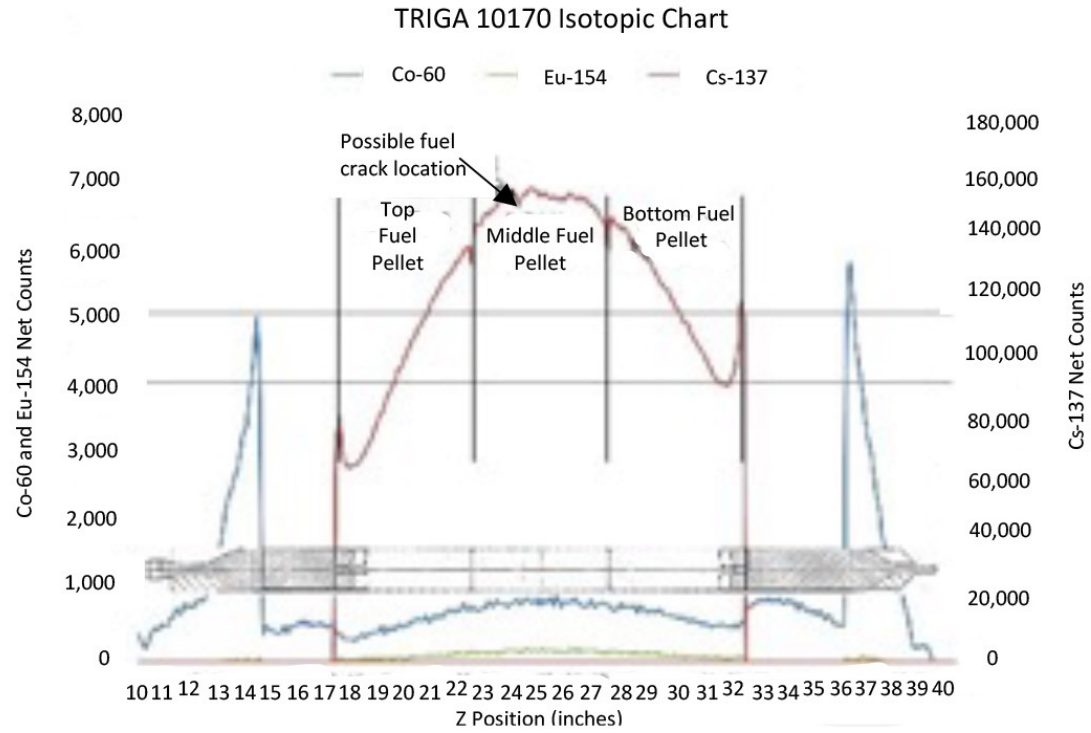
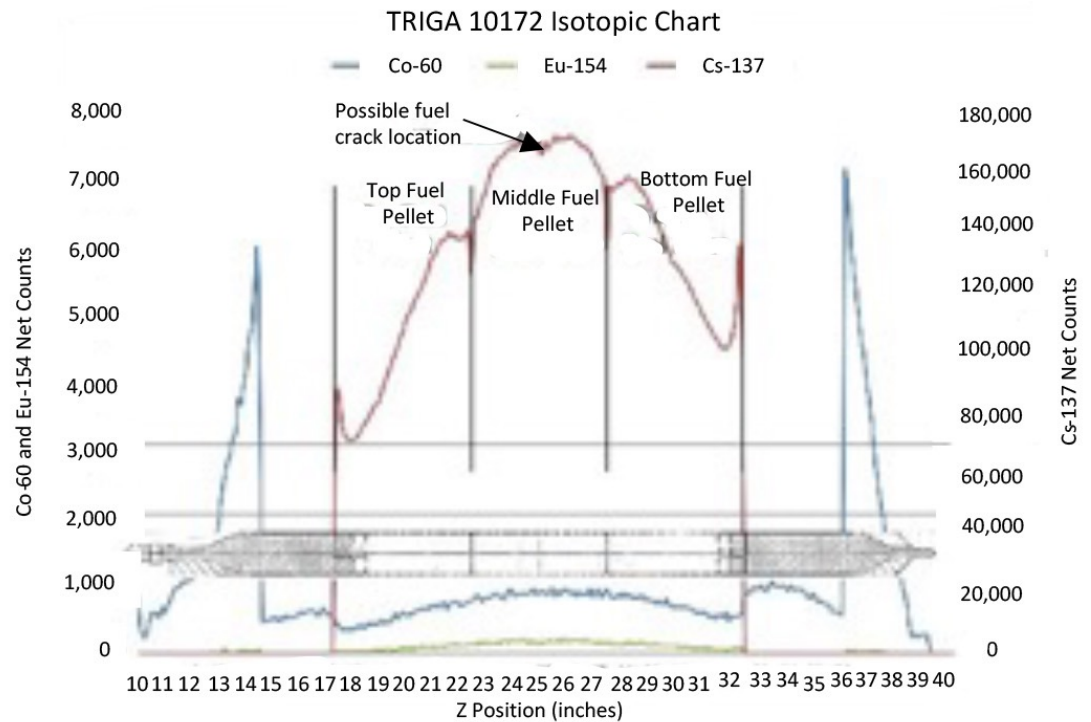
Precision Gamma Scanning

Fuel rod 10172 selected
for annealing experiments

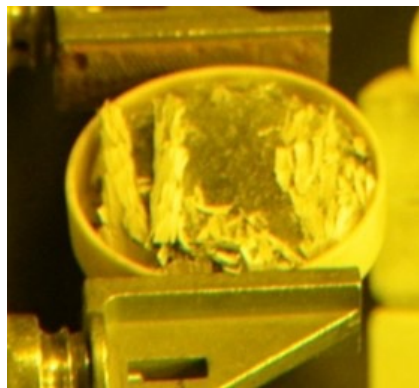
(800°C, 6 hours)

Top Ta layer reacted

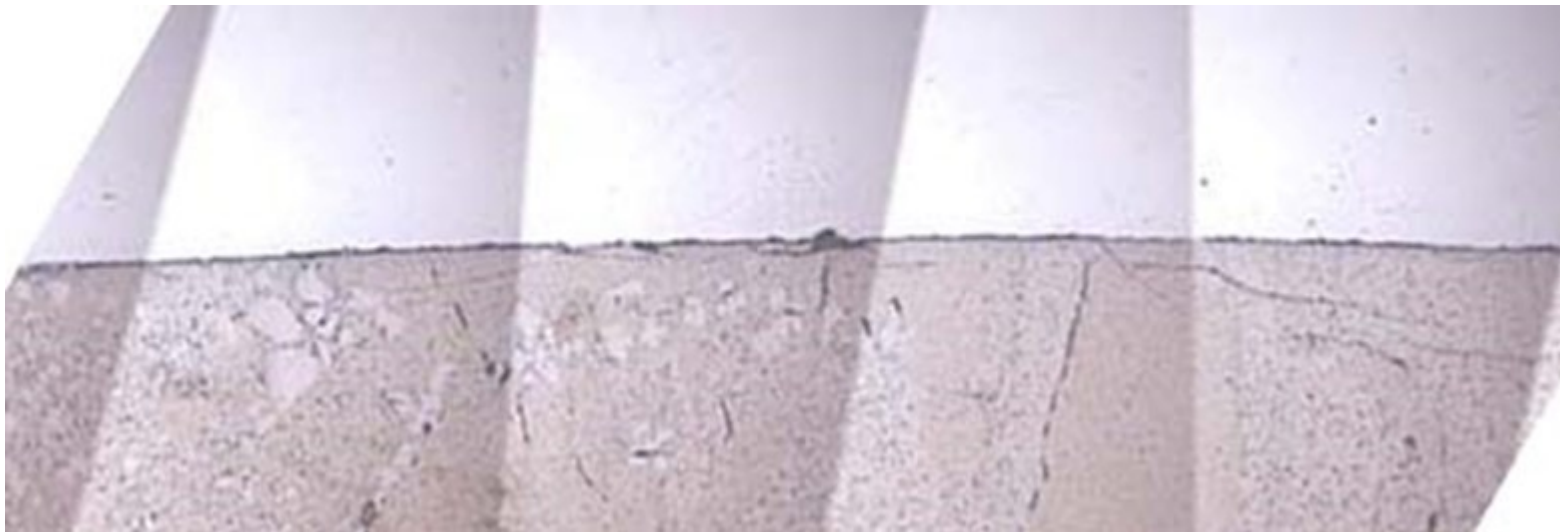
As-irradiated, non-heat-treated (montage of 31.x images)

Montage of 200x images

No obvious contact at the fuel/cladding interface

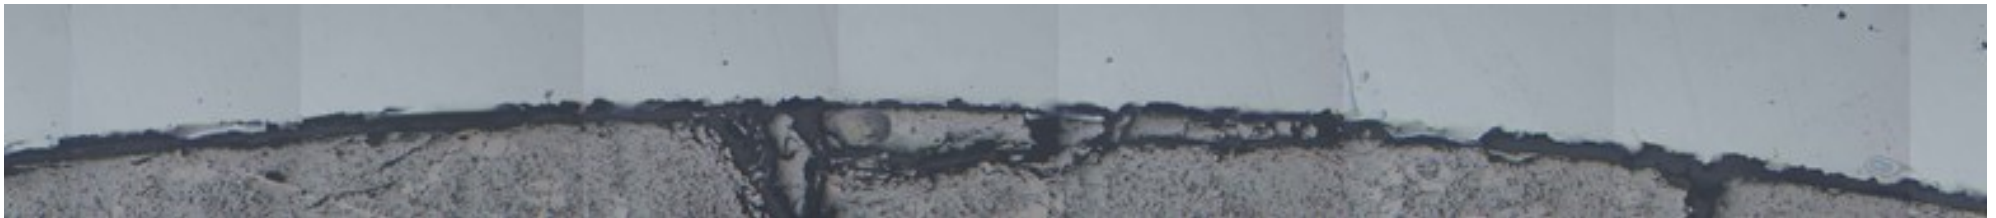
Annealed at 730°C for 6 hours

Montage of 100x images

Some limited fuel/cladding contact possible

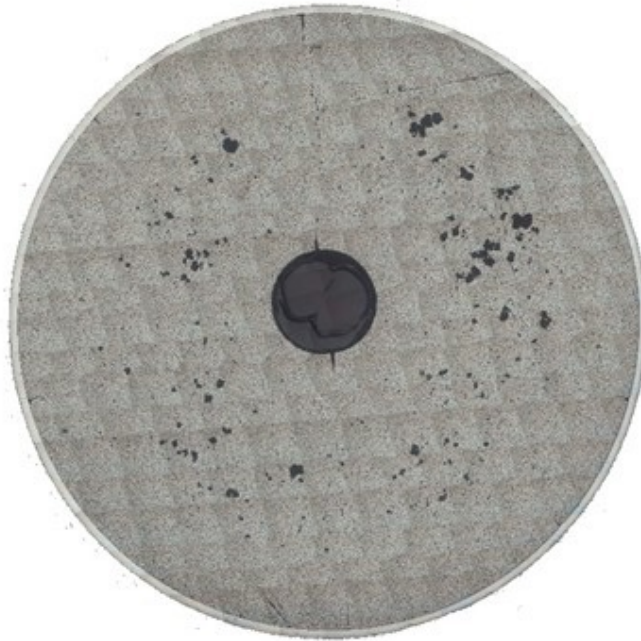
Annealed at 900°C for 6 hours

Montage of 200x images

Appears to be narrow gap at fuel/cladding interface

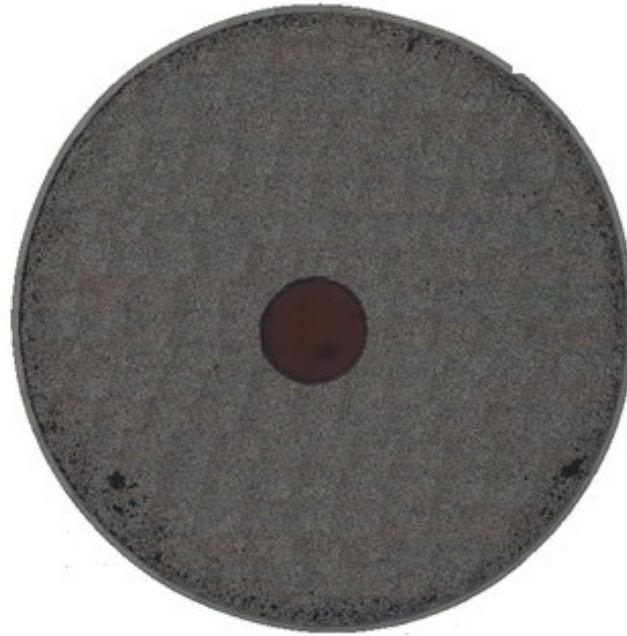
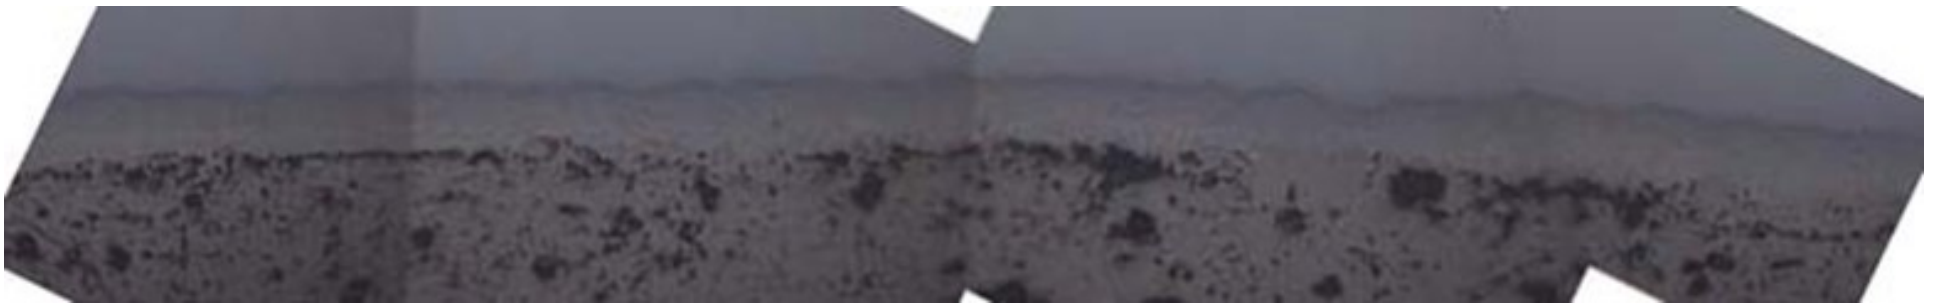
First section annealed at 950°C for 6 hours

Montage of 200x images

Layer due to fuel/cladding chemical interaction (FCCI) seems to be present.

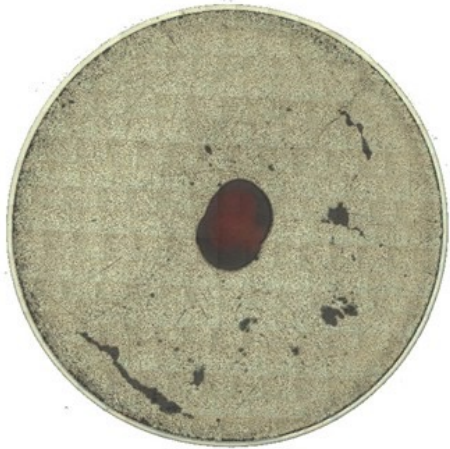
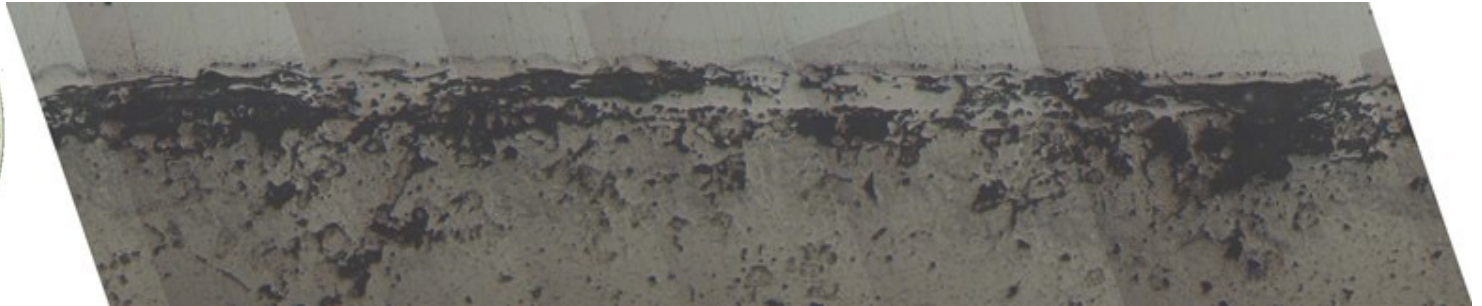
Second section annealed at 950°C for 6 hours

Montage of 200x images

Layer due to fuel/cladding chemical interaction (FCCI) and possible cladding grain boundary phases seem to be present.

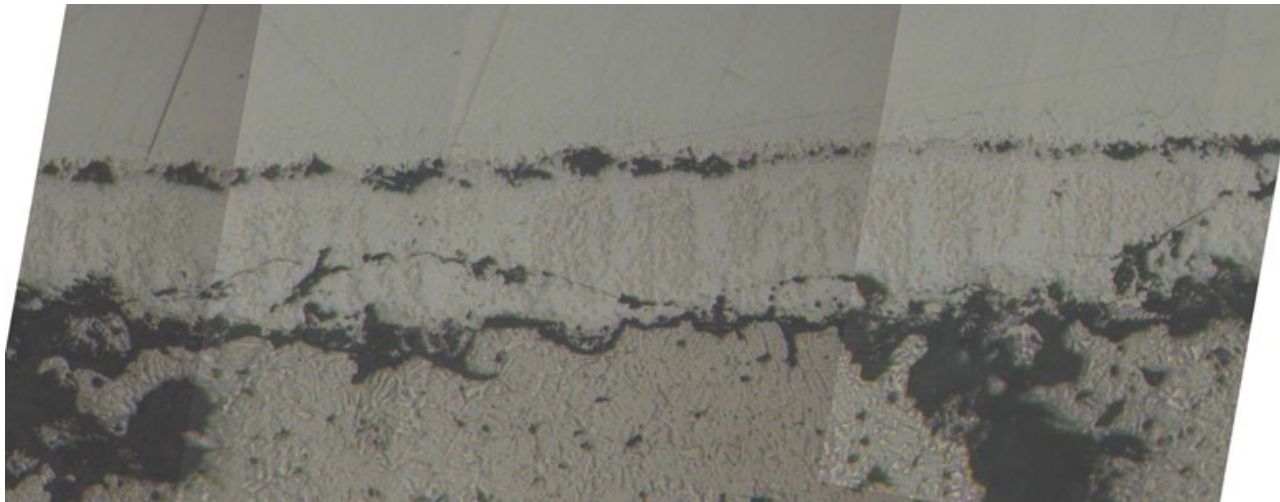
Annealed at 950°C for 12 hours

Montage of 200x images

Layer due to fuel/cladding chemical interaction (FCCI) seems to be present.

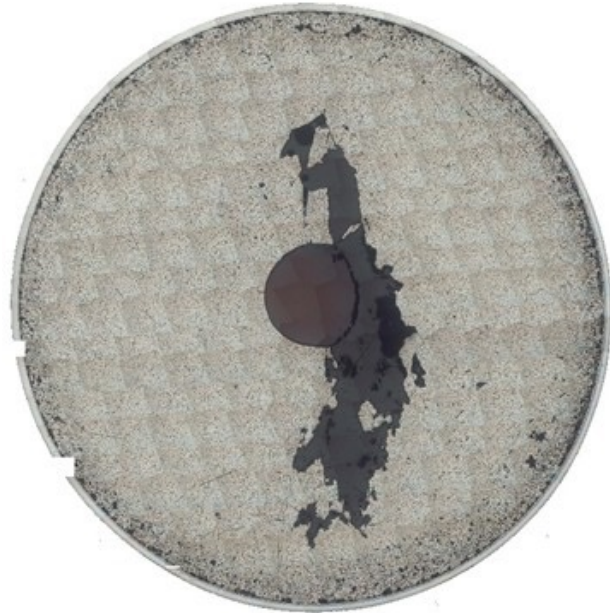
Annealed at 1,000°C for 6 hours

Montage of 200x images

Layer due to fuel/cladding chemical interaction (FCCI) seems to be present.

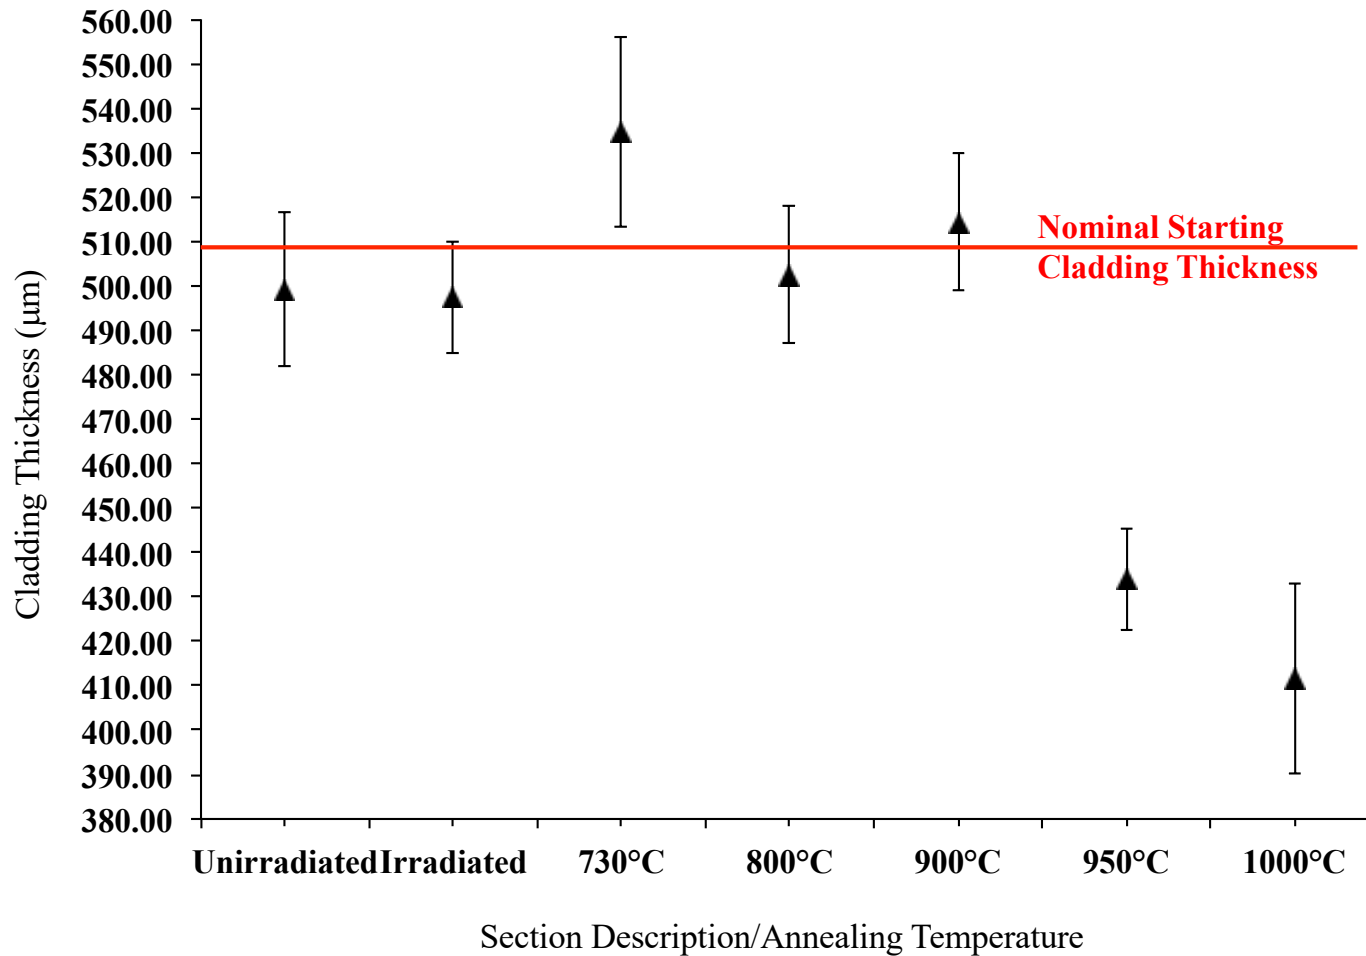
Cladding Thickness not Impacted by FCCI

Even after annealing at 1,000°C for 6 hours, over 75% of the cladding thickness is devoid of observable FCCI

- Annealing experiments performed using sections from (30 wt.% U, ^{235}U <20%) TRIGA fuel rod with Type 304 stainless steel irradiated to a calculated depletion of 20% ^{235}U .
 - Tests run for 6 hours at 730, 800, 900, 950, and 1,000°C, and one test was run at 950°C for 12 hours.
- No evidence of liquefaction after visual examinations were performed.
- Microstructural characterization using optical microscopy (OM) was performed, and no evidence of gross liquefaction was observed in any of the tested sections.
- Using OM, a FCCI zone was identified for the sections tested at 950 and 1,000°C.
 - Gap at fuel/cladding interface seemed prevalent for lower temperature annealing tests.
- Even for the section tested at 1,000°C, over 75% of the cladding thickness was devoid of observable FCCI.
