# Investigation of a cadmium contamination event during a radiotracer production activity

**Jeffrey Geuther**

**Associate Director for Operations, PSU RSEC**

# Introduction

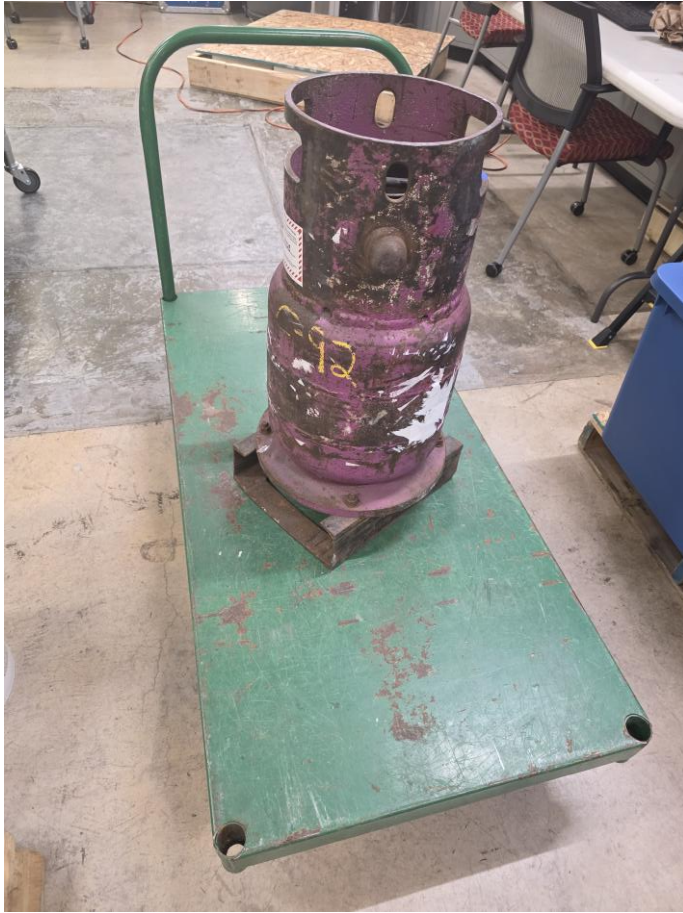
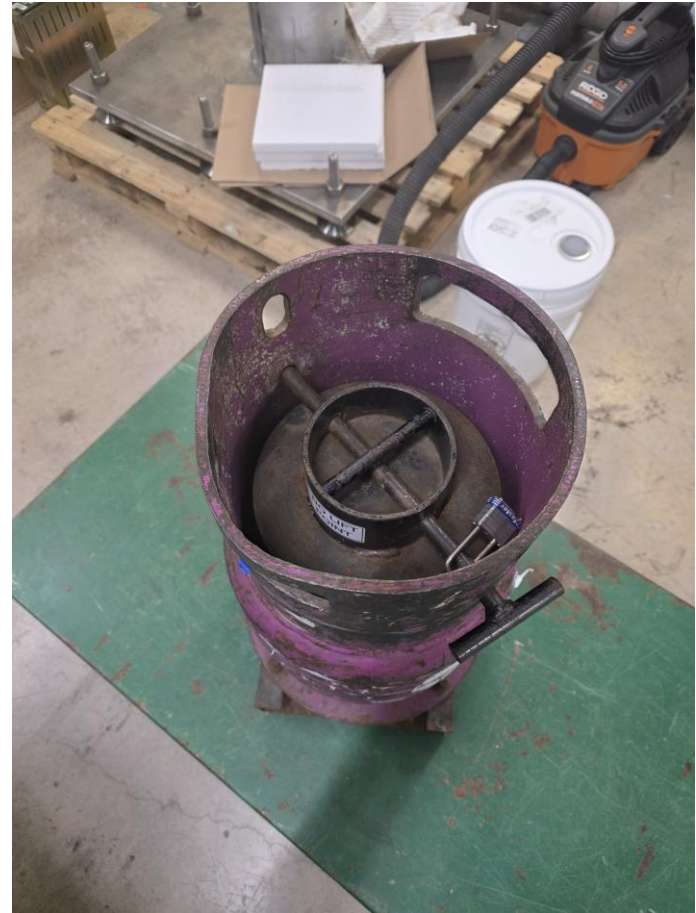
# Cask and Cart

- The shipping cask was returned to PSU by an independent courier contracted by the tracer customer. Their vehicle was a small van with a pet dog in the cargo area.
- The driver needed to brake quickly at the receiving site, which caused the cask to fall over. This is noteworthy as it may have affected the spread of the contamination.
- When the cask was received at RSEC, after the van had departed, ~20,000 CPM of contamination was discovered on a cart holding the cask and inside the cask flange when smeared with a swab.

- The presence of contamination at or above 240 dpm / cm<sup>2</sup> on the outside of the cask was deemed to be a reportable event per 10CFR20.1906(d)(1).
- The event notification was made by the RSO within 24 hours of the receipt of the cask and discovery of contamination.
- The transport van was recalled to campus, and RSEC personnel along with the RSO performed a survey of the vehicle. No contamination was found in the vehicle.

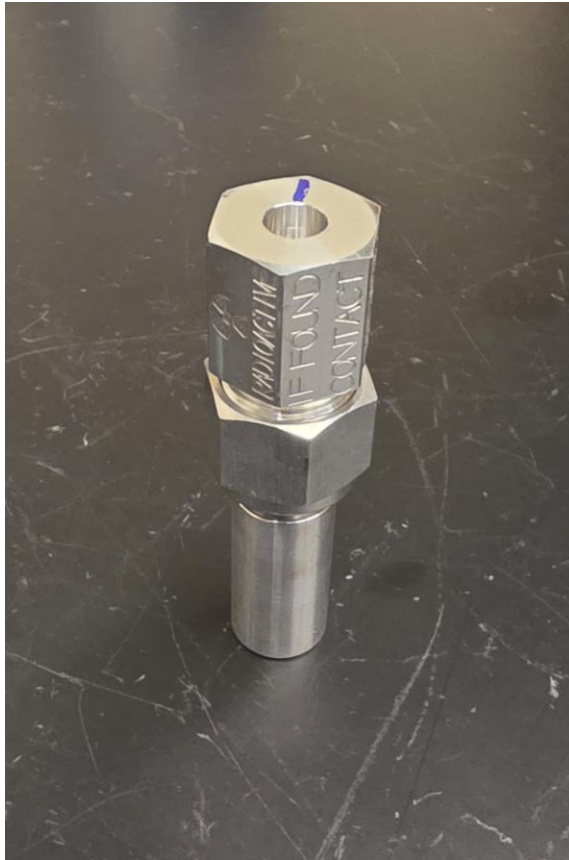
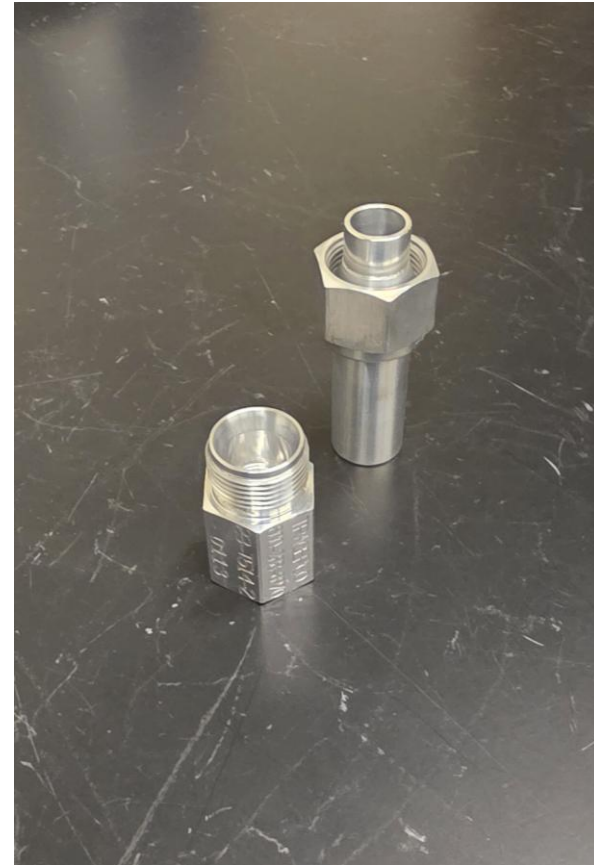
# Swagelok Container

- Ultimately XRF was performed on the components of an unused Swagelok capsule.
  - Brendan Culleton, PSU Institute for Energy and the Environment Radiocarbon Lab
  - Bruker Tracer 5G Handheld
  - 40 kV, 13  $\mu$ A, Ti/Al filter
- Prominent Cd peaks were observed when testing the threaded nut.
- Alloy was specified on the drawing to be Al 2024-T4, which doesn't include Cd as a listed constituent.

- Our tracer services customer contacted Swagelok.
- Swagelok replied that the nut was Al-2024 T4, but the threads were plated with cadmium to prevent galling during assembly.
  - Un-plated nuts are available by request (suffix code on part number)

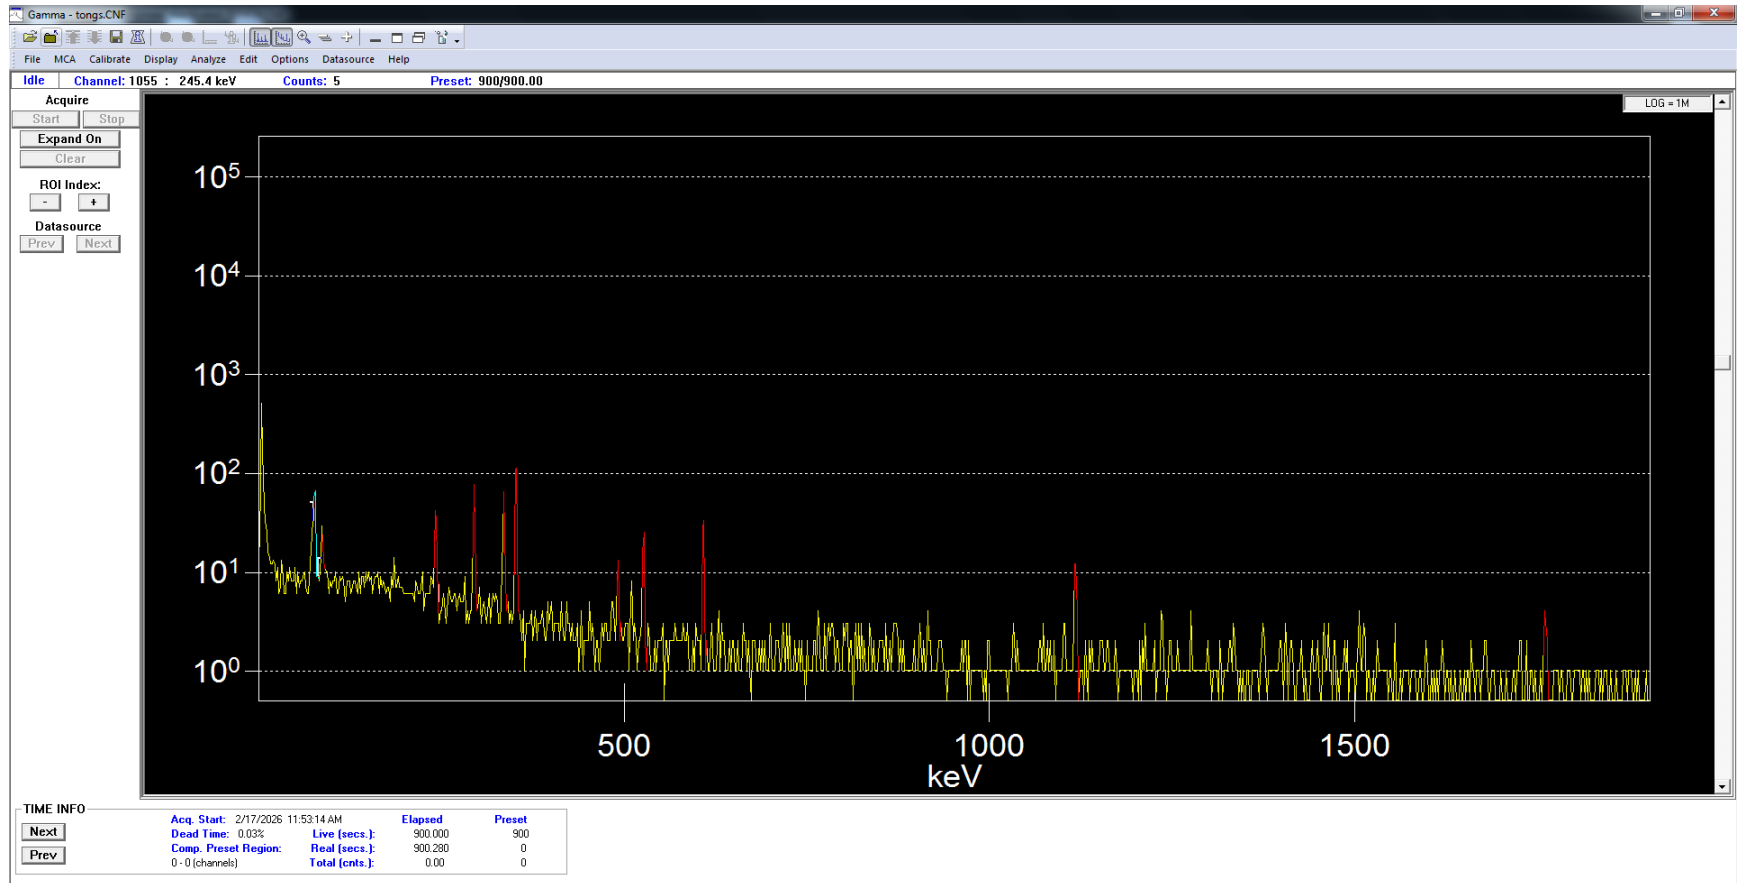
# Contamination Spectrum (Tongs)

- Cadmium-115 is a beta- and gamma-emitting isotope with a half-life of 53.4 hours.
  - Easy to detect for about one week after contamination event.
  - Primary peaks: 336 keV (46%), 492 keV (10%), and 528 keV (27%)
- Cd-115 is produced through neutron capture in Cd-114, which has a thermal cross section of 0.34 b and resonance integral of 16.9 b.
- RSEC calculates expected dose rates and activities prior to irradiation. For the Swagelok, the composition and mass of each alloy in the technical drawings was used in the calculation.
- The list of elements included Al, Fe, Si, Zn, Ti, Mn, etc., but not cadmium.
- The irradiation procedure required 8 hours of irradiation at full power; approximately 1 mg of elemental Cd could have yielded contamination levels similar to what were observed.

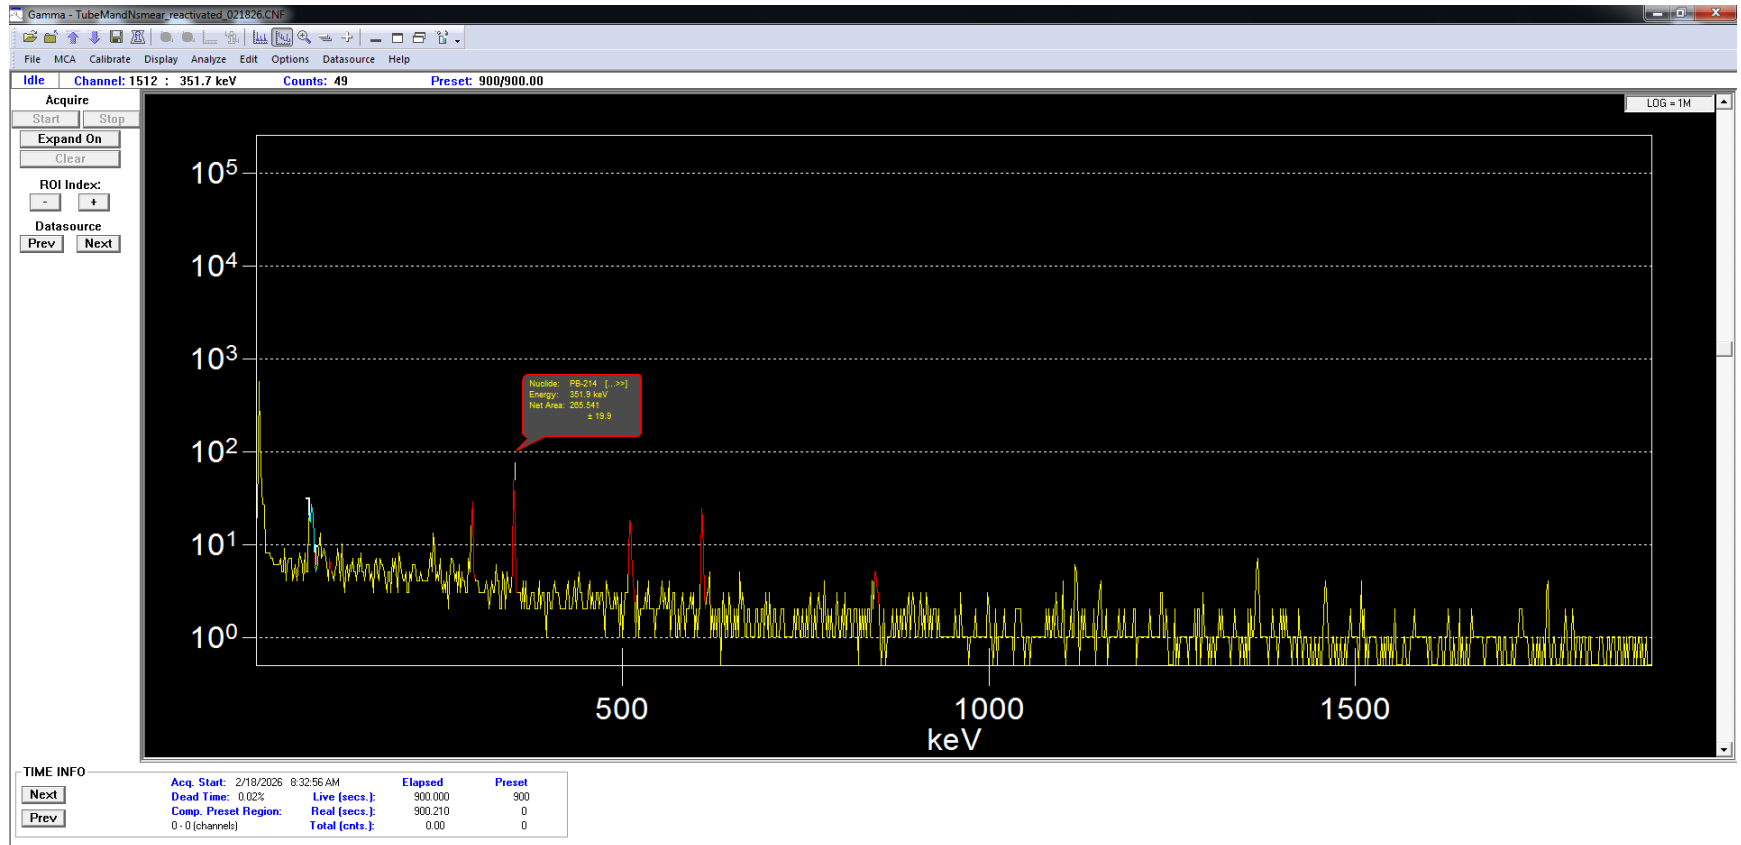
# Contamination (Dry Tube)

The dry tube, when re-irradiated, showed background peaks but no Cd-115

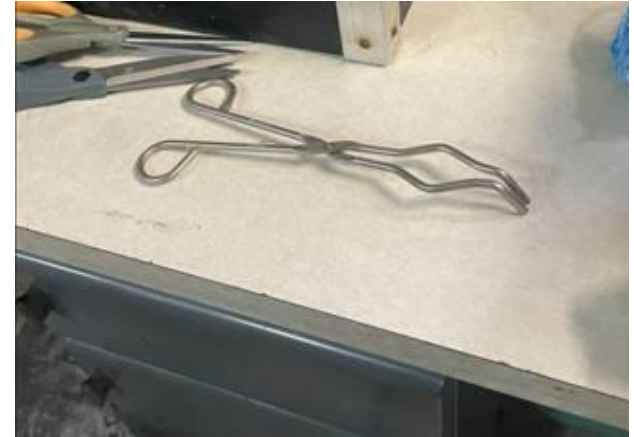
# Contamination Control

- A complicating factor was poor contamination control.
- Several tools used to handle the samples were placed onto benches or into tool chests without checking for contamination.
- This was done on at least two occasions, including once after the reportable event, and had the potential to cause the unknowing spread of contamination.
- During the second event (April 10, 2026), low levels (500 – 700 CPM) of Cd-115 were found on the reactor low bay floor during a daily survey. During follow-up, up to 150,000 CPM was found on a work bench and contaminated tools were discovered in a tool chest, contaminating other tools and the chest drawers. Other contaminated tools were found in a tool chest in the prep lab used for Na-24 samples.

- These events, especially the 2<sup>nd</sup> event (AP-4 #2026-02), show that some senior reactor staff were not taking contamination control seriously, even after they knew of poor contamination control during the lead-up to the reportable event.
- RSEC will be introducing biennial practical radioactive material handling exams to avoid gradual loss of proficiency / diligence.
