Corrosion of Dummy "EE" Plate 19 in YA-M Type ATR Fuel Elements During PALM Cycles INL/EXT-16-38324

Jeffrey O. Brower, Michael V. Glazoff, Aleksey V. Rezvoi, and Thomas J. Eiden Idaho National Laboratory

TRTR Conference August 2016

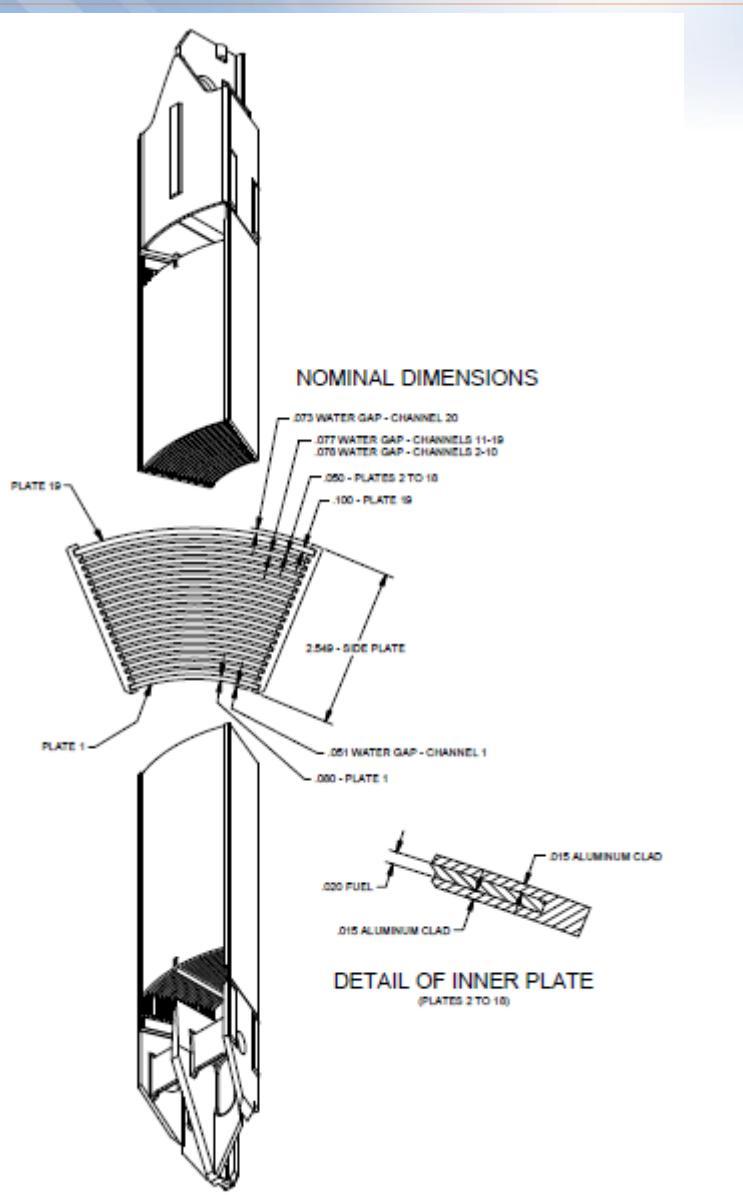
# **ATR Fuel Element**

- Uranium Aluminide UALx fuel matrix
- Aluminum cladding
- 7F/XA Standard Element
- YA-M Type Element No fuel in plate 19 and narrower side plates
- 45° sector of a right cylinder
- 19 fuel plates
- 20 coolant channels

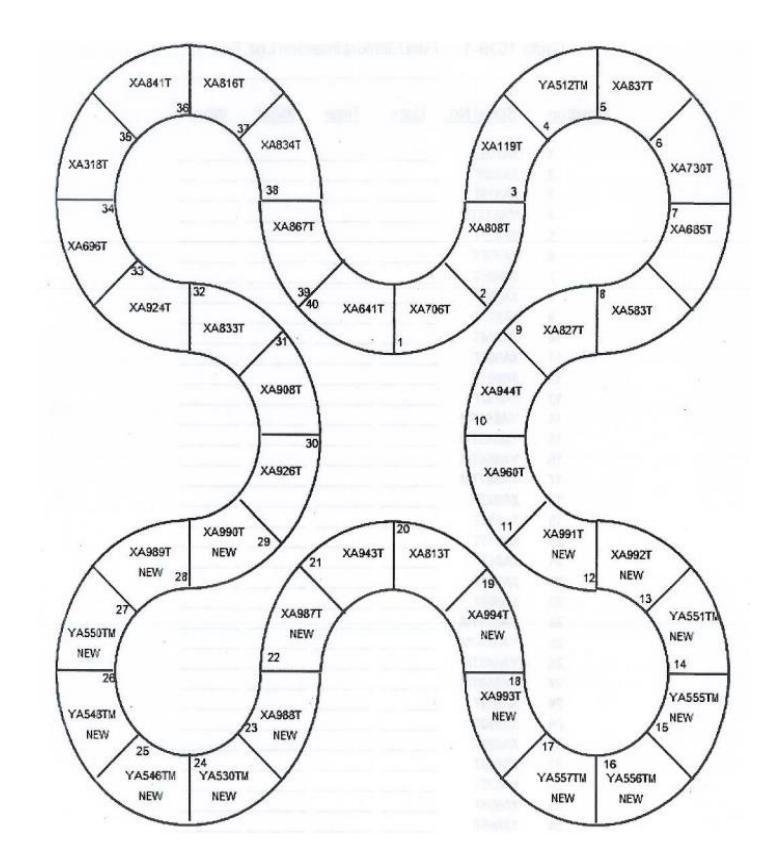
## **Configuration of the fuel elements ATR Core**

- Almost 50 years of operation.
- Rated 250 MW thermal.
- 110 MW typical operations.
- High power in the south.
- Low power in the north.
- 4 quadrants.
- 5 lobes.
- YA-M elements loaded in the south in positions F14-F18 and F24-F28.
- Recycled YA-M element in position F-4 was unaffected.

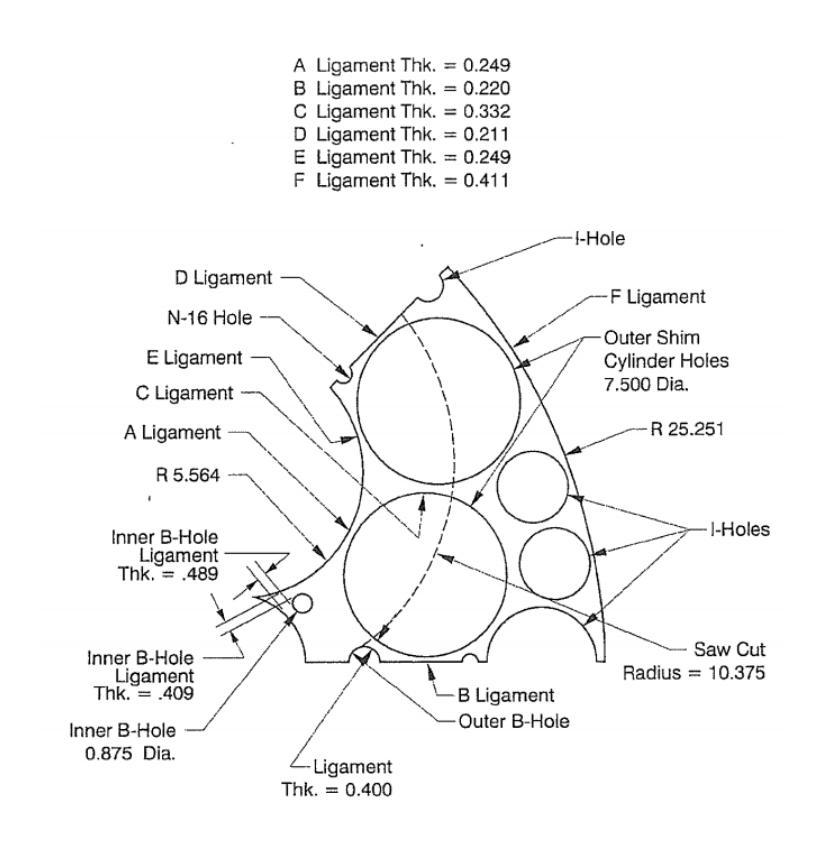
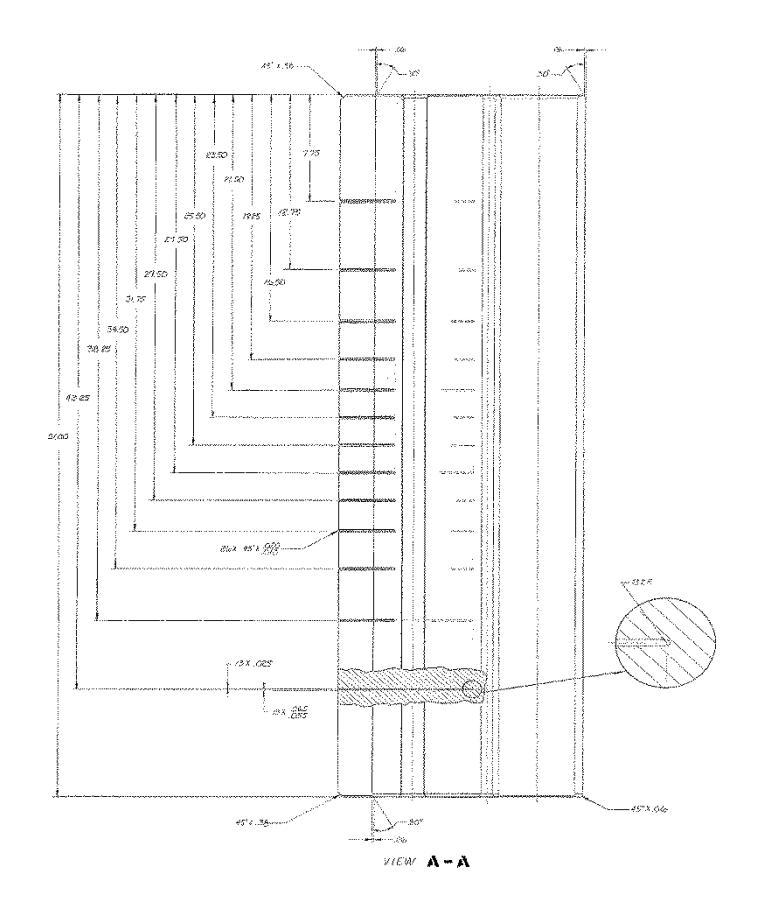
#### **ATR Beryllium Reflector Block**

- ATR beryllium reflector block ligaments
- Horizontal saw cuts
