Replacement of a Leaking Beam Port Bellows in the UT-Austin TRIGA Reactor

Tracy N. Tipping
Nuclear Engineering Teaching Laboratory

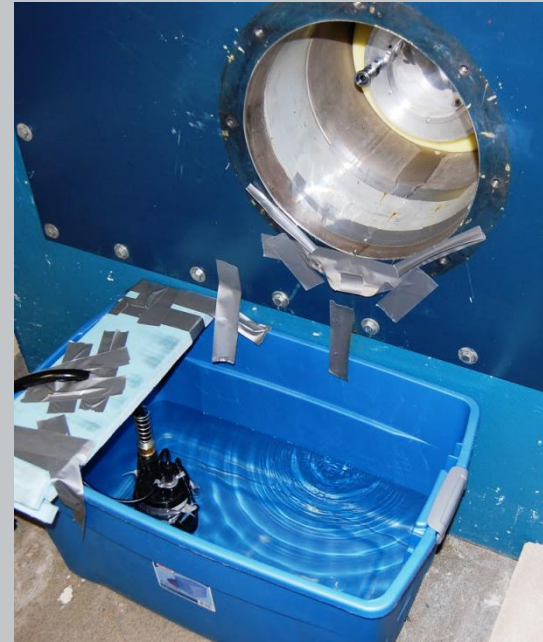
- Heavy run schedule
- Holidays approaching
- Small leak rate
 - Evaporative losses from pool surface greater than leak rate

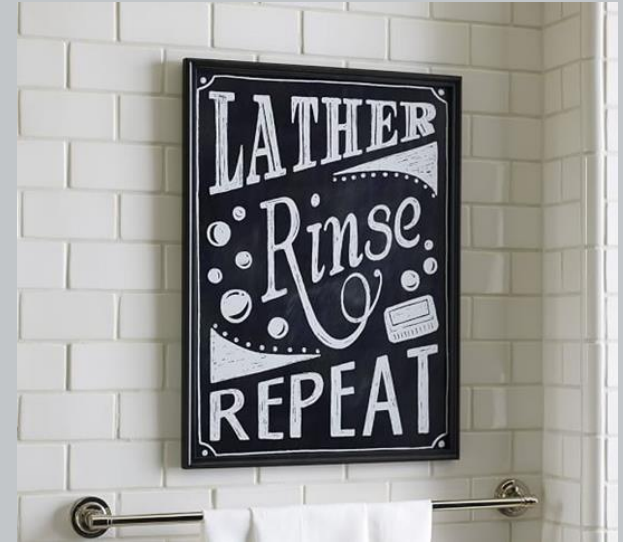
- Out with the old...again
- In with the new...again

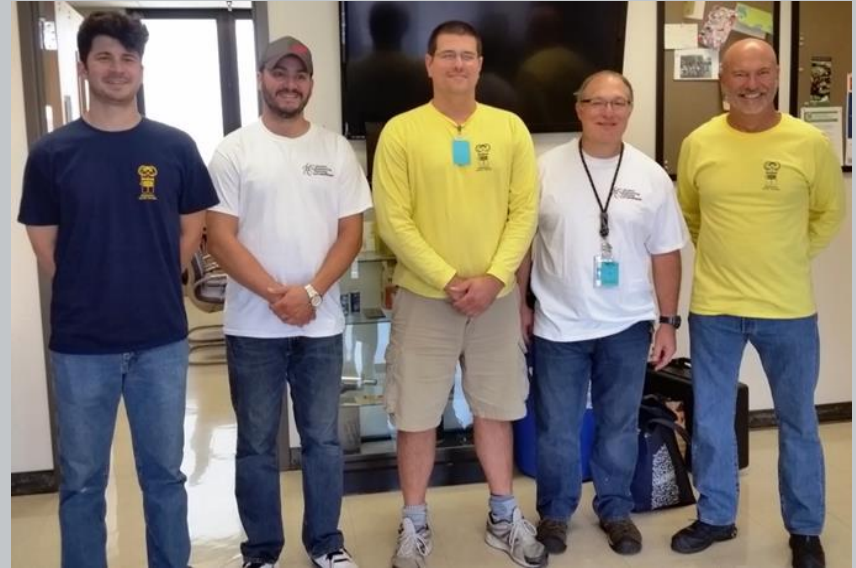
- Divers are dirty!
