# Maintenance Projects at the Oregon State TRIGA Reactor

2023 TRTR/IGORR Conference  
College Park, MD  
June 18-23, 2023

# Major Maintenance Activities

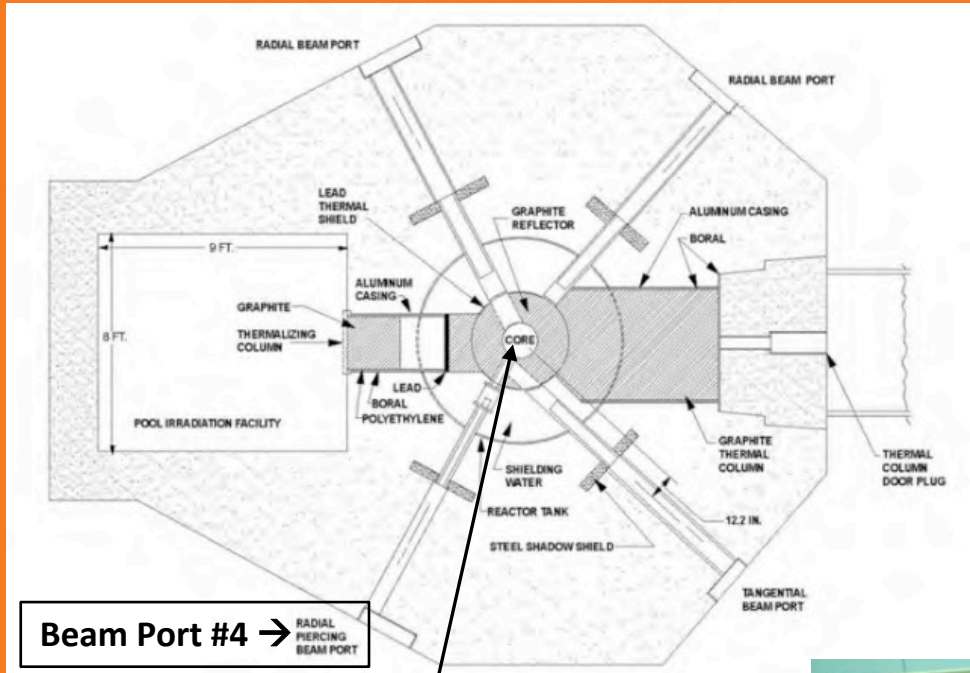
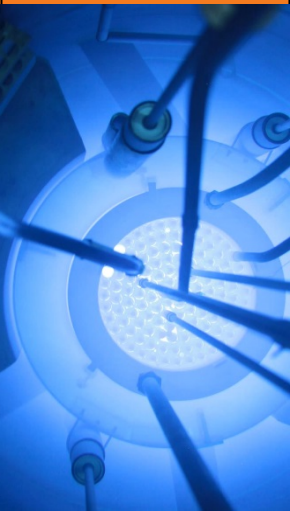
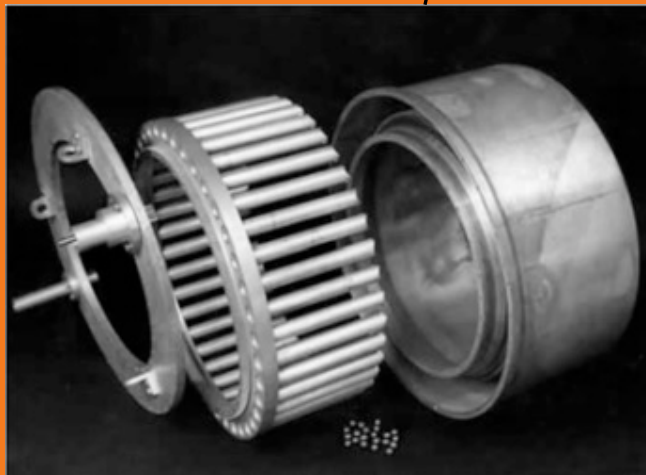
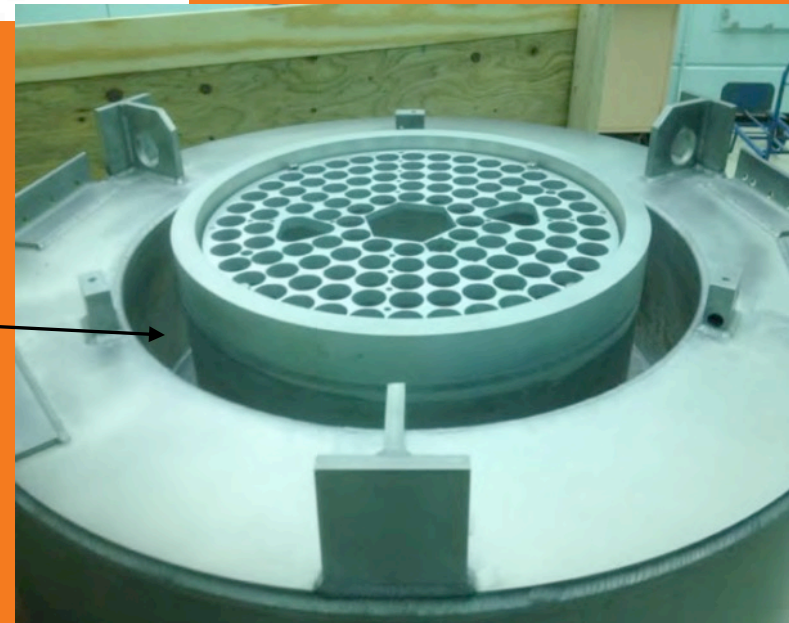
# Beam Port #4

- 7/15/19 – Discovery of leak on east side of PGNAA
  - Drain had stopped leaking after reflector replacement outage of 2013
  - After 6 years, leakage returned, experimenter discovered puddle on the floor
  - Analysis of leakage indicated it was fresh reactor water, making bellows the suspect (rate  $\sim 30$  mL/hr).

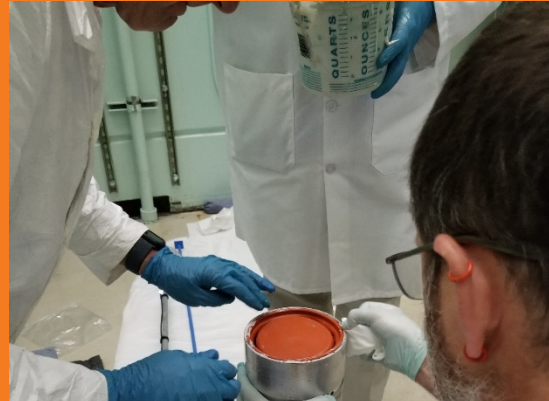
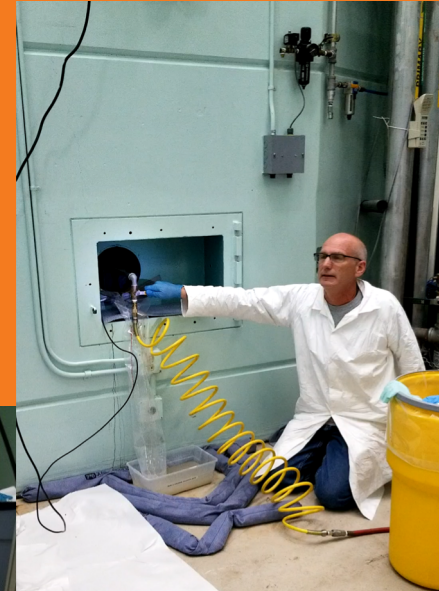
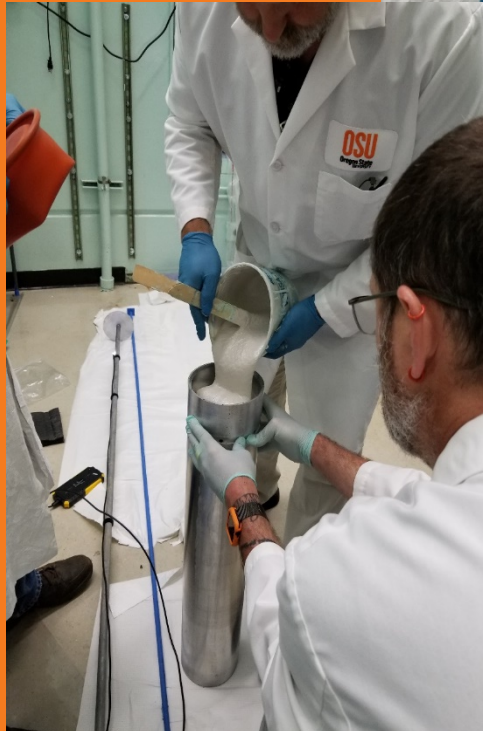
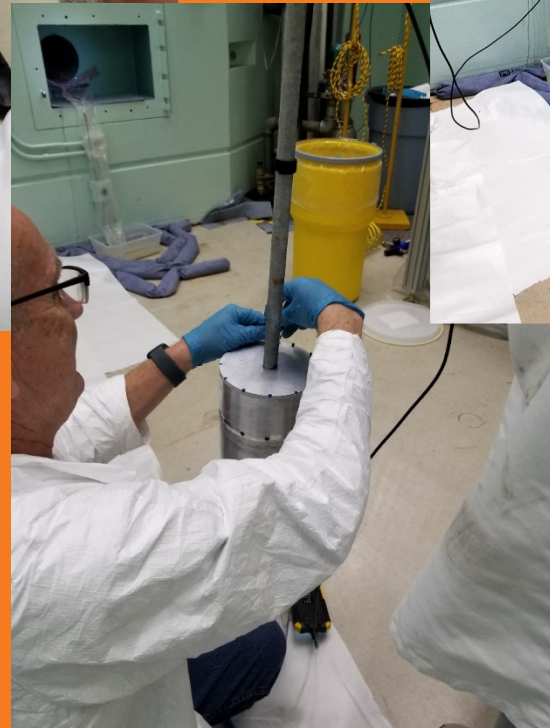
# Beam Port #4

- Plug fill, insertion and injection. How did it do?

- So close! Leak continues through small gap. Epoxy not viscous enough.

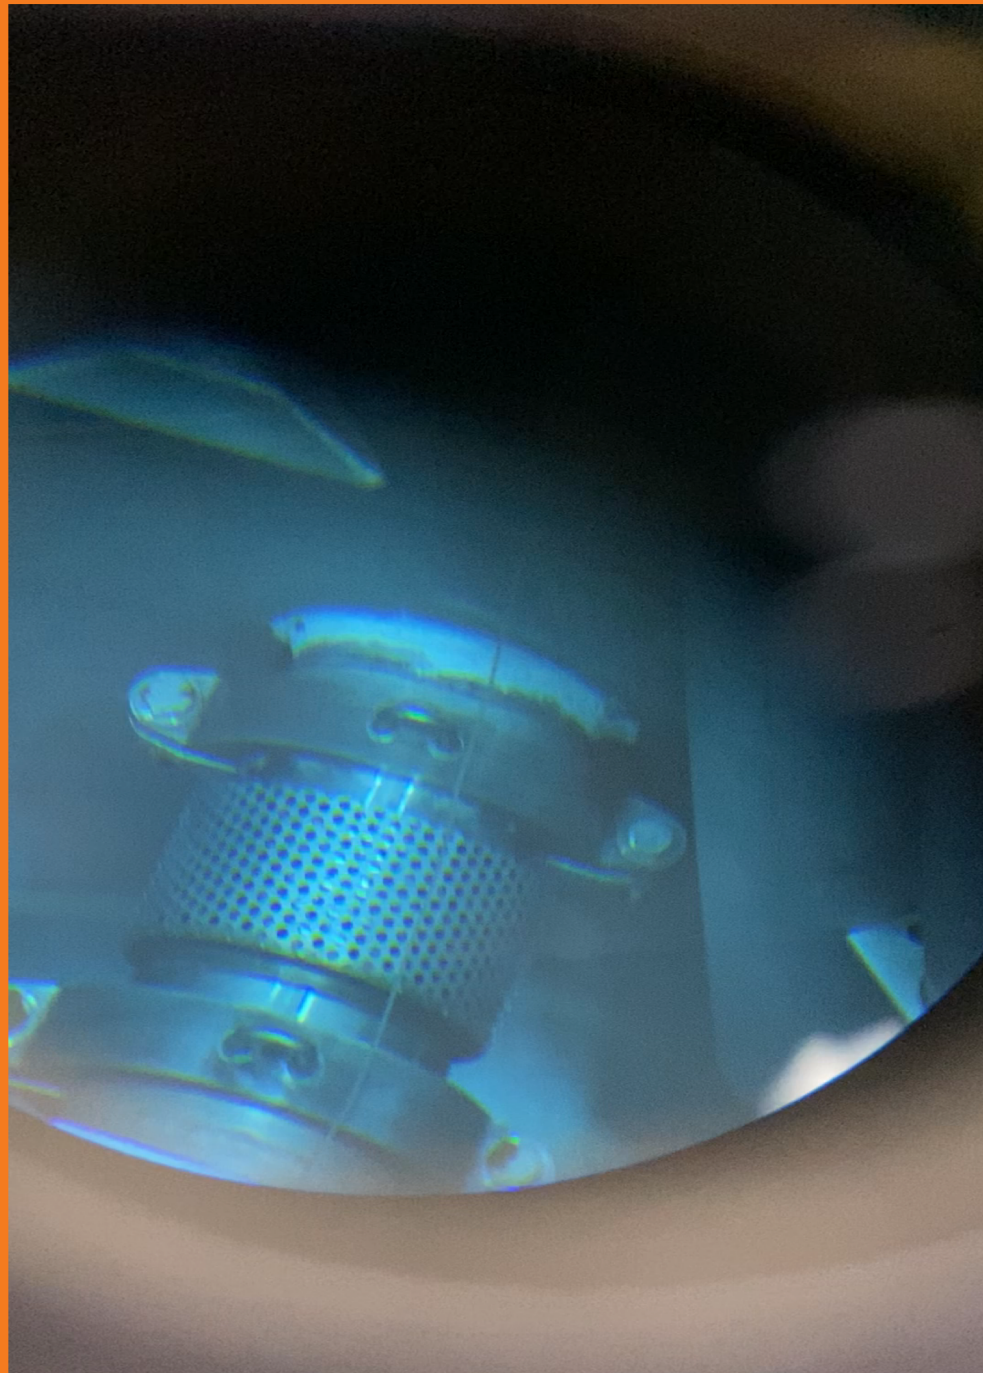
- We have to inject more epoxy in order to properly seal off leak (epoxy needs to inject into weep hole)
- Designed new injection method involving a “paste pot” and retrofitting a plug we initially used as a seal plug for beam port #4 during the 2013 reflector replacement.
- Before injection, a pressure test was performed with the seal plug to determine if pressure could build up against reactor head pressure.
- At this point, we were able to determine the actual leak location!

Radial seal plug installed in front of first attempt and more epoxy was pneumatically injected to seal leak.
