MIT Research Reactor

Edward S. Lau

Big Impact of a Small Leak
at the MIT Reactor

19 June 2023

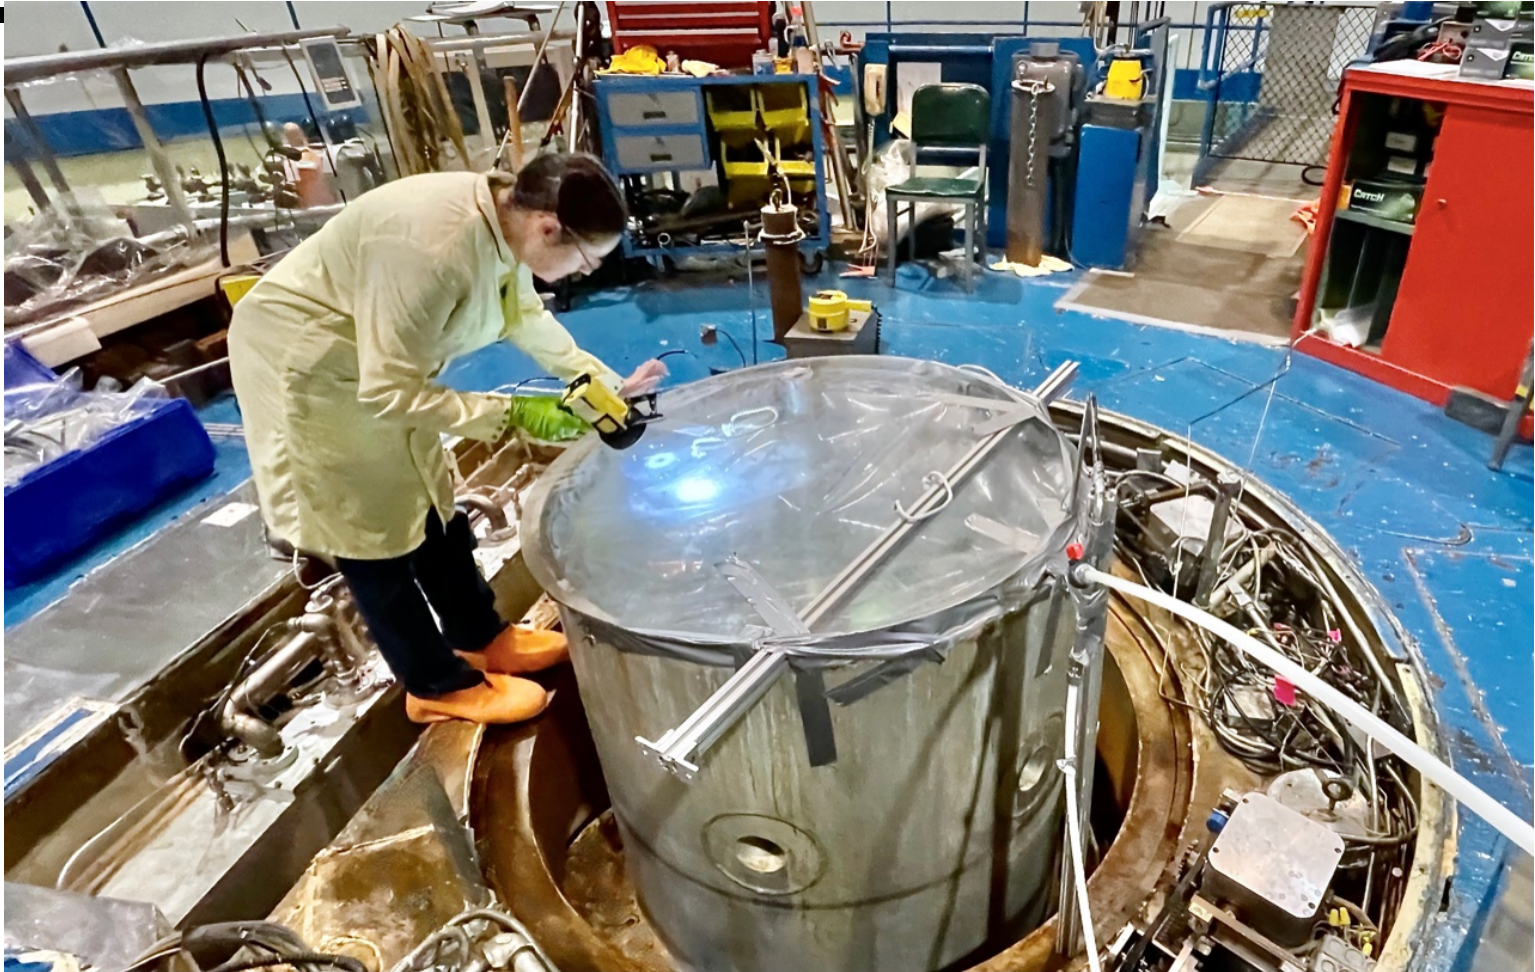
Upper Annular Ring (ok to stand on!)

Leak is at Base of Upper Annular Ring

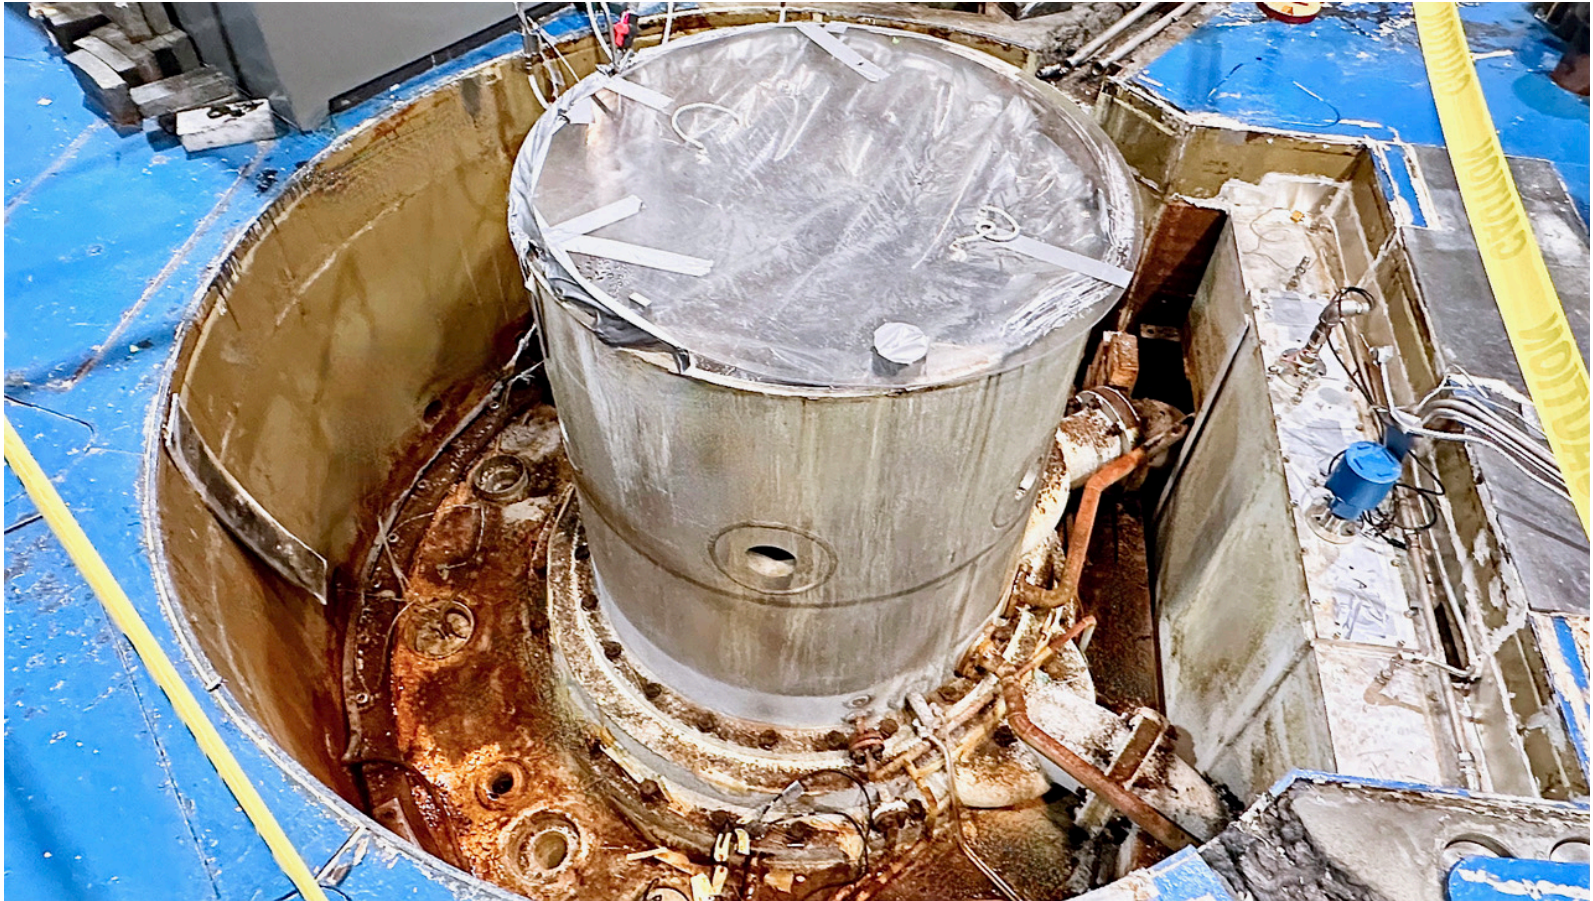
Without the Upper Annular Ring...

[...there was Access to Replace the MP-6A (and MP-6) Pipes]

- The leaking aluminum threaded pipe was replaced with a 316 stainless-steel threaded pipe.
- Other threaded piping in the area was similarly replaced as a preventive measure
- The piping area was cleared of iron rust.
- The inner and outer surfaces of the shield rings that sit above the piping area were carefully cleaned by grinding and sanding, and then coated with rust inhibitor.
- All gaskets in the area were inspected; some were replaced.
- Leak detectors added in many locations for early detection. Use of humidity sensors is being considered as well.
- Inspection tubes added for future use.
