# Failure, Evidence, Redesign

Resolving Retaining-Ring Fractures in the NBSR Refueling Plug

David Hix, Sahar Rubin  
September XX<sup>th</sup>, 2026

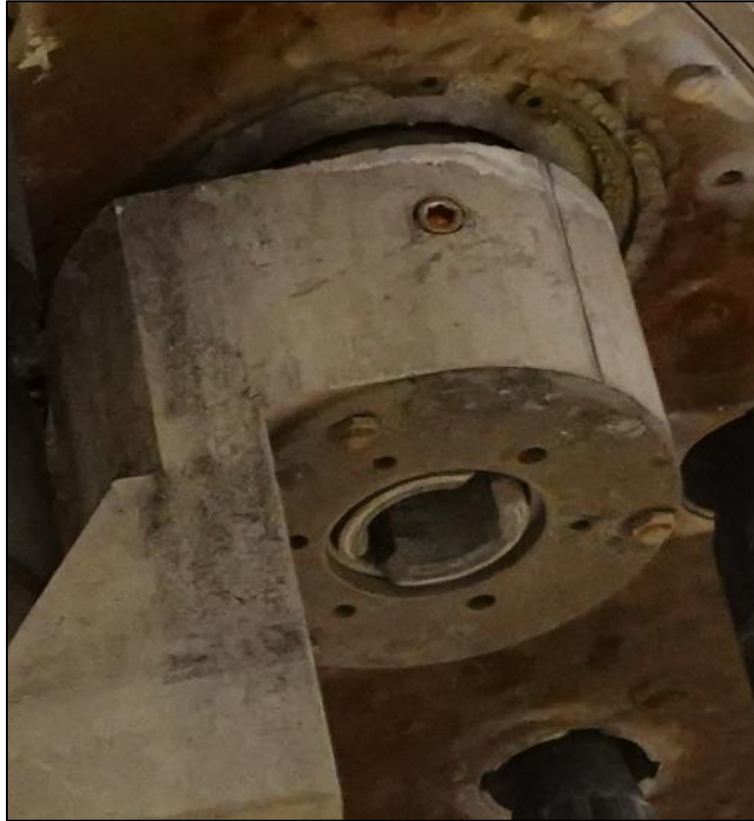
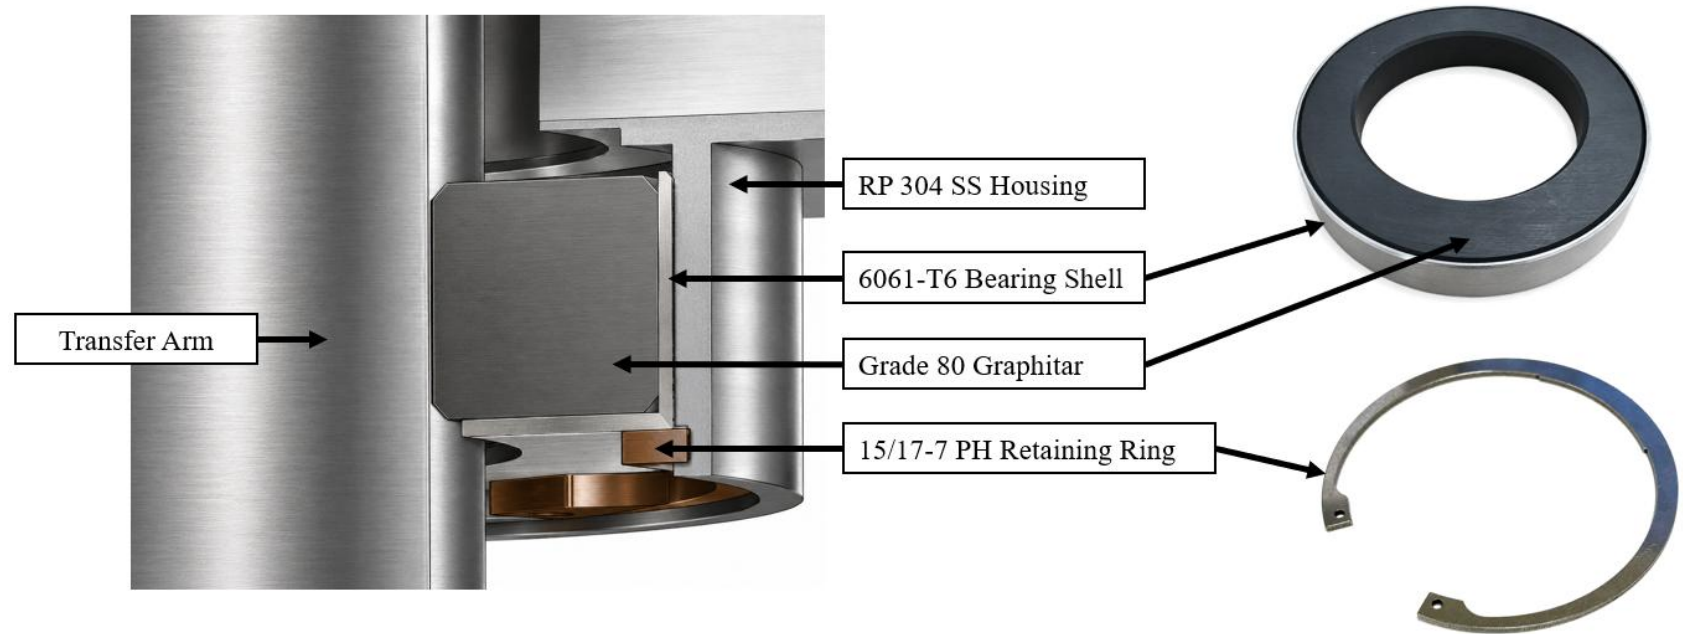
# Existing bearing assembly

**The failed part was not isolated: it sat inside a coupled material, geometry, and environment problem.**

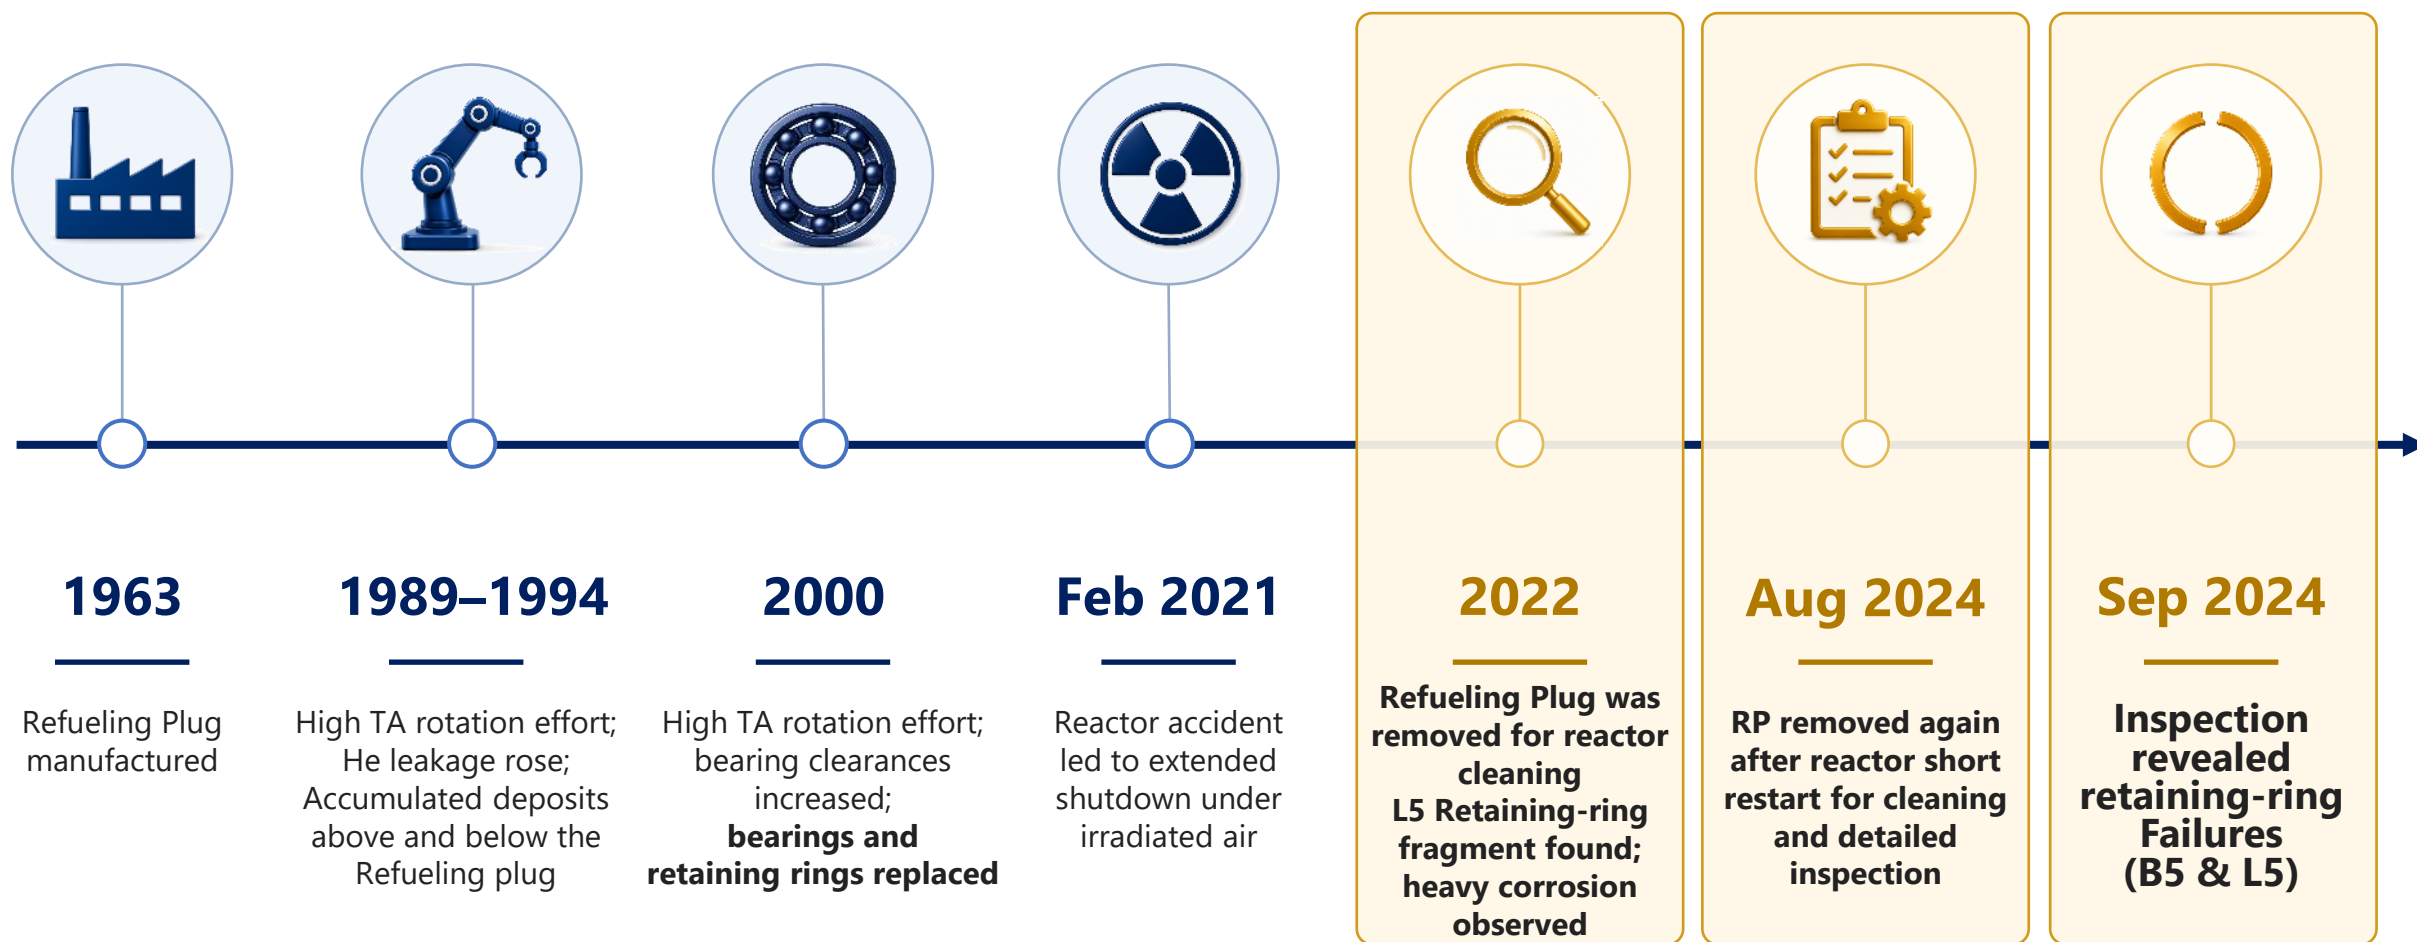
# Failure history: recurrence was the clue

B5 transfer arm ring fractured, was replaced, and fractured again; L5 ring was also found fractured.

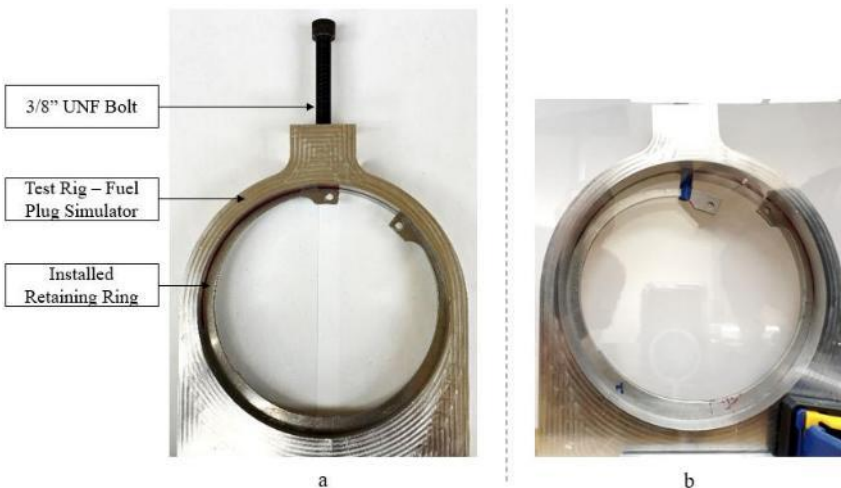
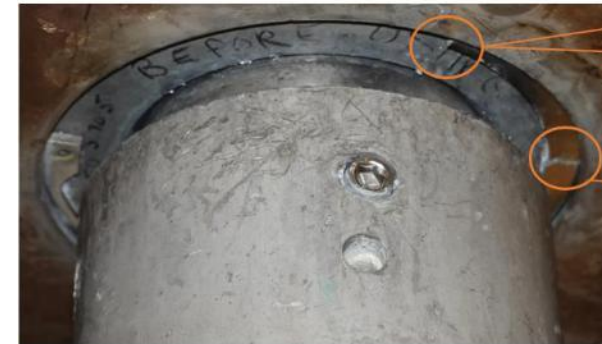
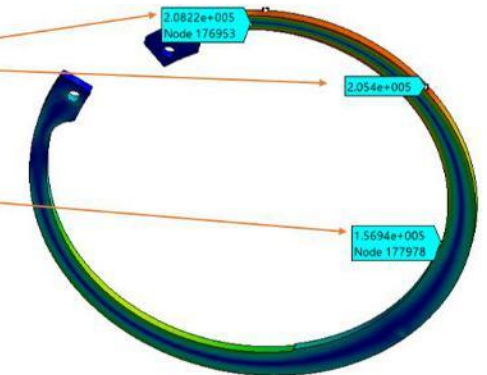
## What The Stress/Load Tests Showed

- Seating in the groove creates sustained tensile stress in the ring.
- Bounding groove-contact loading raised local OD stress at the observed fracture location.
- Mechanical loading produced localized plastic deformation, but no fracture.

**Interpretation: Mechanical Load Was A Contributor To Stress State, Not A Standalone Failure Mechanism.**

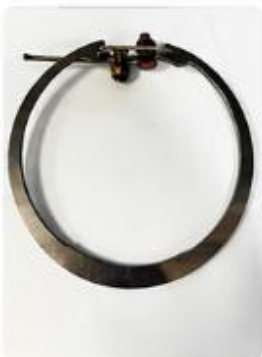
1. Compressed (as-installed)

↓  
↑  
3 rings compressed to as-installed diameter

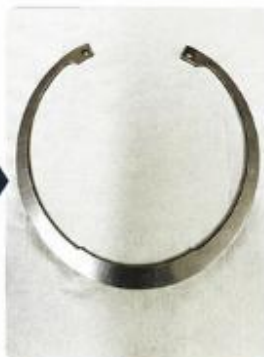
2. Control (uncompressed)

↻  
2 rings left uncompressed as controls

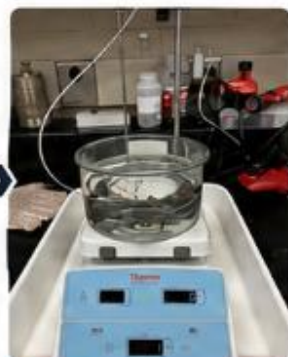
3. Exposure 10% NaCl, Heated

🧪  
Heated 10% NaCl exposure for 14.5 hours

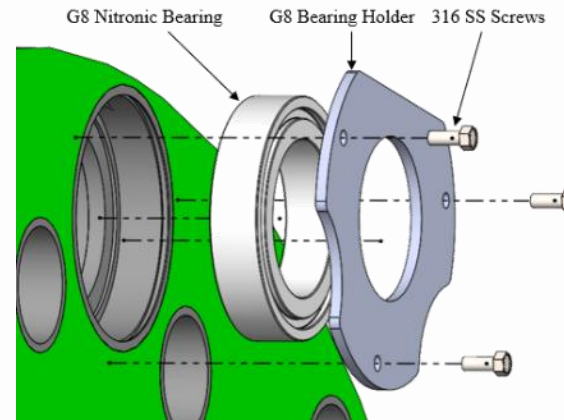
G8 Bearing Concept

**Shallow groove with small worn support shoulder**

A custom external holder replaced the groove-retaining concept
