# **Annular Core Research Reactor**

## **ACRR Advanced In-Service Fuel Inspections**

**SAND # TBD  
TRTR Conference 2021**

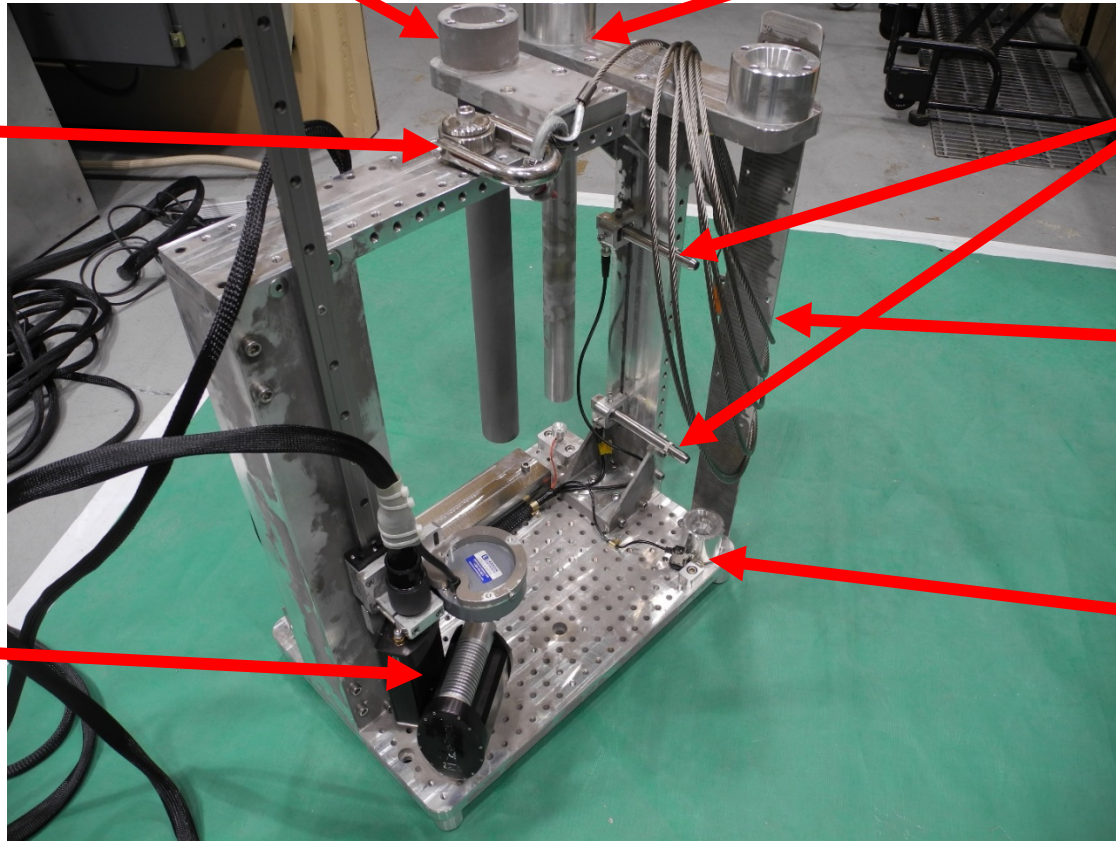
# Fuel Element Inspection Jig (FEIJ)

Go/No-Go Gauge

Load cell weighing station

Lifting swivel hoist ring and 29' wire rope

Ultrasonic probes

Graduated scale

Camera (PTZ) and lighting with vertical movement

Rotatable saddle and encoder

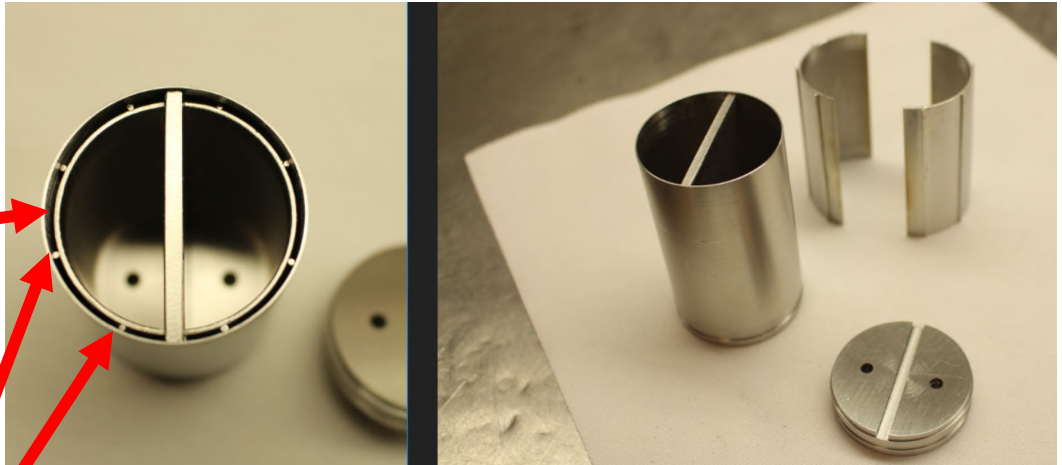
# UT Reference Standard Construction

Water is added to half the cylinder while the other half remains dry

Niobium cup ridges will only be detected when water is present

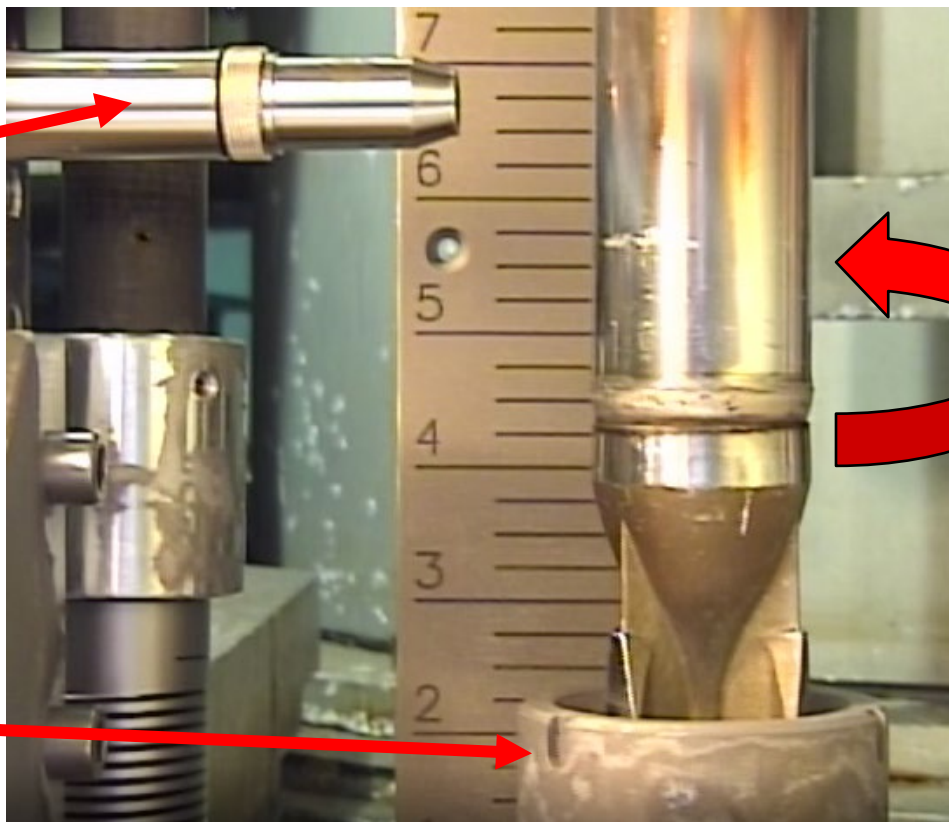
# Performing UT

Bottom UT probe  
(channel 1)

Rotatable  
saddle with  
encoder

Fuel element  
rotated 360°  
while UT  
data is  
collected

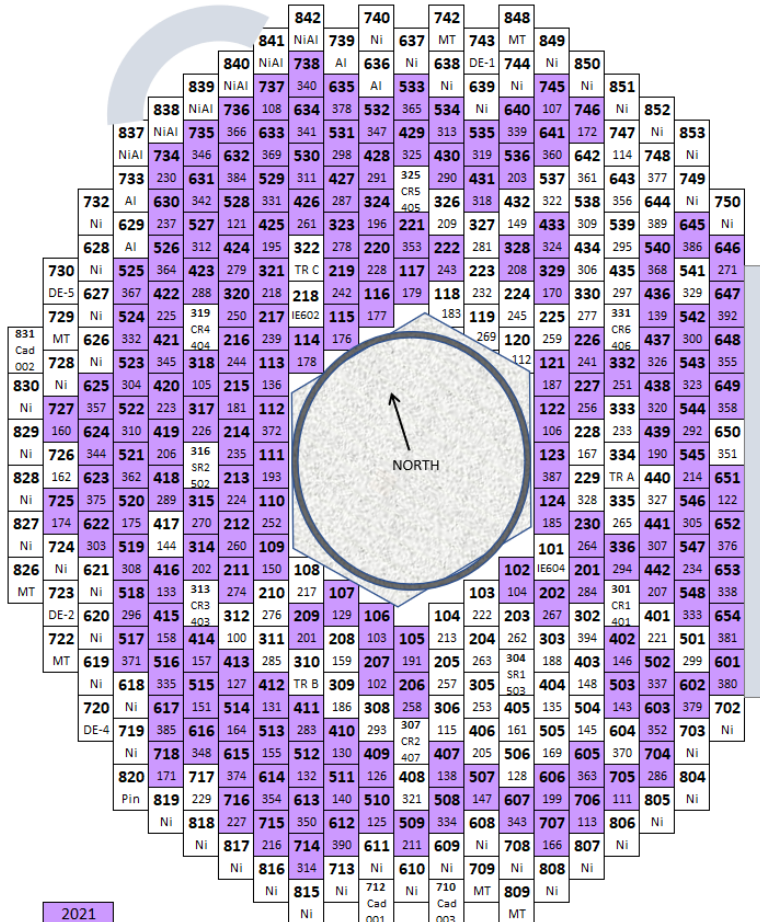
# 2021 Fuel Inspection Campaign

- Planned to inspect 169 (highlighted purple) out of 236 FEs
- 57 FEs were already inspected in 2020, so they were excluded from this list

306 Location  
115 Fuel Element Serial Number
